Report: TAB

Function: Test, Adjust, & Balance

11-18-24 WAWA #6115 GOLDSBORO, NC

Project: 11-18-24 WAWA #6115 GOLDSBORO, NC

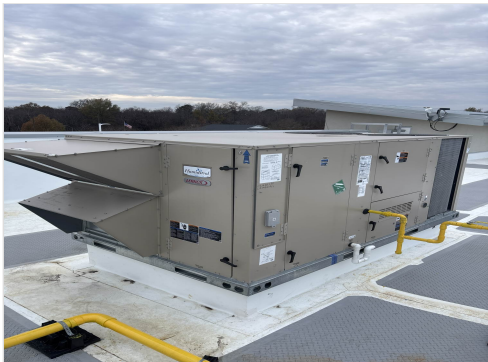
Unit Data - PHOTO LOG

Asset: RTU1

AREA:BACK OF HOUSE

Unit Data		
	Design	Actual
MFG	LENNOX	LENNOX
Serial Num	-	5624J04444
Model Num	LGT120H4E	LGT120H4EM1Y
Type	RTU	RTU
Configuration	VERTICAL	VERTICAL
Num OA Filters 1	-	2
OA Filter Size 1	-	14X23
Num Final Filter 1	-	4
Final Filter Size 1	-	20X25X2

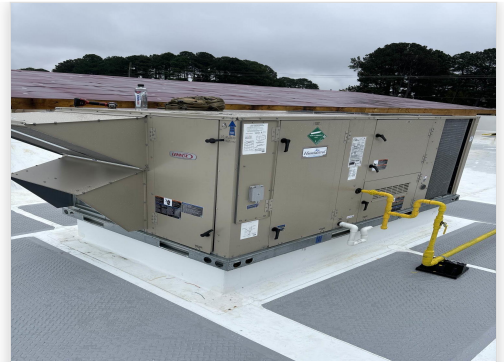
Unit Data - PHOTO LOG

Asset: RTU2

AREA:SALES

Unit Data		
	Design	Actual
MFG	LENNOX	LENNOX
Serial Num	-	5624K01031
Model Num	LGT120H4E	LGT120H4EM2Y
Type	RTU	RTU
Configuration	VERTICAL	VERTICAL
Num OA Filters 1	-	2
OA Filter Size 1	-	23.25x14.25
Num Final Filter 1	-	4
Final Filter Size 1	-	20x25x2

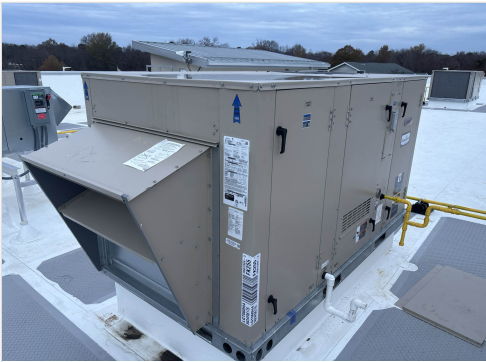
Unit Data - PHOTO LOG

Asset: RTU3

AREA:FRONT OF HOUSE

Unit Data		
	Design	Actual
MFG	LENNOX	LENNOX
Serial Num	-	5624F06176
Model Num	LGT060H4E	LGT060H4EB1Y
Type	RTU	RTU
Configuration	VERTICAL	VERTICAL
Num OA Filters 1	-	1
OA Filter Size 1	-	14.5X29
Num Final Filter 1	-	4
Final Filter Size 1	-	20x20x2
