Report: TAB

Function: Test, Adjust, & Balance

11-18-24 WAWA #6115 GOLDSBORO, NC

Project: 11-18-24 WAWA #6115 GOLDSBORO, NC

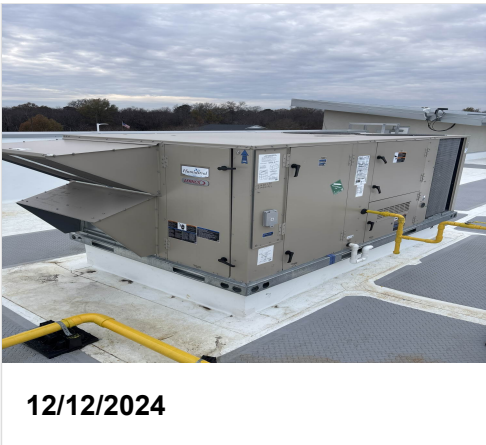
Unit Data - PHOTO LOG

Asset: RTU1

AREA:BACK OF HOUSE

Unit Data		
	Design	Actual
MFG	LENNOX	LENNOX
Serial Num	-	5624J04444
Model Num	LGT120H4E	LGT120H4EM1Y
Type	RTU	RTU
Configuration	VERTICAL	VERTICAL
Num OA Filters 1	-	2
OA Filter Size 1	-	14X23
Num Final Filter 1	-	4
Final Filter Size 1	-	20X25X2

Test Data		
	Design	Actual
SF CFM	3600	3733
SF RPM	-	DIRECT DRIVE
MOTOR RPM	-	DIRECT DRIVE
RA CFM	2900	3048
OA CFM	700	685
RL Voltage	-	210/209/210
RL Amperage	-	4.3/4.4/4.3
SF System SetPt	-	72% POWER
RA Damper Position	-	74%
RA Damper Type	-	OBD
OA Damper Position	-	26%
OA Damper Type	-	ECONOMIZER

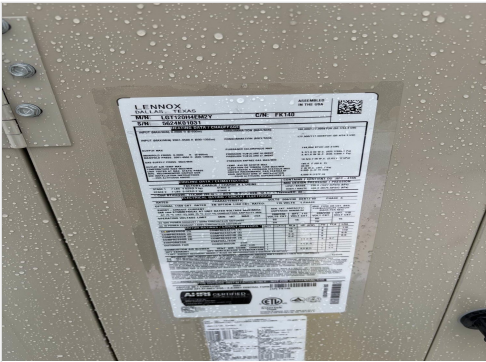
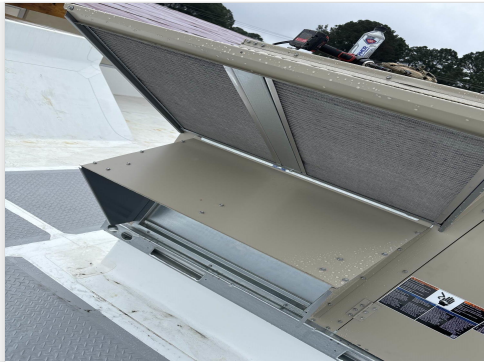
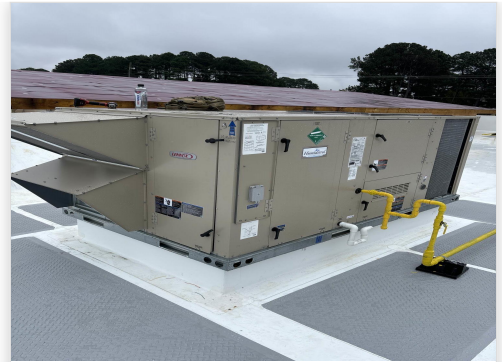
Unit Data - PHOTO LOG

Asset: RTU2

AREA:SALES

Unit Data		
	Design	Actual
MFG	LENNOX	LENNOX
Serial Num	-	5624K01031
Model Num	LGT120H4E	LGT120H4EM2Y
Type	RTU	RTU
Configuration	VERTICAL	VERTICAL
Num OA Filters 1	-	2
OA Filter Size 1	-	23.25x14.25
Num Final Filter 1	-	4
Final Filter Size 1	-	20x25x2

Test Data		
	Design	Actual
SF CFM	3250	3284
SF RPM	-	DIRECT DRIVE
MOTOR RPM	-	DIRECT DRIVE
RA CFM	2870	2893
OA CFM	380	391
RL Voltage	-	209/210/211
RL Amperage	-	1.7/1.8/1.7
SF System SetPt	-	49% (ALL)
RA Damper Position	-	69%
RA Damper Type	-	OBD
OA Damper Position	-	31%
OA Damper Type	-	ECONOMIZER

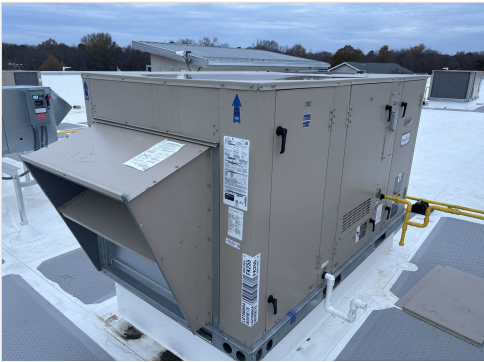
Unit Data - PHOTO LOG

Asset: RTU3

AREA:FRONT OF HOUSE

Unit Data		
	Design	Actual
MFG	LENNOX	LENNOX
Serial Num	-	5624F06176
Model Num	LGT060H4E	LGT060H4EB1Y
Type	RTU	RTU
Configuration	VERTICAL	VERTICAL
Num OA Filters 1	-	1
OA Filter Size 1	-	14.5X29
Num Final Filter 1	-	4
Final Filter Size 1	-	20x20x2

Test Data		
	Design	Actual
SF CFM	2000	1989
SF RPM	-	DIRECT DRIVE
MOTOR RPM	-	DIRECT DRIVE
RA CFM	1800	1785
OA CFM	200	204
RL Voltage	-	210/209/210
RL Amperage	-	4.5/4.6/4.5
SF System SetPt	-	55% SPEED
RA Damper Position	-	96%
RA Damper Type	-	OBD
OA Damper Position	-	4%
OA Damper Type	-	ECONOMIZER

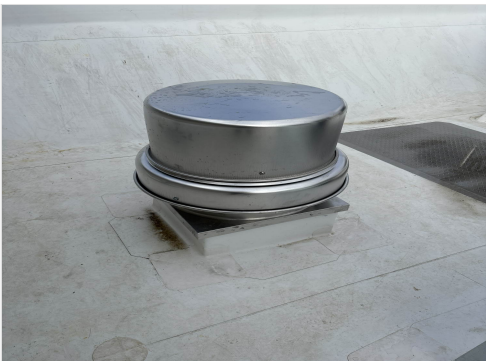
Unit Data - PHOTO LOG

Asset: EF1

AREA:RESTROOMS

Unit Data		
	Design	Actual
MFG	GREENHECK	GREENHECK
Model Num	GB-098-6	GB-098-6
Serial Num	-	25401603
Type	DOWNBLAST	DOWNBLAST
Configuration	VERTICAL	VERTICAL

Test Data		
	Design	Actual
CFM	375	378
Fan RPM	-	960
Fan Rotation	-	CW
Motor RPM	-	1752
System SetPt	-	4 TO
RL Voltage	-	120
RL Amperage	-	NA
Total ESP	0.38"	0.25"
Fan Inlet SP	-	-0.25"
Fan Discharge SP	-	ATM

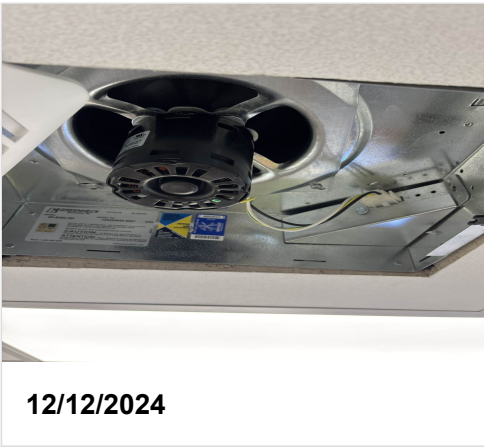
Unit Data - PHOTO LOG

Asset: EF3

AREA:TRASH/STAGING

Unit Data		
	Design	Actual
MFG	GREENHECK	GREENHECK
Model Num	SP-B200	SP-B200
Serial Num	-	1844548260057
Type	INLINE	INLINE
Configuration	HORIZONTAL	HORIZONTAL

Test Data		
	Design	Actual
CFM	200	185
Fan RPM	-	DIRECT DRIVE
Fan Rotation	-	CW
Motor RPM	-	1000
System SetPt	-	MAX SPEED ON DIAL
RL Voltage	-	120
RL Amperage	-	2.7
Total ESP	0.50"	0.07"
Fan Inlet SP	-	-0.07"
Fan Discharge SP	-	ATM
