**Report: TAB Report**  
**Function: Test, Adjust, & Balance**  
**Date: 01/15/2026**  
**Completed By: National TAB**

**PROJECT**  
**01-12-26 QT #0727 MARIETTA, GA**

QUIKTRIP  
4705 SOUTH 129TH EAST AVENUE  
TULSA, OK 74134

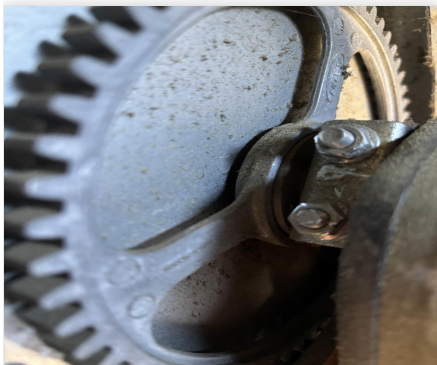
**Issue Name :** All RTUs: Economizer Can Not Be Loosened  
**Description :** The economizer on all units are unable to be loosened.  
**Created By :** National TAB                      **Assigned To :** National TAB - Dan Hertenstein  
**Status :** Open  
**Priority :** Medium                                      **Asset Tag :**  
**Originated Date :** 01/15/2026 - Sagar Patel - National TAB

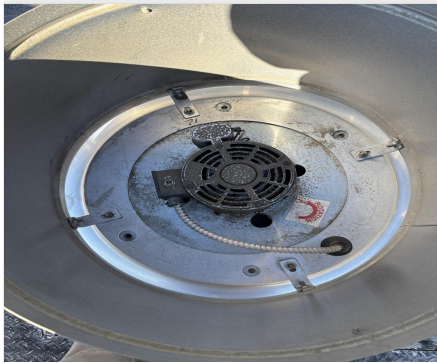
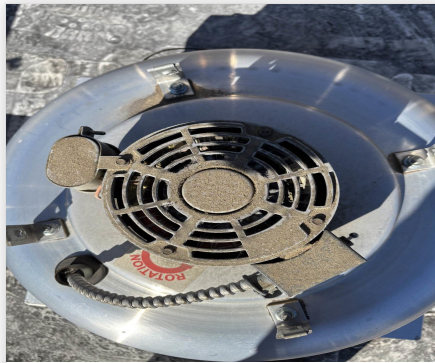
**Issue Name :** EF-1 & EF-2: No Speed Control  
**Description :** There is no speed control in order to increase or decrease the motor speed. EF-1, women's restroom, is at 407 cfm. EF-2, combi-oven exhaust and men's restroom, is low on design. Men's restroom is at 224 cfm and the combi-oven is at 117 cfm  
**Created By :** National TAB      **Assigned To :** National TAB - Dan Hertenstein  
**Status :** Open  
**Priority :** High      **Asset Tag :**  
**Originated Date :** 01/15/2026 - Sagar Patel - National TAB

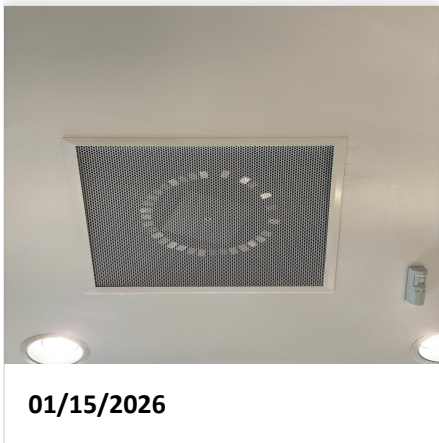
**Issue Name :** RTU-3: Incorrect Diffuser Style  
**Description :** Diffusers 3-1, 3-2, 3-3, and 3-4 are not correct. Correct style, Titus diffusers, are on back order. The substitute diffusers are causing a 5% - 20% loss around the smoke capture of the hood perimeter.  
**Created By :** National TAB                      **Assigned To :** National TAB - Dan Hertenstein  
**Status :** Open  
**Priority :** Medium                                      **Asset Tag :**  
**Originated Date :** 01/15/2026 - Sagar Patel - National TAB
