Report: TAB REPORT
Function: Test, Adjust, & Balance
Date: 10/30/2024
Completed By: National TAB

10-14-24 WALGREENS #9983
BLOOMINGTON, IL (REACTIVE)

1408 N MAIN ST

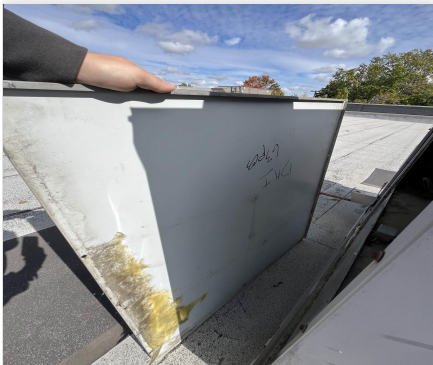
Issue Name : RTU-3 missing insulation on blower panel
Description : RTU-3 missing insulation on Blower panel door.
Created By : National TAB **Assigned To :** National TAB - Dylan Crisman
Status : Open
Priority : High **Asset Tag :**
Originated Date : 10/14/2024 - Dylan Crisman - National TAB

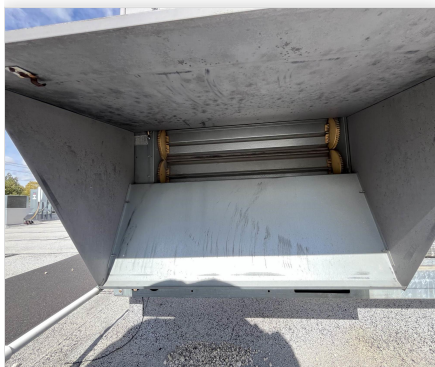
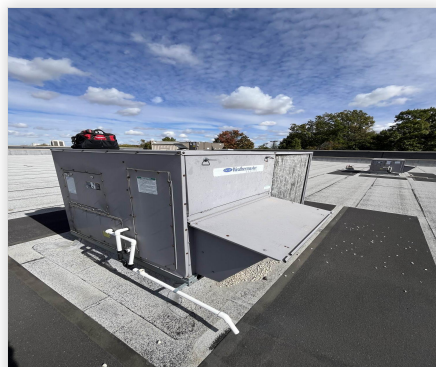
Issue Name : RTU-3 missing OA filter
Description : RTU-3 missing OA mesh filter. Recommend replacing with correct size Mesh Filter.
Created By : National TAB **Assigned To :** National TAB - Dylan Crisman
Status : Open
Priority : High **Asset Tag :**
Originated Date : 10/14/2024 - Dylan Crisman - National TAB

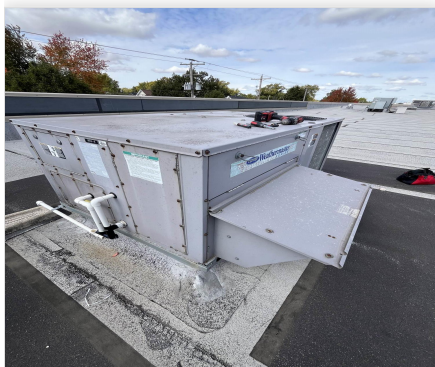
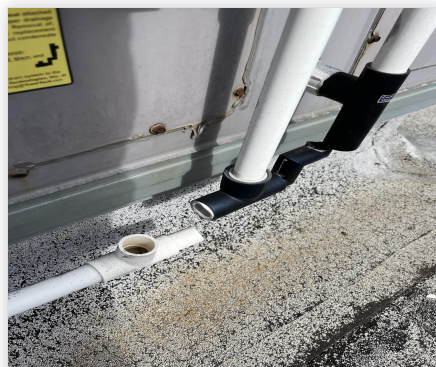
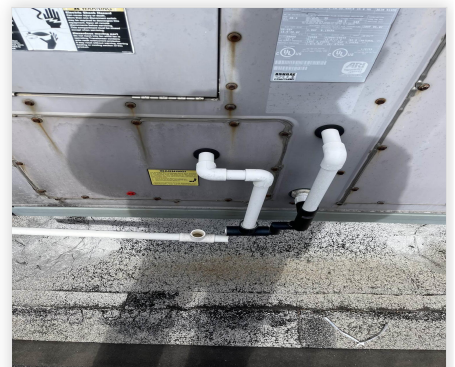
Issue Name : RTU-4 Condensate connections
Description : RTU-4 Condensate line is broken at 2 connections, recommend replacing piping and seal connections.
Created By : National TAB **Assigned To :** National TAB - Dylan Crisman
Status : Open
Priority : High **Asset Tag :**
Originated Date : 10/14/2024 - Dylan Crisman - National TAB

RTU-4 two connections on condensate line are broken, issue created.

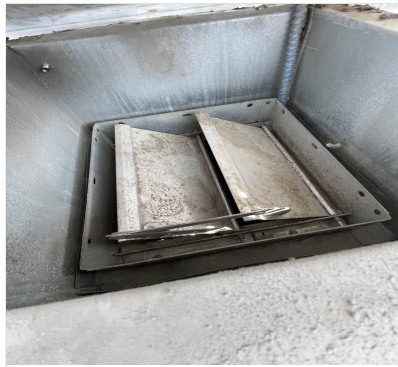
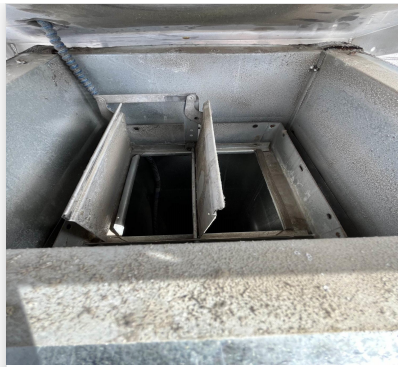
Back draft damper is installed and functional Pass

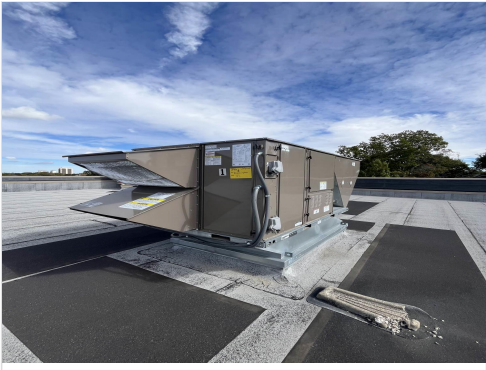
IMG_5892_1099464010.j..

General	
	Actual
Fan Rotation Correct	YES
Unit Filters Clean	YES
Condensate Drain Installed	YES

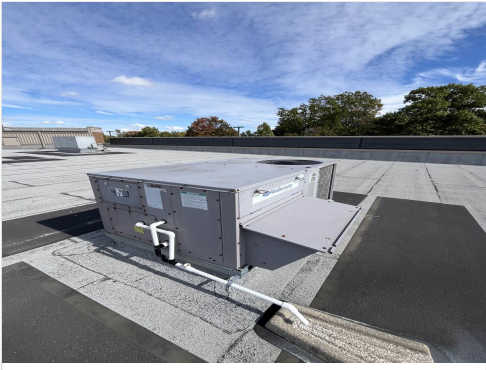
IMG_5895_1228791402.j..

General	
	Actual
Fan Rotation Correct	YES
Unit Filters Clean	YES
Condensate Drain Installed	YES

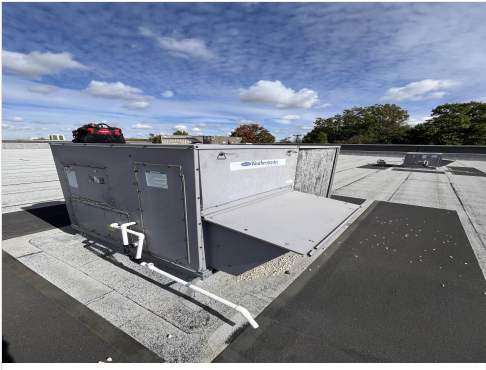
IMG_5899_431303708.jp..

General	
	Actual
Fan Rotation Correct	YES
Unit Filters Clean	YES
Condensate Drain Installed	YES

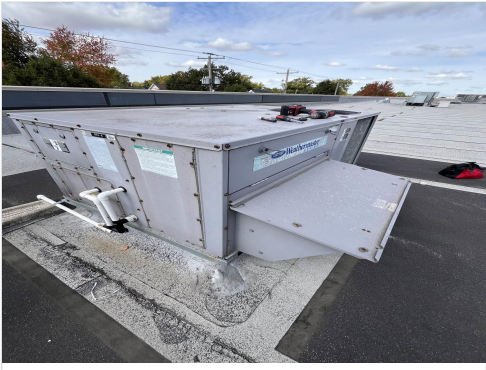
IMG_5905_1651146162.j..

General	
	Actual
Fan Rotation Correct	YES
Unit Filters Clean	YES
Condensate Drain Installed	YES

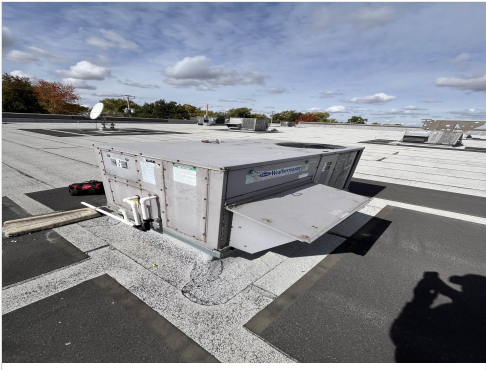
IMG_5911_1145137092.j..

General	
	Actual
Fan Rotation Correct	YES
Unit Filters Clean	YES
Condensate Drain Installed	YES

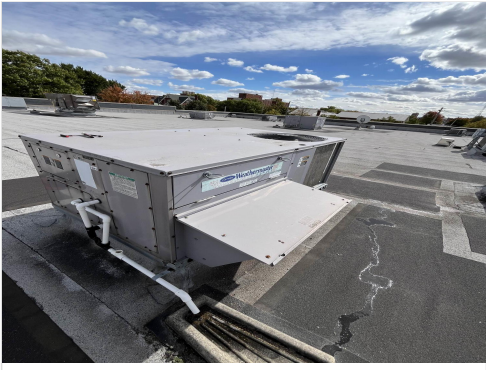
IMG_5914_1080084114.j..

General	
	Actual
Fan Rotation Correct	YES
Unit Filters Clean	YES
Condensate Drain Installed	YES

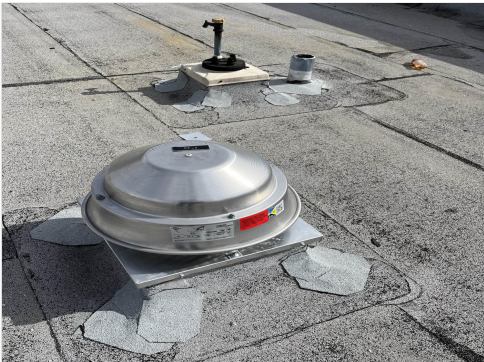
IMG_5917_1197660047.j..

Motor Data		
	Design	Actual
Motor MFG	-	GENTEQ
Frame	-	NL
Horsepower	1/15	1/5
Motor Rpm	-	1725
Phase	1	1
Voltage (rated)	120	115
Amperage (rated)	-	3.0
Service Factor	-	1.15

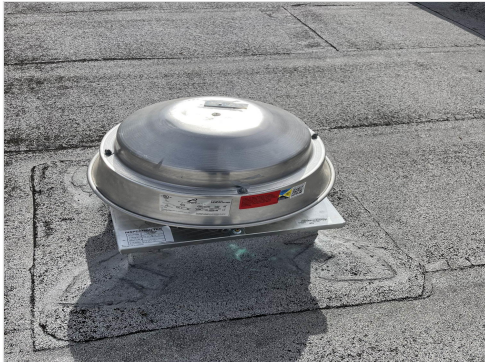
IMG_5921_517171651.jp..

Motor Data		
	Design	Actual
Motor MFG	-	GENTEQ
Frame	-	NL
Horsepower	1/15	1/5
Motor Rpm	-	1725
Phase	1	1
Voltage (rated)	120	115
Amperage (rated)	-	3.0
Service Factor	-	1.15
