Report: TAB REPORT
Function: Test, Adjust, & Balance
Date: 8/2/2022

08-01 MENDOCINO FARMS - ENCINTAS, CA

Project: 08-01 MENDOCINO FARMS - ENCINTAS, CA

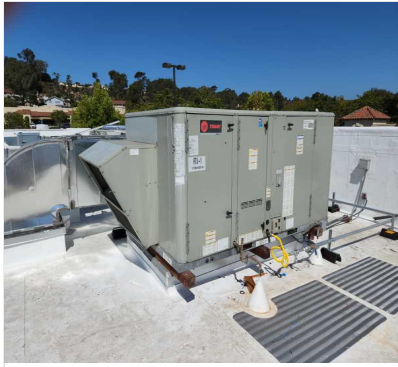
RTU-1

General		
	Design	Actual
Fan Rotation Correct	-	YES
Unit Filters Clean	-	YES
Condensate Drain Installed	-	YES, BUT NEEDS TO BE REPAIRED

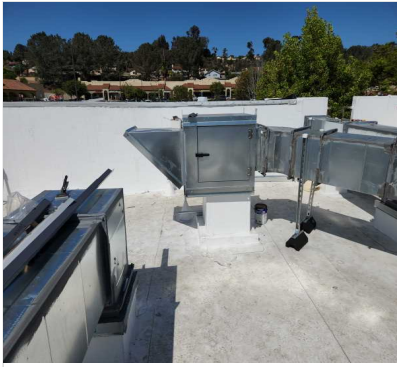
MAU-1

Rotation is correct?	Yes
Gas piping is installed and valves are in on position?	No
Heater tested and is functional?	No
Internal motorized damper is fully opening?	Yes
Motor is operating below the FLA rating?	Yes
Unit free of noticeable noise and vibration?	Yes
