Report: TAB REPORT
Function: Test, Adjust, & Balance
Date: 8/2/2022

08-01 MENDOCINO FARMS - ENCINTAS, CA

Project: 08-01 MENDOCINO FARMS - ENCINTAS, CA

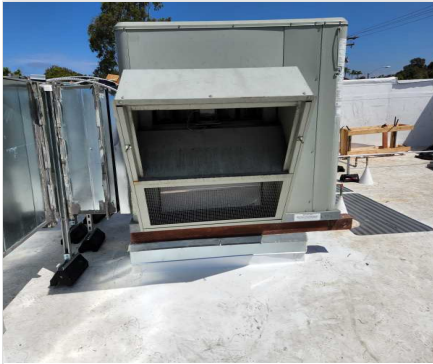
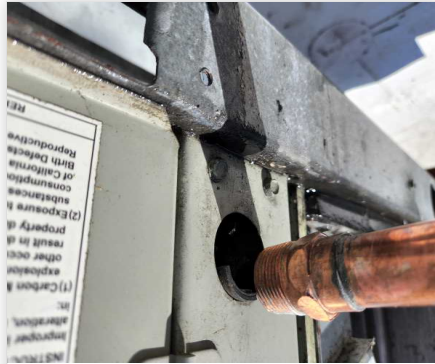
Issue Name : EXISTING RTU-1

Description : IT DID NOT AFFECT ABILITY TO COMPLETE BALANCING, BUT A COUPLE INSTALLATION ITEMS WERE NOTED ON EXISTING RTU-1. THE OA FILTER IS MISSING AND NEEDS TO BE INSTALLED. THE THREADS ARE ALSO MISSING FROM THE CONDENSATE PAN CONNECTION TO THE DRAIN, SO THE DRAIN CANNOT BE INSTALLED. RECOMMEND HAVING MECHANICAL CONTRACTOR REPAIR.
