**National TAB
1329 E. KEMPER ROAD
SUITE 4210
CINCINNATI, OH 45246**

**Report: TAB REPORT
Function: Test, Adjust, & Balance
Date: 04/20/2023**

**PROJECT
04-17-23 FREDDY'S - AUGUSTA, SC**

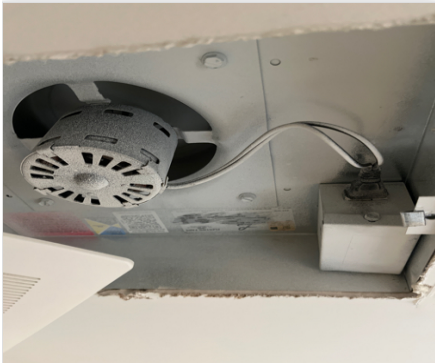
EF1.jpeg

Issue Name : EF1 / SPEED CONTROLLER

Description : EF1 IS OPERATING AT 157 CFM OUT OF 75 DESIGN CFM. NO SPEED CONTROLLER IS INSTALLED TO REDUCE AIRFLOW. NO FURTHER ACTION REQUIRED AS THE AIRFLOW EXCEEDS THE REQUIREMENT IN THE RESTROOM AND THE OVERALL BUILDING PRESSURE IS SLIGHTLY POSITIVE.

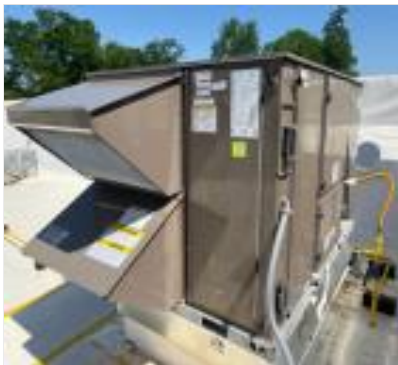
DOAS-1

Unit Data		
	Design	Actual
MFG	CAPTIVEAIRE	YORK
Serial Num	-	N243361852
Model Num	CASRTU3- I.200-15-15T- DOAS	ZJ090N18R2B5EAE1A3
Type	DOAS	RTU
Configuration	VERTICAL	VERTICAL
Num OA Filters 1	-	1
OA Filter Size 1	-	29X 19.5
Num Final Filter 1	-	4
Final Filter Size 1	-	20X24X2

Test Data		
	Design	Actual
SF CFM	3050	3092
SF RPM	-	1064
RA CFM	2450	2439
OA CFM	600	653
RL Voltage	-	211/212/211
RL Amperage	-	7.9/7.9/8.1
SF Rotation	-	CCW
RA Damper Position	-	5.75"
Min OA Damper Position	-	26%
Min OA Damper Type	-	ECON

Performance Data		
	Design	Actual
MA Plenum SP	-	-0.708"
Fan Suction SP	-	-1.03"
Fan Discharge SP	-	0.422"
Total ESP	0.5"	1.13"
Fan Total SP	-	1.452"

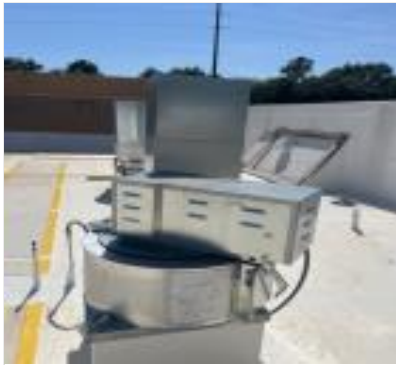
KEF-1

Test Data		
	Design	Actual
CFM	1600	1539
Fan RPM	1105	1106 / 57.7HZ
Fan Rotation	-	CCW
Motor RPM	-	1106 / 57.7 HZ
System SetPt	-	57.7 HZ
RL Voltage	-	211/210/210
RL Amperage	-	3.2
Total ESP	1.4"	N/R
Fan Inlet SP	-	N/R
Fan Discharge SP	-	ATM

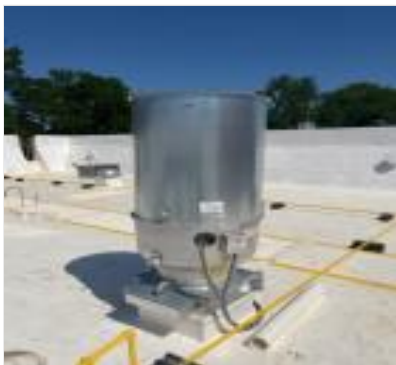
KEF-2

Test Data		
	Design	Actual
CFM	775	743
Fan RPM	1532	62% / 1116
Fan Rotation	-	CCW
Motor RPM	-	62% / 1116
System SetPt	-	62%
RL Voltage	-	121
RL Amperage	-	3.22
Total ESP	1.250"	0.583"
Fan Inlet SP	-	-0.583"
Fan Discharge SP	-	ATM

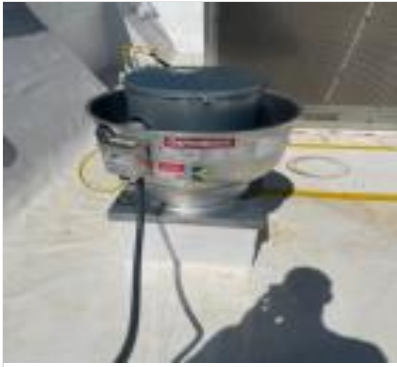
KEF-3

Test Data		
	Design	Actual
CFM	525	544
Fan RPM	1500	903
Fan Rotation	-	CCW
Motor RPM	-	903
System SetPt	-	P-50
RL Voltage	-	121
RL Amperage	-	0.88
Total ESP	0.8"	0.18"
Fan Inlet SP	-	-0.18"
Fan Discharge SP	-	ATM

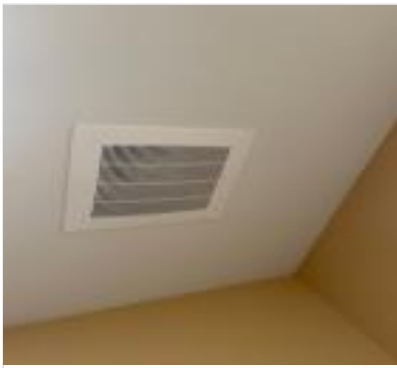
EF-1

Test Data		
	Design	Actual
CFM	75	157
Fan RPM	-	1550
Fan Rotation	-	CCW
Motor RPM	-	1550
System SetPt	-	HIGH
RL Voltage	-	122
RL Amperage	-	1.3
Total ESP	-	N/L
Fan Inlet SP	-	N/L
Fan Discharge SP	-	ATM

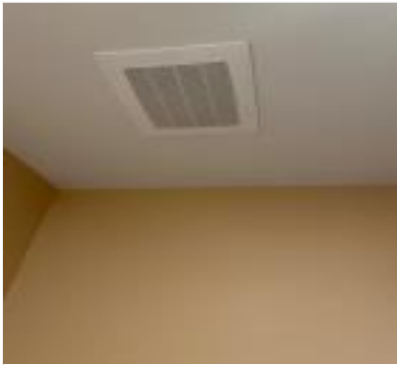
EF-2

Test Data		
	Design	Actual
CFM	150	160
Fan RPM	-	1550
Fan Rotation	-	CCW
Motor RPM	-	1550
System SetPt	-	HIGH
RL Voltage	-	121
RL Amperage	-	1.3
Total ESP	-	N/R
Fan Inlet SP	-	N/R
Fan Discharge SP	-	ATM

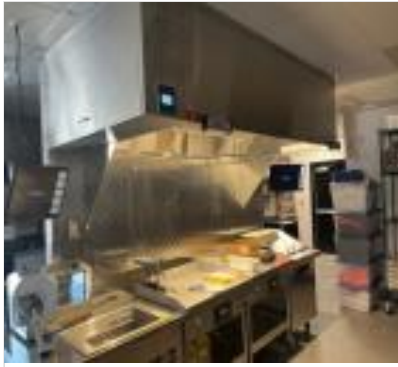
HOOD-1

Test Data Exhaust		
	Design	Actual
Filter Type	CAPTRATE SOLO	CAPTRATE SOLO
Filter Size 1	16X16	16X16
Filter Qty 1	5	5
Filter AK factor size 1	1.62	1.62
Filter Total AK Area	8.1	8.1
Filter1 FPM	-	196
Filter2 FPM	-	194
Filter3 FPM	-	197
Filter4 FPM	-	186
Filter5 FPM	-	175
Filter Ave FPM(corr)	-	190
CFM	1600	1539

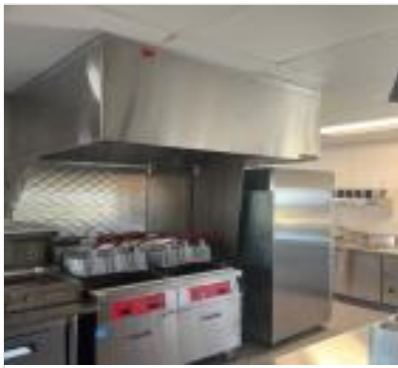
HOOD-2

Design	Actual
Filter Type	CAPTRATE SOLO	CAPTRATE SOLO
Filter Size 1	16X16	16X16
Filter Qty 1	3	3
Filter AK factor size 1	1.62	1.62
Filter Total AK Area	4.86	4.86
Filter1 FPM	-	161
Filter2 FPM	-	152
Filter3 FPM	-	147
Filter Ave FPM(corr)	-	153
CFM	775	743

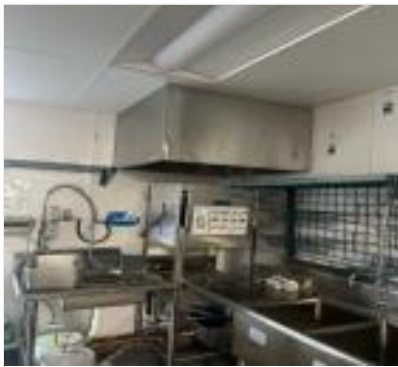
HOOD-3

Test Data		
	Design	Actual
Exhaust CFM	525	544
