**National TAB
1329 E. KEMPER ROAD
SUITE 4210
CINCINNATI, OH 45246**

**Report: TAB REPORT
Function: Test, Adjust, & Balance
Date: 04/20/2023**

**PROJECT
04-17-23 FREDDY'S - AUGUSTA, SC**

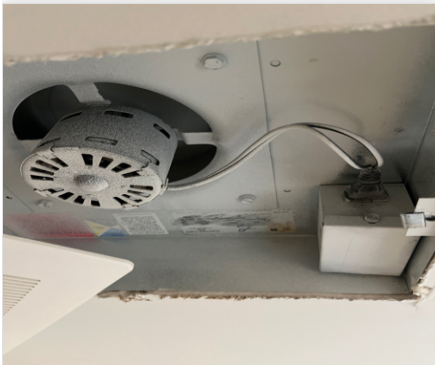
EF1.jpeg

Issue Name : EF1 / SPEED CONTROLLER

Description : EF1 IS HIGH OF DESIGN CFM. NO SPEED CONTROLLER IS INSTALLED. THIS IS A NON-CRITICAL ISSUE. RR HAS NEGATIVE PRESSURE.

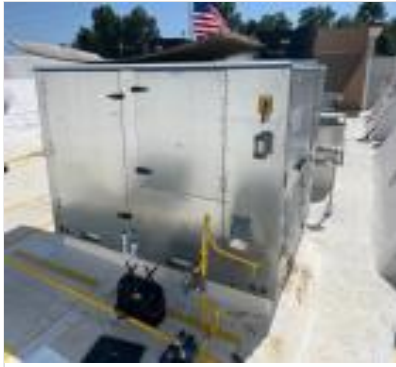
DOAS-2

General		
	Design	Actual
Fan Rotation Correct	-	YES
Unit Filters Clean	-	NO
Condensate Drain Installed	-	YES
