**Report: FINAL TAB REPORT
Function: Test, Adjust, & Balance
Date: 09/27/2022**

**PROJECT
09-26 NIKE - THE WOODLANDS, TX**

Project: 09-26 NIKE - THE WOODLANDS, TX

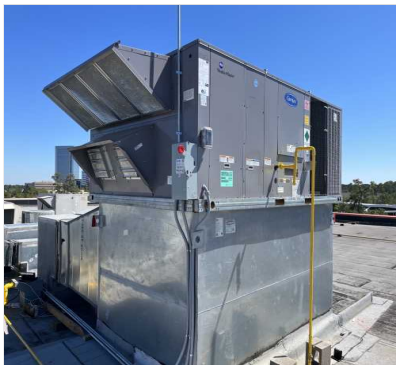
Economizers are assembled and functional?	YES
Motors are all operating below the FLA rating?	RTU-1 OPERATING AT FLA.
Are belts tight?	YES
If direct drive unit is the speed controller working.	N/A
Is gas piping installed and valves turned on?	YES
Unit free of noticeable noise and vibration	YES

Test Data		
	Design	Actual
SF CFM	3660	3681
SF RPM	-	826
RA CFM	2675	2726
OA CFM	985	955
RL Voltage	-	479/480/477
RL Amperage	-	4.3/4.6/4.6
SF Rotation	-	CW
RA Damper Position	-	65%
Min OA Damper Position	-	35%
Min OA Damper Type	-	OPPOSED BLADE

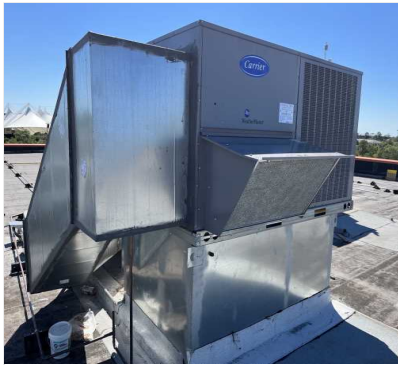
Each VAV-diffuser is calibrated for max airflow?	VAV DIFFUSERS NOT SET YET DUE TO RTU-2 BEING DUCTED BACKWARDS. VAV DIFFUSERS TO BE SET AT RETURN TRIP ON 9/30. (RETURN TRIP COMPLETED. VAV DIFFUSER BALANCE COMPLETED.)
Each VAV diffuser is set for minimum airflow? Record value in notes on the individual diffuser asset	VAV DIFFUSERS NOT SET YET DUE TO RTU-2 BEING DUCTED BACKWARDS. VAV DIFFUSERS TO BE SET AT RETURN TRIP ON 9/30. (RETURN TRIP COMPLETED. VAV DIFFUSER BALANCE COMPLETED.)

Test Data		
	Design	Actual
SF CFM	2135	2164
SF RPM	-	988
RA CFM	1785	1797
OA CFM	350	367
RL Voltage	-	482/482/484
RL Amperage	-	2.8/2.8/2.8
SF Rotation	-	CCW
RA Damper Position	-	75%
Min OA Damper Position	-	25%
Min OA Damper Type	-	OPPOSED BLADE

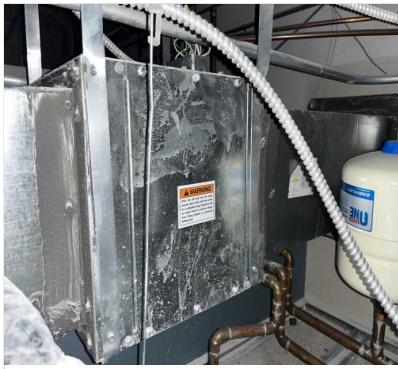
EF-1

Test Data		
	Design	Actual
CFM	200	200
Fan RPM	1548	DIRECT DRIVE
Fan Rotation	-	CW
Motor RPM	-	DIRECT DRIVE
System SetPt	-	LOW
RL Voltage	-	121
RL Amperage	-	0.94
Total ESP	0.5"	0.39"
Fan Inlet SP	-	-0.22"
Fan Discharge SP	-	0.17"

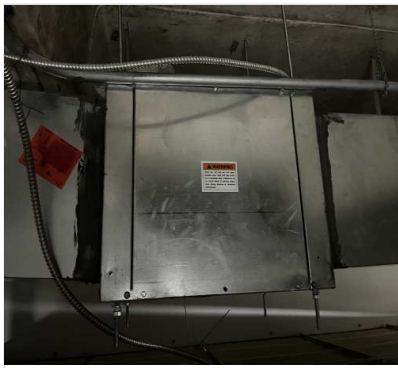
EF-2 DOES NOT EXHAUST AIR TO OUTSIDE. EF-2 AIR FLOW REMOVED FROM NET PRESSURIZATION CALCULATION.

Rotation is correct?	YES
Belts are tight?	N/A
There is no major leakage around base of fan?	YES
Is the motor operating below the motor FLA rating?	YES
For restroom fan(s) is the back draft damper installed and can it fully open?	YES
Unit free of noticeable noise and vibration?	EF-2 RATTLES DURING OPERATION. UNIT KEPT OFF. FAN TO BE BALANCED ON RETURN TRIP ON 9/30. (RETURN TRIP COMPLETED. EF-2 BALANCED TO DESIGN.)

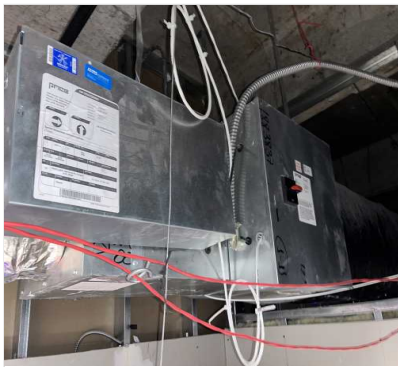
VAV- 1

Asset									
Asset Name	Type	Size	Design Max CFM	Max CFM	Design Min CFM	Min CFM	Design Heat CFM	Heat CFM	Ak (max)
VAV1	VAV	12"	975	975	0	0	535	540	2250
VAV2	VAV	7"	300	279	175	170	175	178	670
