**Report: TAB REPORT**  
**Function: Test, Adjust, & Balance**  
**Date: 07/19/2023**

## 06-26-23 CARMAX #7179 - MILWAUKEE, WI

11011 WEST METRO BLVD

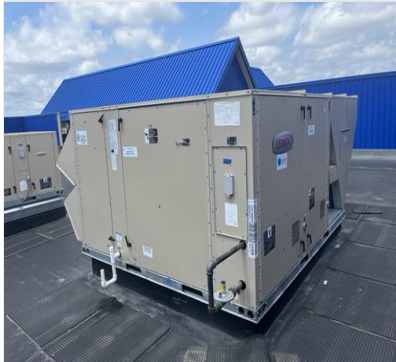
**RTU-2(1)**  
**07/19/2023**

On arrival, RTU-1 and RTU-2 motors operating above FLA. Fans were slowed to within amperage rating.

RTU-2 economizer was not operating on arrival. Damper was not attached to actuator. NTAB corrected.

See issue regarding service to RTU-2.
