**Report: TAB REPORT**  
**Function: Test, Adjust, & Balance**  
**Date: 07/19/2023**

## 06-26-23 CARMAX #7179 - MILWAUKEE, WI

## Issue List

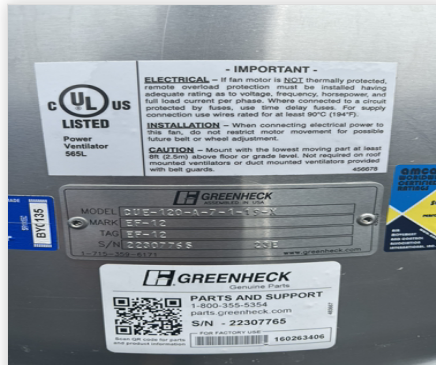
**Issue Name :** EF-12 High On Airflow  
**Description :** EF-12 measured at 2,037 CFM. Unable to decrease flow. Currently a single speed fan. Recommend having a speed controller installed.  
**Created By :** National TAB **Assigned To :** National TAB - Dylan Crisman  
**Status :** Open  
**Originated Date :** 06/29/2023 - Dylan Crisman - National TAB

**EF12motorhousing  
06/29/2023**

**EF12  
06/29/2023**

[1] UNABLE TO SLOW FAN TO DESIGN W/O SPEED CONTROL.

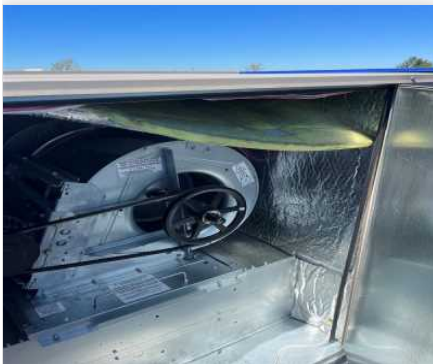
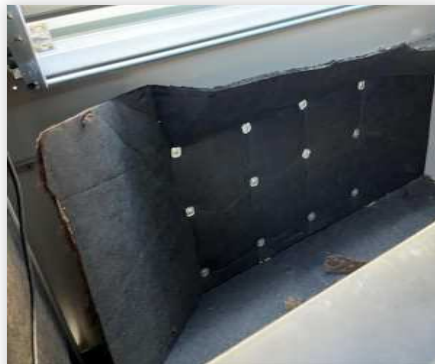
**Issue Name :** RTU-9 and 10 Internal Insulation Loose  
**Description :** Both RTUs 9 and ten have insulation hanging loose that may lead to issues with the unit. RTU-9 in the blower compartment, RTU-10 in the mixed air compartment, Recommend insulation is corrected so as to not cause future issues with RTUs. OA filter found in 9 removed.  
**Created By :** National TAB                      **Assigned To :** National TAB - Michael McDonnell  
**Status :** Open  
**Originated Date :** 08/31/2023 - Michael McDonnell - National TAB

**RTU\_9\_Insulation  
08/31/2023**

**RTU\_10\_insulation  
08/31/2023**

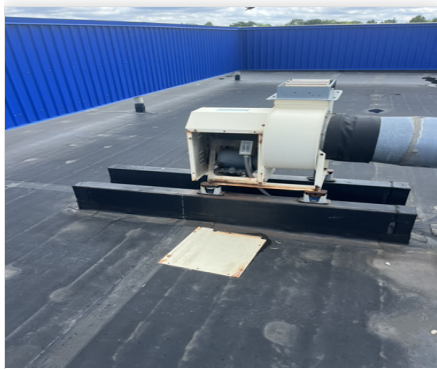
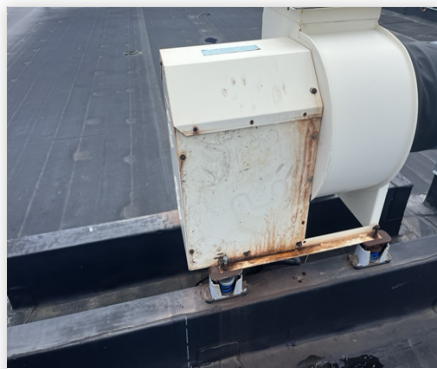
**Issue Name :** Utility Exhaust Fan on Roof- Cover Not Installed  
**Description :** Utility fan above the service garage (not in scope) did not have its motor covered installed. Cover was temporarily affixed with screws located on roof. Recommend cover is properly secured.  
**Created By :** National TAB                      **Assigned To :** National TAB - Michael McDonnell  
**Status :** Open  
**Originated Date :** 07/16/2023 - Michael McDonnell - National TAB

**Coveroff**  
**07/16/2023**

**Temporarysecure**  
**07/16/2023**
