Report: TAB REPORT
Function: Test, Adjust, & Balance
Date: 07/19/2023

06-26-23 CARMAX #7179 - MILWAUKEE, WI

Issue List

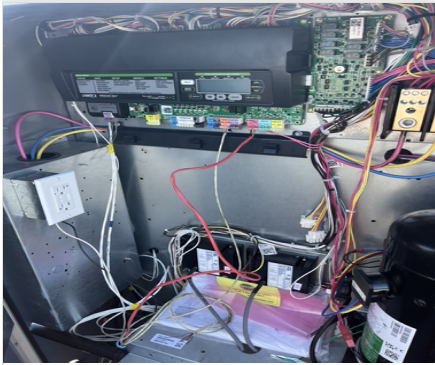
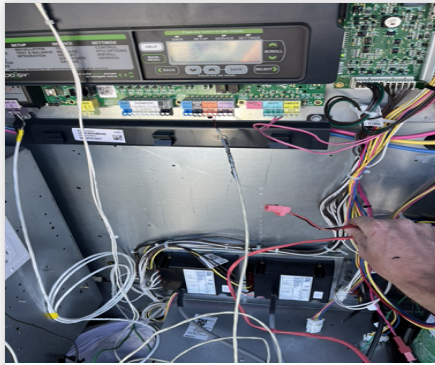
Issue Name : DI Smoke is not Landed in RTU-10
Description : DI Smoke input is not connected in RTU-10. Unsure of reason, left disconnected. Recommend service.
Created By : National TAB **Assigned To :** National TAB - Michael McDonnell
Status : Open
Originated Date : 08/31/2023 - Michael McDonnell - National TAB

**RTU-9connected
08/31/2023**

**RTU-10disconnected.jp..
08/31/2023**

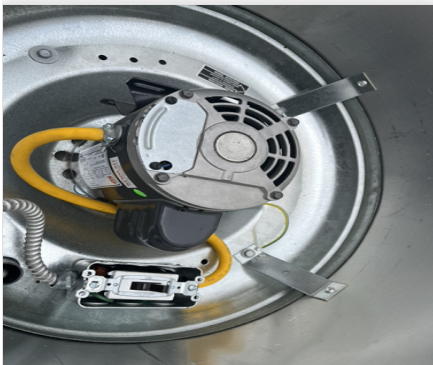
Issue Name : EF-12 High On Airflow
Description : EF-12 measured at 2,037 CFM. Unable to decrease flow. Currently a single speed fan. Recommend having a speed controller installed.
Created By : National TAB **Assigned To :** National TAB - Dylan Crisman
Status : Open
Originated Date : 06/29/2023 - Dylan Crisman - National TAB

EF12motorhousing
06/29/2023

EF12
06/29/2023

[1] UNABLE TO SLOW FAN TO DESIGN W/O SPEED CONTROL.

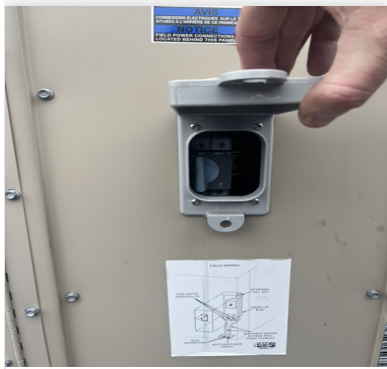
Disconnect
07/16/2023

- **07/16/2023 National TAB - Michael McDonnell**
 - Disconnect switch is not accessible and cannot be operated without removing outer unit cover. Recommend service.

Yes, however RTU-2 disconnect switch cannot be operated without removing unit cover. Recommend service.

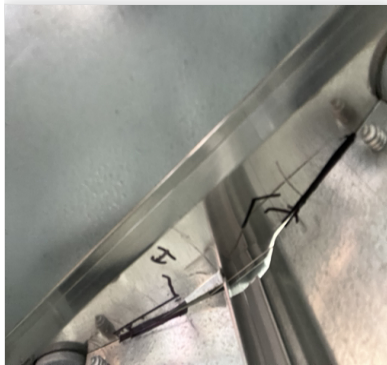
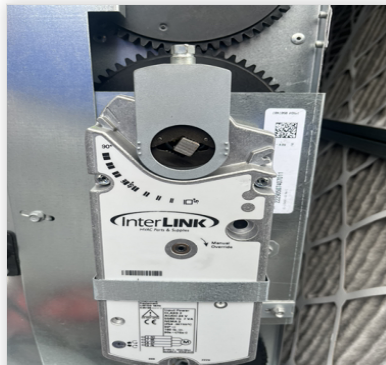
- Economizer dampers were not secured to actuator and were not opening or closing. NTAB tech secured dampers to actuator and performed calibration. Recommend actuator and dampers are inspected. OA positions marked on damper.

Positions marked
07/16/2023

Actuator not secured
07/16/2023

RTU-2 economizer was not operating on arrival. Damper was not attached to actuator. NTAB corrected but recommend damper is inspected.

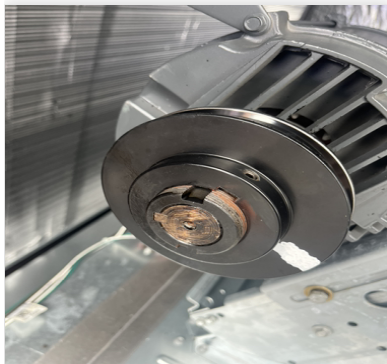
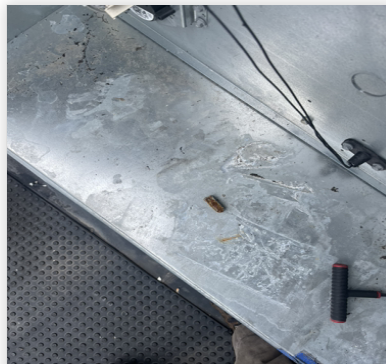
- Motor sheave set key was found on bottom of blower compartment and sheave was frozen, turned all the way in at 0 turns open. NTAB tech was able to break pulley loose and reduce motor speed to below motor FLA.

Sheavefrozen
07/16/2023

Setkeynotinstalled
07/16/2023

On arrival, RTU-1 and RTU-2 motors operating above FLA. Fans were slowed to within amperage rating.

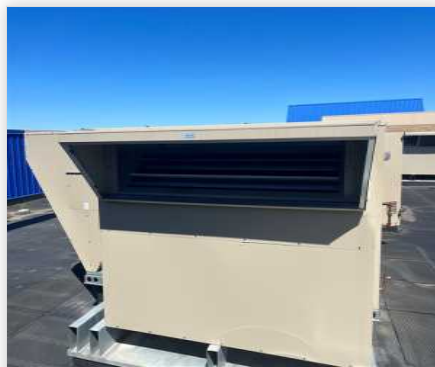
Issue Name : RTU-9 and RTU-10 OA filters Not installed.
Description : RTU-9 has one OA filter installed, it is clogged, recommend it is cleaned. The other filter is missing. Both OA filters on RTU-10 are missing.
Created By : National TAB **Assigned To :** National TAB - Michael McDonnell
Status : Open
Originated Date : 07/16/2023 - Michael McDonnell - National TAB

**RTU10nofilters
08/31/2023**

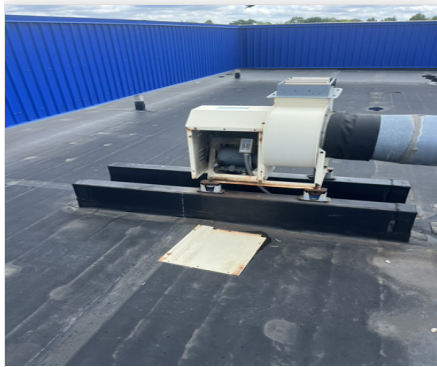
Issue Name : Utility Exhaust Fan on Roof- Cover Not Installed
Description : Utility fan above the service garage (not in scope) did not have its motor covered installed. Cover was temporarily affixed with screws located on roof. Recommend cover is properly secured.
Created By : National TAB **Assigned To :** National TAB - Michael McDonnell
Status : Open
Originated Date : 07/16/2023 - Michael McDonnell - National TAB

Coveroff
07/16/2023

Temporarysecure
07/16/2023
