National TAB  
1329 E. KEMPER ROAD  
SUITE 4210  
CINCINNATI, OH 45246

**Report: TAB REPORT**  
**Function: Test, Adjust, & Balance**  
**Date: 07/19/2023**

**06-26-23 CARMAX #7179 - MILWAUKEE, WI**

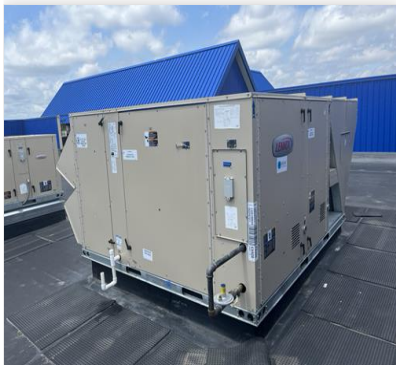
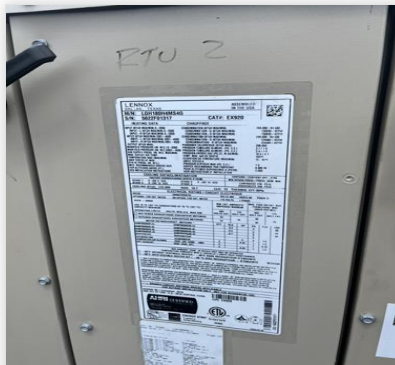
**RTU-2(1)**  
**07/19/2023**

On arrival, RTU-1 and RTU-2 motors operating above FLA. Fans were slowed to within amperage rating.

RTU-2 economizer was not operating on arrival. Damper was not attached to actuator. NTAB corrected.

See issue regarding service to RTU-2.

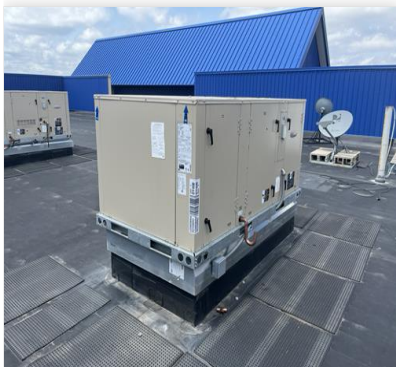
**RTU-6**  
**07/19/2023**

Yes, RTU-6 does not have heat.
