Report: TAB REPORT
Function: Test, Adjust, & Balance
Date: 07/19/2023

06-26-23 CARMAX #7179 - MILWAUKEE, WI

Issue List

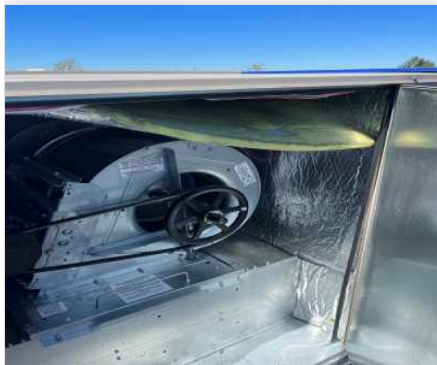
**RTU_9_Insulation
08/31/2023**

Issue Name : 5. RTU-9 and 10 Internal Insulation Loose
Description : Both RTUs 9 and ten have insulation hanging loose that may lead to issues with the unit. RTU-9 in the blower compartment, RTU-10 in the mixed air compartment, Recommend insulation is corrected so as to not cause future issues with RTUs.
Created By : National TAB **Assigned To :** National TAB - Michael McDonnell
Status : Open
Priority : Low **Asset Tag :**
Originated Date : 08/31/2023 - Michael McDonnell - National TAB

Notes:
[1] INSULATION LOOSE IN BLOWER COMPARTMENT.

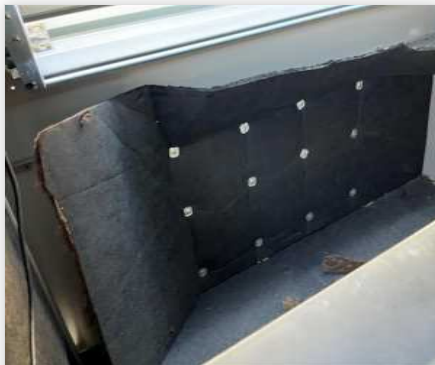
**RTU_10_insulation
08/31/2023**

[1] INSULATION LOOSE IN MIXED AIR COMPARTMENT.
