Report: TAB REPORT
Function: Test, Adjust, & Balance
Date: 07/19/2023

06-26-23 CARMAX #7179 - MILWAUKEE, WI

Issue List

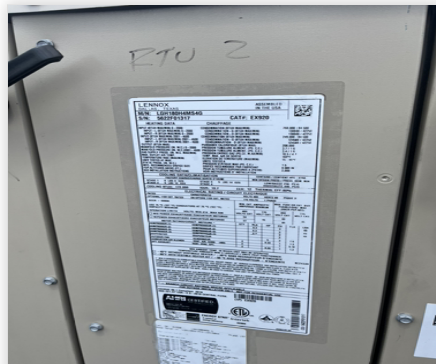
RTU-2(1)
07/16/2023

Issue Name : 2. RTU-2: Recommend Service
Description : RTU-2 was found with several issues and it's motor was operating above FLA on arrival. The supply vfd is running at 20 HZ at times when normal operation calls for it to be off. VFD amperage was measured unstable on arrival. Recommend unit is inspected and serviced.
Created By : National TAB **Assigned To :** National TAB - Michael McDonnell
Status : Open
Originated Date : 07/16/2023 - Michael McDonnell - National TAB

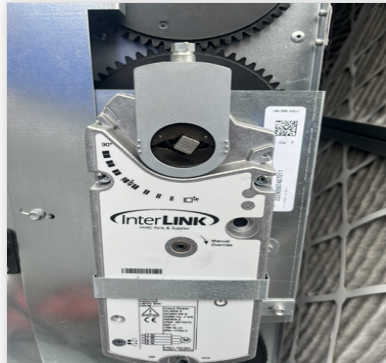
- Economizer dampers were not secured to actuator and were not opening or closing. NTAB tech secured dampers to actuator and performed calibration. Recommend actuator and dampers are inspected. OA positions marked on damper.

Positions marked
07/16/2023

Actuator not secured
07/16/2023

RTU-2 economizer was not operating on arrival. Damper was not attached to actuator. NTAB corrected but recommend damper is inspected.

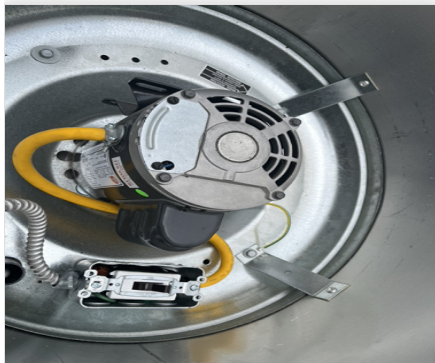
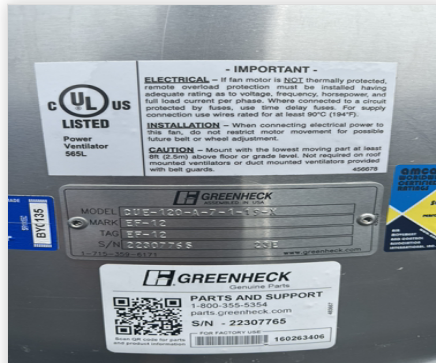
**EF12
06/29/2023**

Issue Name : 3. EF-12 High On Airflow
Description : EF-12 measured at 2,037 CFM. Unable to decrease flow. Currently a single speed fan. Recommend having a speed controller installed.
Created By : National TAB **Assigned To :** National TAB - Dylan Crisman
Status : Open
Originated Date : 06/29/2023 - Dylan Crisman - National TAB

[1] UNABLE TO SLOW FAN TO DESIGN W/O SPEED CONTROL.

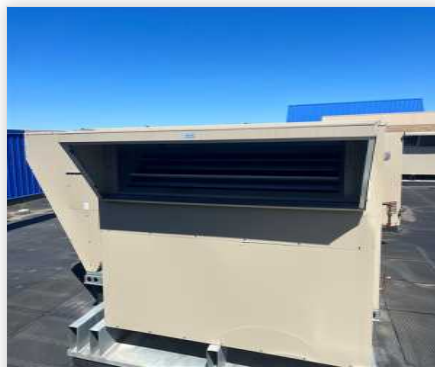
Issue Name : 6. RTU-9 and RTU-10 OA filters Not installed.
Description : RTU-9 has one OA filter installed, it is clogged, recommend it is cleaned. The other filter is missing. Both OA filters on RTU-10 are missing.
Created By : National TAB **Assigned To :** National TAB - Michael McDonnell
Status : Open
Originated Date : 07/16/2023 - Michael McDonnell - National TAB

**RTU-9filterdirty
07/16/2023**

**RTU10nofilters
08/31/2023**
