Report: TAB REPORT
Function: Test, Adjust, & Balance
Date: 07/19/2023

06-26-23 CARMAX #7179 - MILWAUKEE, WI

Issue List

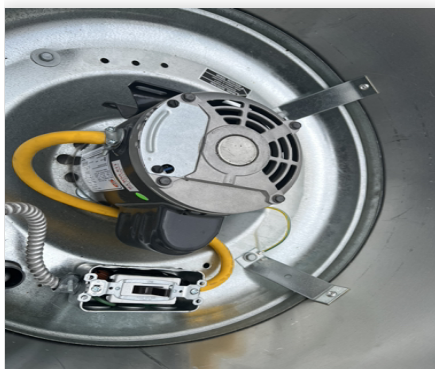
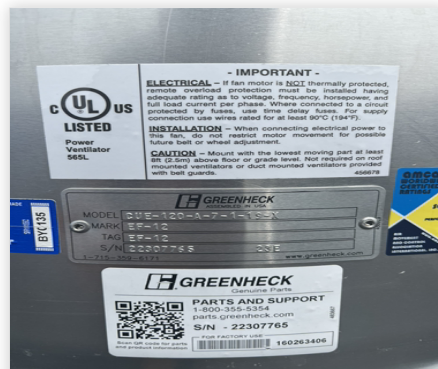
Issue Name : 3. EF-12 High On Airflow
Description : EF-12 measured at 2,037 CFM. Unable to decrease flow. Currently a single speed fan. Recommend having a speed controller installed.
Created By : National TAB **Assigned To :** National TAB - Dylan Crisman
Status : Open
Priority : Urgent **Asset Tag :**
Originated Date : 06/29/2023 - Dylan Crisman - National TAB

EF12motorhousing
06/29/2023

EF12
06/29/2023

- **01/19/2024 National TAB - Michael McDonnell**
 - On Return Trip, speed controller was found installed on fan. The controller, however, is not functional. It is only functioning as a disconnect, and is not able to adjust fan RPM. Fan could not be slowed into design; Needs service.

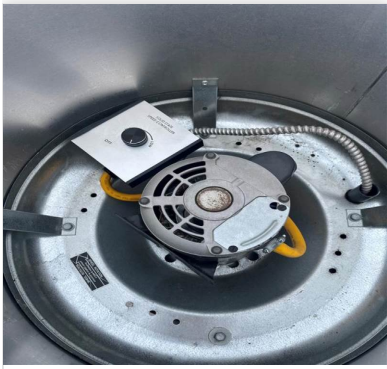
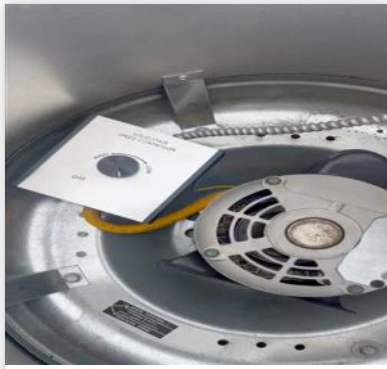
Speed_Controller
01/19/2024

Not_Functional
01/19/2024

[1] SPEED CONTROLLER WAS INSTALLED AS OF VISIT 1/18/24. CONTROLLER IS NOT FUNCTIONAL, SEE ISSUE. UNABLE TO SLOW FAN INTO DESIGN.

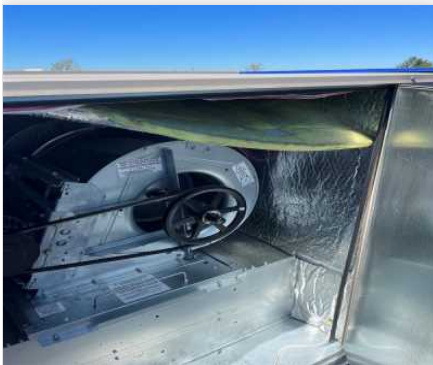
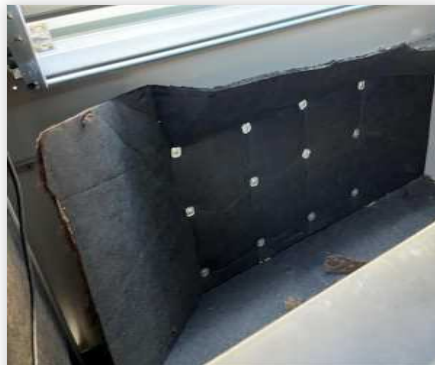
Issue Name : 5. RTU-9 and 10 Internal Insulation Loose
Description : Both RTUs 9 and ten have insulation hanging loose that may lead to issues with the unit. RTU-9 in the blower compartment, RTU-10 in the mixed air compartment, Recommend insulation is corrected so as to not cause future issues with RTUs.
Created By : National TAB **Assigned To :** National TAB - Michael McDonnell
Status : Open
Priority : Urgent **Asset Tag :**
Originated Date : 08/31/2023 - Michael McDonnell - National TAB

**RTU_9_Insulation
08/31/2023**

**RTU_10_insulation
08/31/2023**

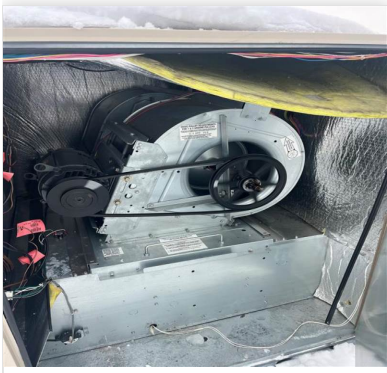
Insulation_Hanging
01/19/2024

- **01/19/2024 National TAB - Michael McDonnell**
 - On Return 1/18/24, insulation still hanging in blower compartment.

Notes:
[1] INSULATION LOOSE IN BLOWER COMPARTMENT.

[1] INSULATION LOOSE IN MIXED AIR COMPARTMENT.
