**Report: TAB REPORT**  
**Function: Test, Adjust, & Balance**  
**Date: 07/19/2023**

**06-26-23 CARMAX #7179 - MILWAUKEE, WI**

11011 WEST METRO BLVD

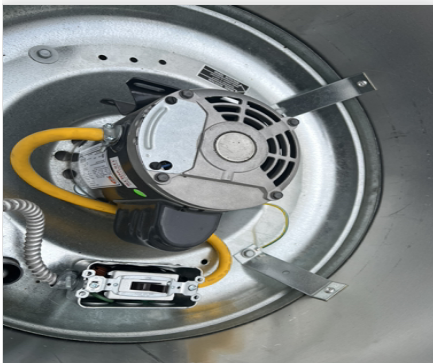
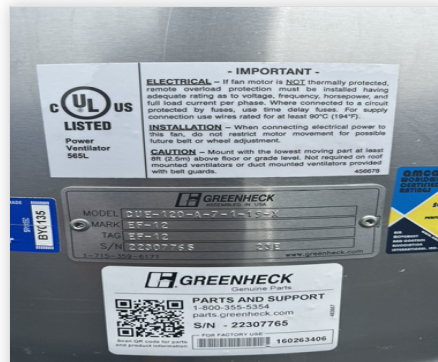
EF12  
06/29/2023

**Issue Name :** EF-12 High On Airflow  
**Description :** EF-12 measured at 2,037 CFM. Unable to decrease flow. Currently a single speed fan. Recommend having a speed controller installed.  
**Created By :** National TAB  
**Assigned To :** National TAB - Dylan Crisman  
**Status :** Open  
**Originated Date :** 06/29/2023 - Dylan Crisman - National TAB

[1] UNABLE TO SLOW FAN TO DESIGN W/O SPEED CONTROL.

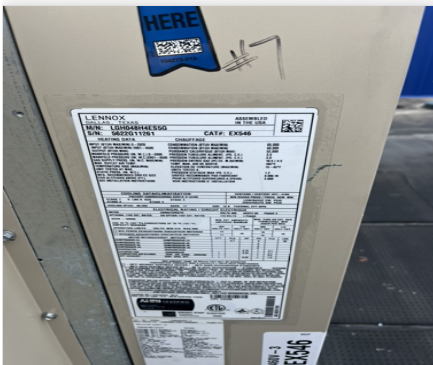
RTU-7  
07/16/2023

**Issue Name :** RTU-7: Needs Service  
**Description :** RTU-7 supply fan vibrates and makes noise when in high speed. Recommend unit is serviced.  
**Created By :** National TAB **Assigned To :** National TAB - Michael McDonnell  
**Status :** Open  
**Originated Date :** 07/16/2023 - Michael McDonnell - National TAB

All except RTU-7. See motor vibration issue.

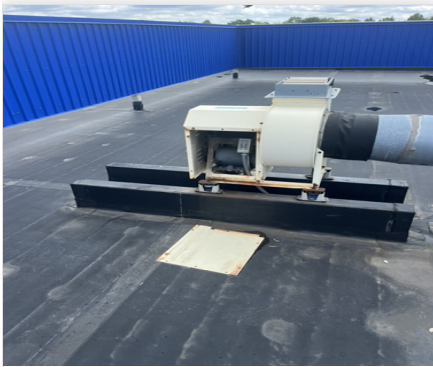
Coveroff  
07/16/2023

**Issue Name :** Utility Exhaust Fan on Roof- Cover Not Installed  
**Description :** Utility fan above the service garage (not in scope) did not have its motor covered installed. Cover was temporarily affixed with screws located on roof. Recommend cover is properly secured.  
**Created By :** National TAB      **Assigned To :** National TAB - Michael McDonnell  
**Status :** Open  
**Originated Date :** 07/16/2023 - Michael McDonnell - National TAB

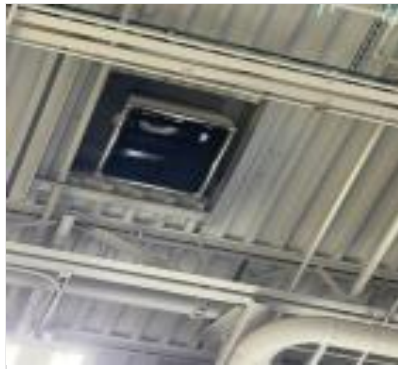
EF12backdraftdamper.j..  
06/29/2023

Is back draft damper installed?

Yes
