**Report: TAB REPORT**  
**Function: Test, Adjust, & Balance**  
**Date: 07/19/2023**

## 06-26-23 CARMAX #7179 - MILWAUKEE, WI

## Issue List

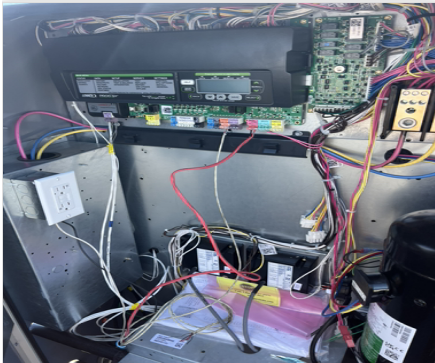
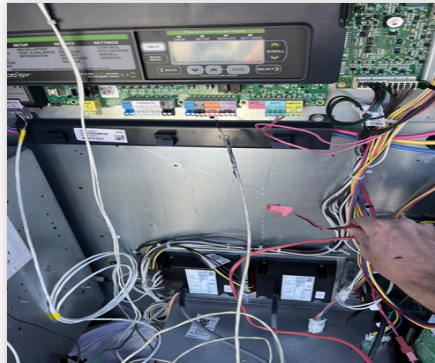
**Issue Name :** DI Smoke is not Landed in RTU-10  
**Description :** DI Smoke input is not connected in RTU-10. Unsure of reason, left disconnected. Recommend service.  
**Created By :** National TAB                      **Assigned To :** National TAB - Michael McDonnell  
**Status :** Open  
**Originated Date :** 08/31/2023 - Michael McDonnell - National TAB

**RTU-9connected  
08/31/2023**

**RTU-10disconnected.jp..  
08/31/2023**

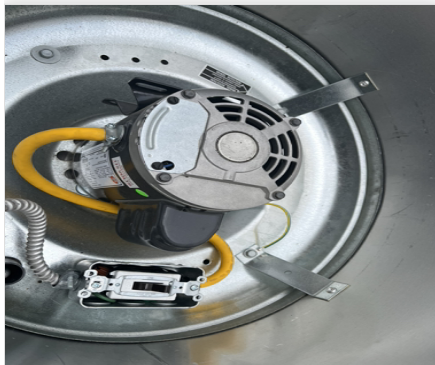
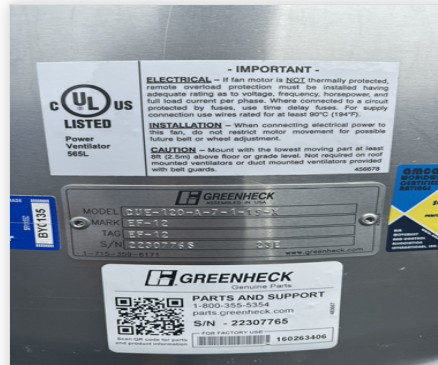
**Issue Name :** EF-12 High On Airflow  
**Description :** EF-12 measured at 2,037 CFM. Unable to decrease flow. Currently a single speed fan. Recommend having a speed controller installed.  
**Created By :** National TAB **Assigned To :** National TAB - Dylan Crisman  
**Status :** Open  
**Originated Date :** 06/29/2023 - Dylan Crisman - National TAB

**EF12motorhousing  
06/29/2023**

**EF12  
06/29/2023**

[1] UNABLE TO SLOW FAN TO DESIGN W/O SPEED CONTROL.

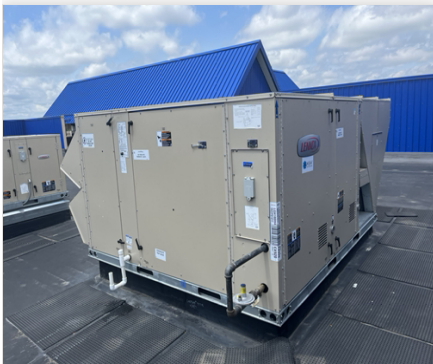
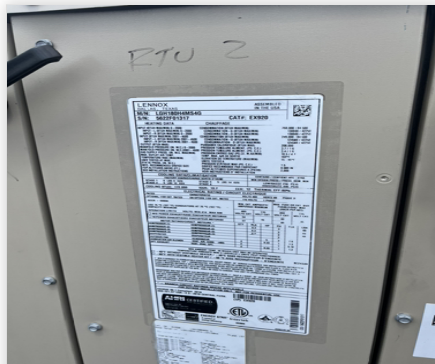
**Issue Name :** RTU-2: Recommend Service  
**Description :** RTU-2 was found with several issues and it's motor was operating above FLA on arrival. The supply vfd is running at 20 HZ at times when normal operation calls for it to be off. VFD amperage was measured unstable on arrival. Recommend unit is inspected and serviced.  
**Created By :** National TAB                      **Assigned To :** National TAB - Michael McDonnell  
**Status :** Open  
**Originated Date :** 07/16/2023 - Michael McDonnell - National TAB

**RTU-2(1)**  
**07/16/2023**

**RTU-2-unitlabel**  
**07/16/2023**

[1] UNIT NEEDS SERVICE, SEE ISSUE.

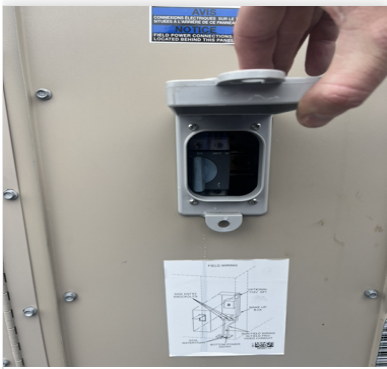
**Disconnect**  
**07/16/2023**

- **07/16/2023 National TAB - Michael McDonnell**
  - Disconnect switch is not accessible and cannot be operated without removing outer unit cover. Recommend service.

Yes, however RTU-2 disconnect switch cannot be operated without removing unit cover. Recommend service.

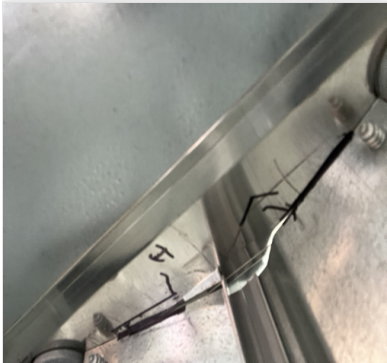
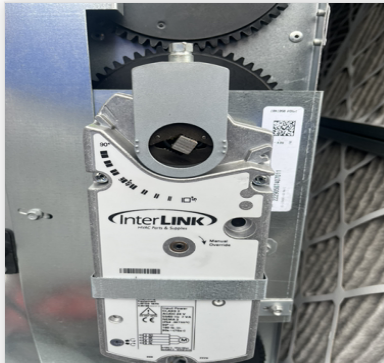
- Economizer dampers were not secured to actuator and were not opening or closing. NTAB tech secured dampers to actuator and performed calibration. Recommend actuator and dampers are inspected. OA positions marked on damper.

**Positions marked**  
**07/16/2023**

**Actuator not secured**  
**07/16/2023**

RTU-2 economizer was not operating on arrival. Damper was not attached to actuator. NTAB corrected but recommend damper is inspected.

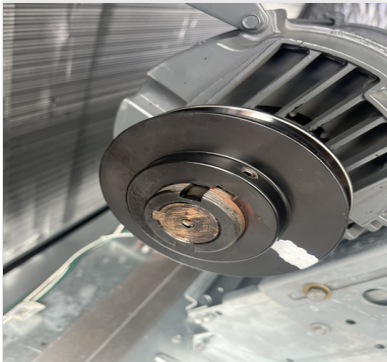
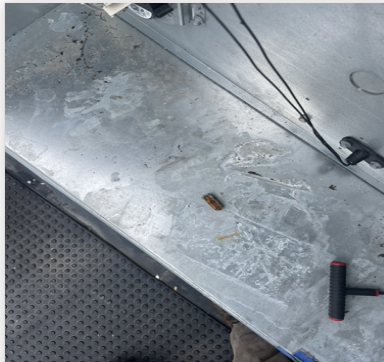
- Motor sheave set key was found on bottom of blower compartment and sheave was frozen, turned all the way in at 0 turns open. NTAB tech was able to break pulley loose and reduce motor speed to below motor FLA.

**Sheavefrozen**  
**07/16/2023**

**Setkeynotinstalled**  
**07/16/2023**

On arrival, RTU-1 and RTU-2 motors operating above FLA. Fans were slowed to within amperage rating.

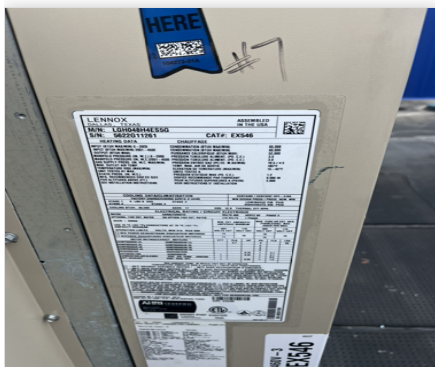
**RTU-7**  
**07/16/2023**

**Issue Name :** RTU-7: Needs Service  
**Description :** RTU-7 supply fan vibrates and makes noise when in high speed. Recommend unit is serviced.  
**Created By :** National TAB                      **Assigned To :** National TAB - Michael McDonnell  
**Status :** Open  
**Originated Date :** 07/16/2023 - Michael McDonnell - National TAB

All except RTU-7. See motor vibration issue.

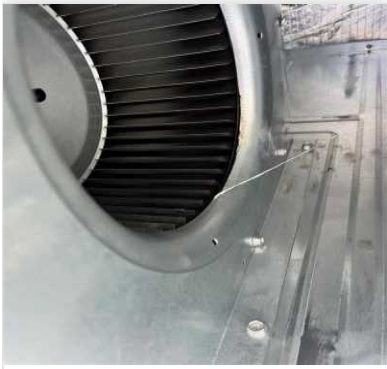
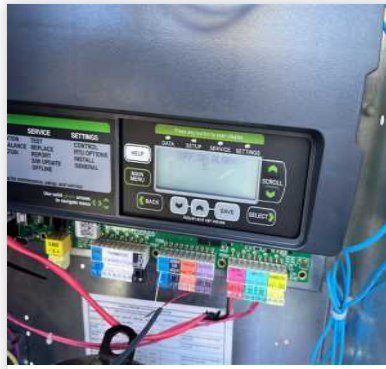
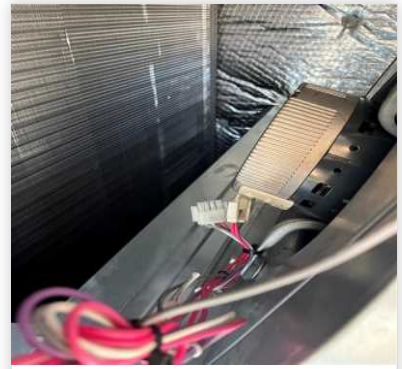
- **08/31/2023 National TAB - Michael McDonnell**
  - On return trip, RTU-7 was off on alarm 5, loss of blower. Tech found blower wiring disconnected. Left as is. Suspect fan vibration led to further issue. Appears metal shaving was created by blower (pictured). Turned unit off at roof disconnect.

**Metal\_Shaving**  
**08/31/2023**

**ALARM**  
**08/31/2023**

**Motor\_Disconnected**  
**08/31/2023**

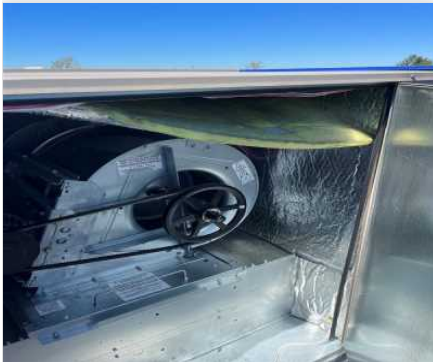
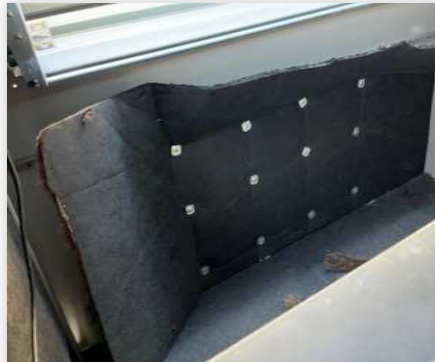
**Issue Name :** RTU-9 and 10 Internal Insulation Loose  
**Description :** Both RTUs 9 and ten have insulation hanging loose that may lead to issues with the unit. RTU-9 in the blower compartment, RTU-10 in the mixed air compartment, Recommend insulation is corrected so as to not cause future issues with RTUs. OA filter found in 9 removed.  
**Created By :** National TAB                      **Assigned To :** National TAB - Michael McDonnell  
**Status :** Open  
**Originated Date :** 08/31/2023 - Michael McDonnell - National TAB

**RTU\_9\_Insulation  
08/31/2023**

**RTU\_10\_insulation  
08/31/2023**

- [1] 1 OA FILTER DIRTY, 1 MISSING.
- [2] INSULATION LOOSE IN BLOWER COMPARTMENT.

- [1] BOTH OA FILTERS MISSING
- [2] INSULATION LOOSE IN MIXED AIR COMPARTMENT.

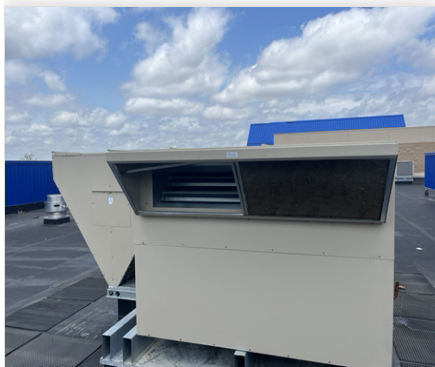
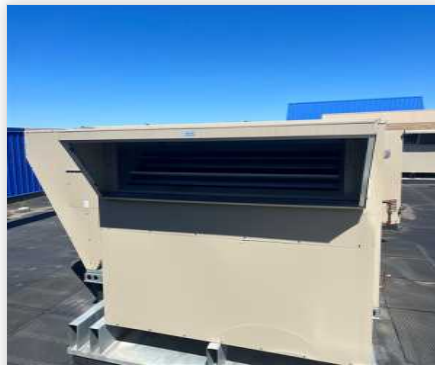
**Issue Name :** RTU-9 and RTU-10 OA filters Not installed.  
**Description :** RTU-9 has one OA filter installed, it is clogged, recommend it is cleaned. The other filter is missing. Both OA filters on RTU-10 are missing.  
**Created By :** National TAB                      **Assigned To :** National TAB - Michael McDonnell  
**Status :** Open  
**Originated Date :** 07/16/2023 - Michael McDonnell - National TAB

**RTU-9filterdirty  
07/16/2023**

**RTU10nofilters  
08/31/2023**

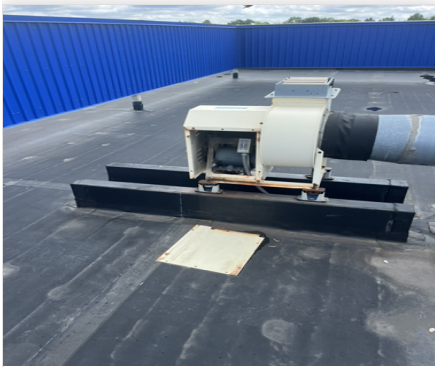
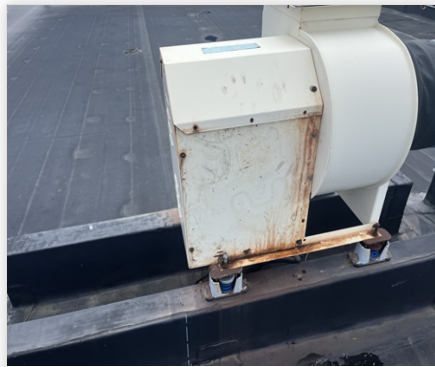
**Issue Name :** Utility Exhaust Fan on Roof- Cover Not Installed  
**Description :** Utility fan above the service garage (not in scope) did not have its motor covered installed. Cover was temporarily affixed with screws located on roof. Recommend cover is properly secured.  
**Created By :** National TAB                      **Assigned To :** National TAB - Michael McDonnell  
**Status :** Open  
**Originated Date :** 07/16/2023 - Michael McDonnell - National TAB

**Coveroff**  
**07/16/2023**

**Temporarysecure**  
**07/16/2023**

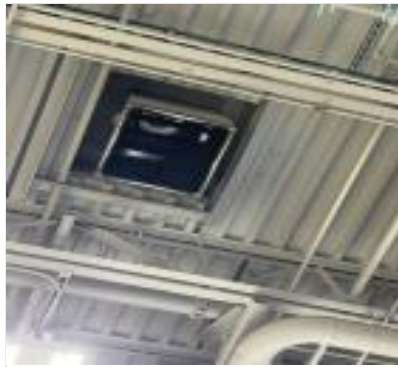
EF12backdraftdamper.j..  
06/29/2023

Is back draft damper installed?

Yes

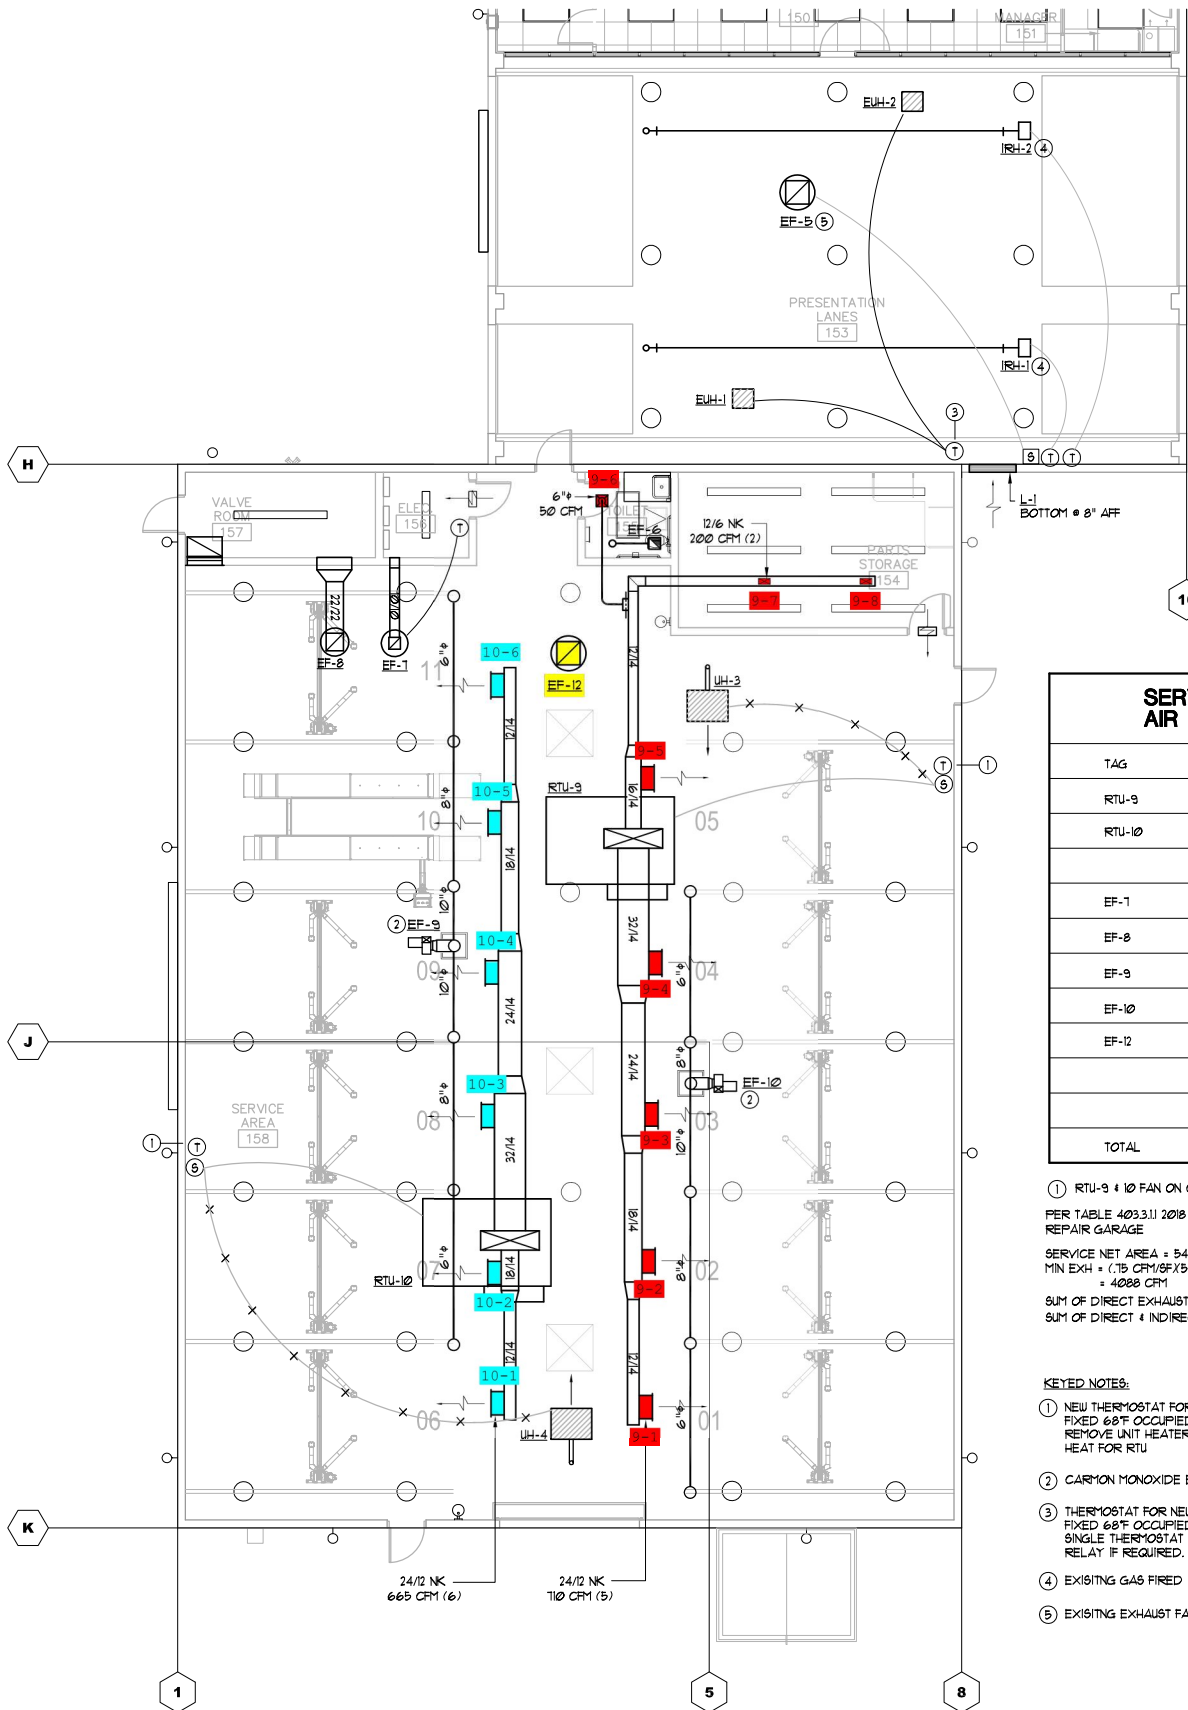
SERVICE AREA AIR BALANCE		
TAG	OUTSIDE AIR	EXHAUST
RTU-9	4000 (1)	
RTU-10	4000 (1)	
EF-1		300
EF-8		2000
EF-9		1800
EF-10		1500
EF-12		1500
TOTAL	8000	7100

(1) RTU-9 & 10 FAN ON CONTINUOUSLY DURING OCCUPIED  
 PER TABLE 409.3.11 2018 IMC MINIMUM DIRECT EXHAUST .75 CFM/SF REPAIR GARAGE  
 SERVICE NET AREA = 5450 SF  
 MIN EXH = (.75 CFM/SF x 5450 SF) = 4088 CFM  
 SUM OF DIRECT EXHAUST FROM EF- 9, 10, 12 = 4800 CFM  
 SUM OF DIRECT & INDIRECT EXHAUST = 7,100 CFM
