National TAB
1329 E. KEMPER ROAD
SUITE 4210
CINCINNATI, OH 45246

Report: TAB REPORT
Function: Test, Adjust, & Balance
Date: 07/19/2023

06-26-23 CARMAX #7179 - MILWAUKEE, WI

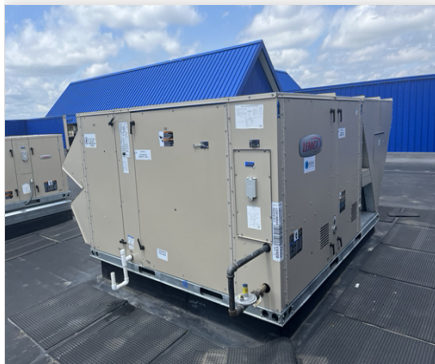
Issue Name : RTU-2: Recommend Service
Description : RTU-2 was found with several issues and it's motor was operating above FLA on arrival. The supply vfd is running at 20 HZ at times when normal operation calls for it to be off. VFD amperage was measured unstable on arrival. Recommend unit is inspected and serviced.
Created By : National TAB **Assigned To :** National TAB - Michael McDonnell
Status : Open
Originated Date : 07/16/2023 - Michael McDonnell - National TAB

RTU-2(1)
07/16/2023

RTU-2-unitlabel
07/16/2023

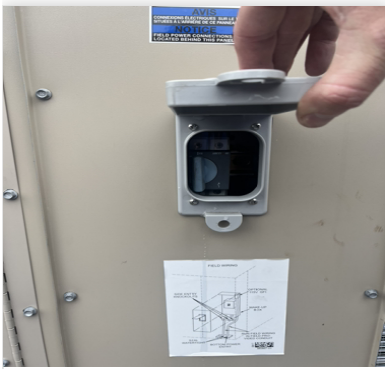
Disconnect
07/16/2023

- **07/16/2023 National TAB - Michael McDonnell**
 - Disconnect switch is not accessible and cannot be operated without removing outer unit cover. Recommend service.

Yes, however RTU-2 disconnect switch cannot be operated without removing unit cover. Recommend service.

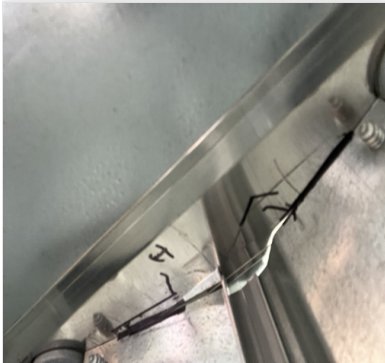
- Economizer dampers were not secured to actuator and were not opening or closing. NTAB tech secured dampers to actuator and performed calibration. Recommend actuator and dampers are inspected. OA positions marked on damper.

Positions marked
07/16/2023

Actuator not secured
07/16/2023

RTU-2 economizer was not operating on arrival. Damper was not attached to actuator. NTAB corrected but recommend damper is inspected.

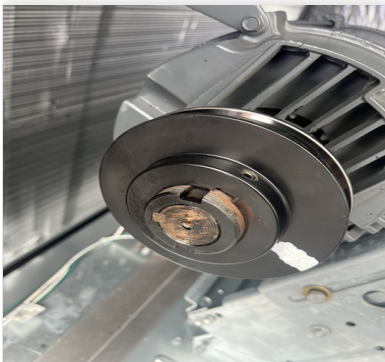
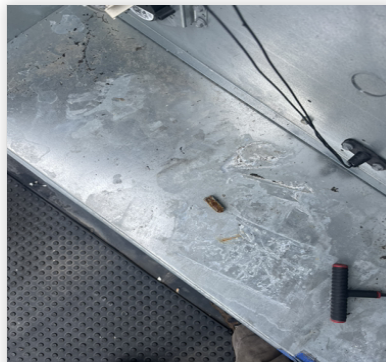
- Motor sheave set key was found on bottom of blower compartment and sheave was frozen, turned all the way in at 0 turns open. NTAB tech was able to break pulley loose and reduce motor speed to below motor FLA.

Sheavefrozen
07/16/2023

Setkeynotinstalled
07/16/2023

On arrival, RTU-1 and RTU-2 motors operating above FLA. Fans were slowed to within amperage rating.

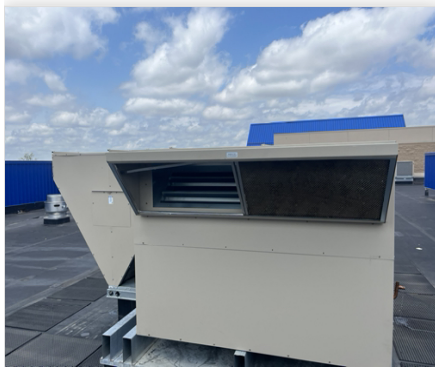
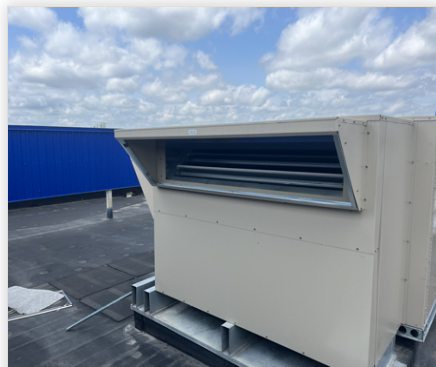
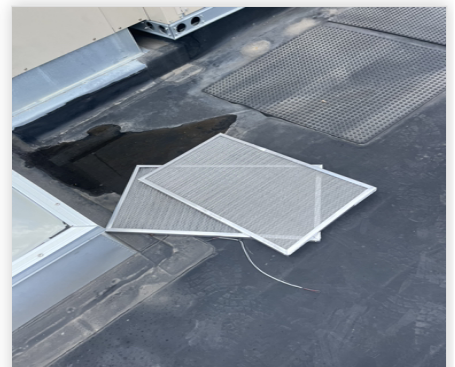
Issue Name : RTU-9 and RTU-10 OA filters Not installed.
Description : RTU-9 and 10 OA filters are not installed and are laying on the roof. RTU-9 has one filter installed, recommend it is cleaned.
Created By : National TAB **Assigned To :** National TAB - Michael McDonnell
Status : Open
Originated Date : 07/16/2023 - Michael McDonnell - National TAB

**RTU-9filterdirty
07/16/2023**

**RTU-10filtersnotinsta..
07/16/2023**

**OAfilters
07/16/2023**
