Report: TAB REPORT
Function: Test, Adjust, & Balance
Date: 07/19/2023

06-26-23 CARMAX #7179 - MILWAUKEE, WI

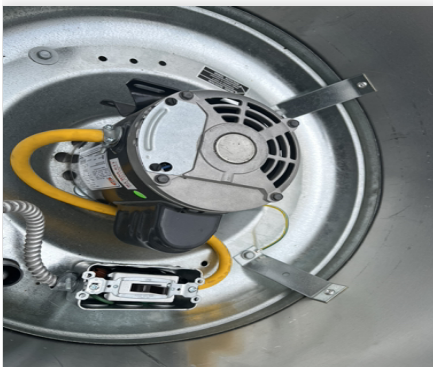
EF12motorhousing
06/29/2023

Issue Name : 3. EF-12 High On Airflow
Description : EF-12 measured at 2,037 CFM. Unable to decrease flow. Currently a single speed fan. Recommend having a speed controller installed.
Created By : National TAB **Assigned To :** National TAB - Dylan Crisman
Status : Closed
Priority : High **Asset Tag :**
Originated Date : 06/29/2023 - Dylan Crisman - National TAB

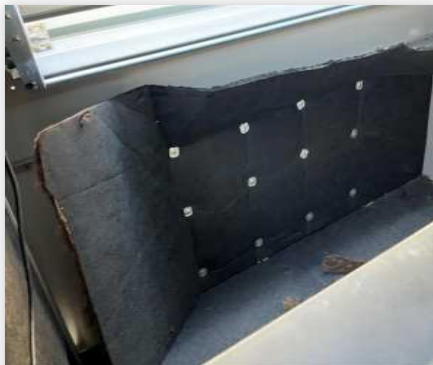
**RTU_9_Insulation
08/31/2023**

Issue Name : 5. RTU-9 and 10 Internal Insulation Loose
Description : Both RTUs 9 and ten have insulation hanging loose that may lead to issues with the unit. RTU-9 in the blower compartment, RTU-10 in the mixed air compartment, Recommend insulation is corrected so as to not cause future issues with RTUs.
Created By : National TAB **Assigned To :** National TAB - Michael McDonnell
Status : Open
Priority : Low **Asset Tag :**
Originated Date : 08/31/2023 - Michael McDonnell - National TAB

Notes:
[1] INSULATION LOOSE IN BLOWER COMPARTMENT.

[1] INSULATION LOOSE IN MIXED AIR COMPARTMENT.
