**Report: TAB Report**  
**Function: Test, Adjust, & Balance**  
**Date: 01/06/2026**  
**Completed By: National TAB**

**PROJECT**  
**03-16-26 QT #0825 FAIRBURN, GA**

QUIKTRIP  
4705 SOUTH 129TH EAST AVENUE  
TULSA, OK 74134

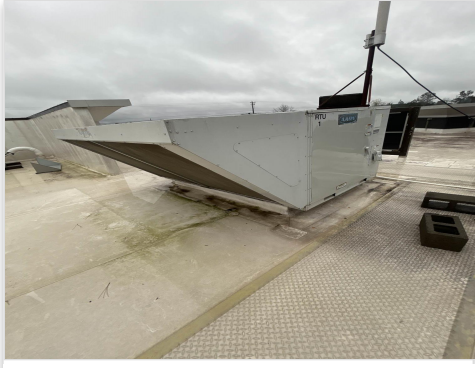
**Unit Data - PHOTO LOG**

Asset: RT-1

Unit Data	
	Actual
MFG	AAON
Serial Num	201112-ANEK06080
Model Num	RN-013-8-0-EA0A-152
Num OA Filters 1	1
OA Filter Size 1	23X45
Num Final Filter 1	4
Final Filter Size 1	20X25X2

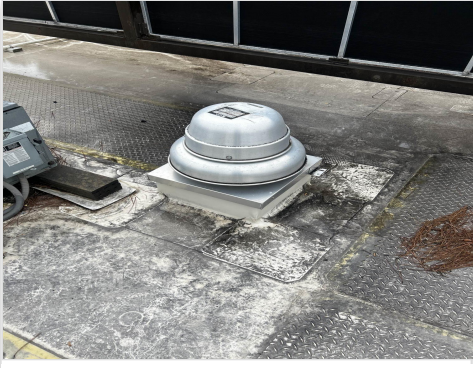
**Unit Data - PHOTO LOG**

Asset: EF1

Unit Data		
	Design	Actual
MFG	NA	LOREN COOK
Model Num	NA	90 ACEH 90C15DH
Serial Num	-	050SD88575
Type	-	DOWNBLAST
Configuration	-	ATM

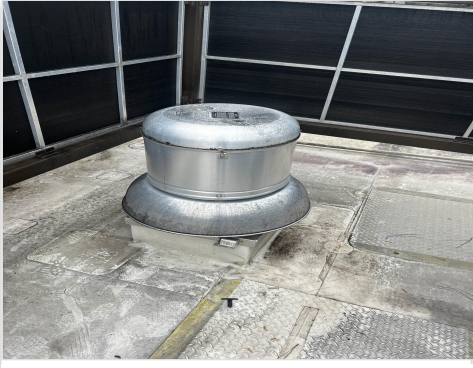
**Unit Data - PHOTO LOG**

Asset: EF2

Unit Data		
	Design	Actual
MFG	NA	LOREN COOK
Model Num	NA	120 ACE 120C1 3D 33
Serial Num	-	050SD88575
Type	-	DOWNBLAST
Configuration	-	ATM

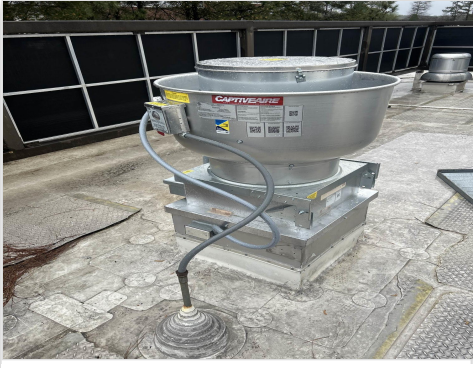
## Unit Data - PHOTO LOG

Asset: EF3

Unit Data		
	Design	Actual
MFG	NA	CAPTIVEAIRE
Model Num	NA	DU50HFA
Serial Num	-	8225652
Type	UPBLAST	UPBLAST
Configuration	VERTICAL	VERTICAL

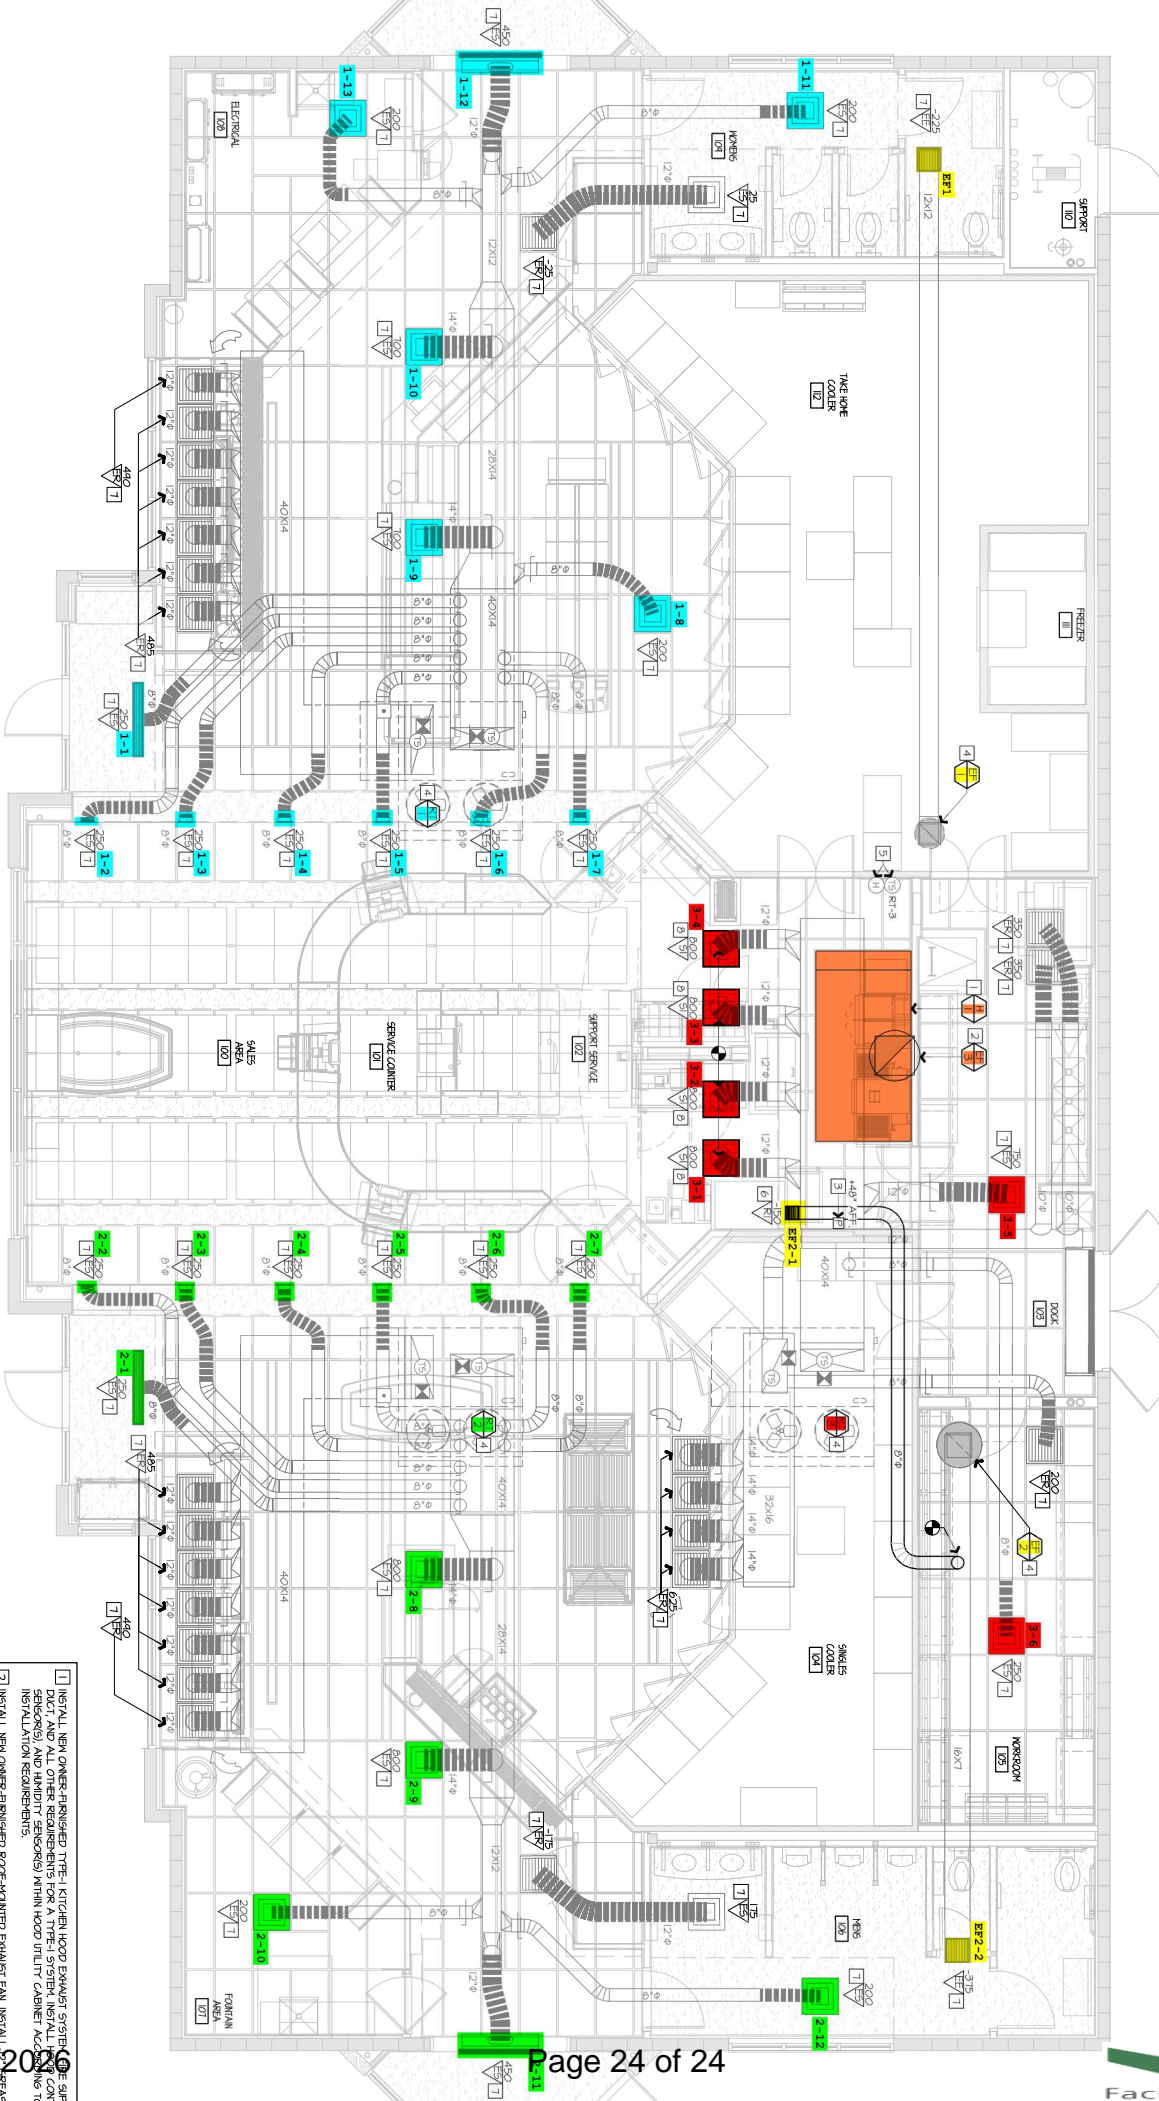
INSTALL NEW OWNER-FURNISHED TIRE-KITCHEN HOOD EXHAUST SYSTEMS. SUPPLY AIR SYSTEMS SHALL BE INSTALLED IN ACCORDANCE WITH ALL APPLICABLE CODES AND REGULATIONS FOR A TIRE-KITCHEN HOOD EXHAUST SYSTEM. ALL OTHER REQUIREMENTS SHALL BE AS SHOWN ON THE DRAWING.

INSTALL NEW OWNER-FURNISHED ROOF-MOUNTED EXHAUST FAN INSTALLATION REQUIREMENTS.
