Report: TAB Report
Function: Test, Adjust, & Balance
Date: 01/06/2026
Completed By: National TAB

PROJECT
03-16-26 QT #0825 FAIRBURN, GA

Project: 03-16-26 QT #0825 FAIRBURN, GA

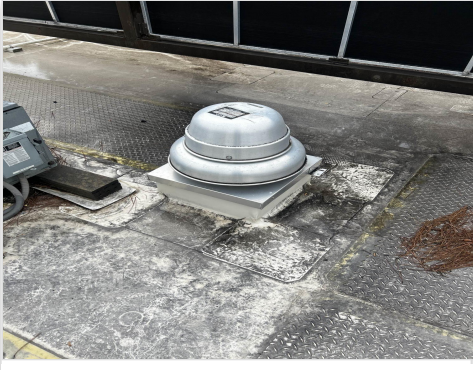
Unit Data - PHOTO LOG

Asset: EF1

Unit Data		
	Design	Actual
MFG	NA	LOREN COOK
Model Num	NA	90 ACEH 90C15DH
Serial Num	-	050SD88575
Type	-	DOWNBLAST
Configuration	-	ATM

Test Data		
	Design	Actual
CFM	225	256
Fan RPM	-	1550
Fan Rotation	-	CCW
Motor RPM	-	1550

Notes:
FAN AIRFLOW SLIGHTLY ABOVE DESIGN, NOT ANTICIPATED TO CAUSE ANY ISSUE.
