Report: FINAL TAB REPORT
Function: Test, Adjust, & Balance
Date: 09/22/2022

10-17 TACO BELL - MT. VERNON, IN

1328 E 4TH ST

MOUNT VERNON, IN

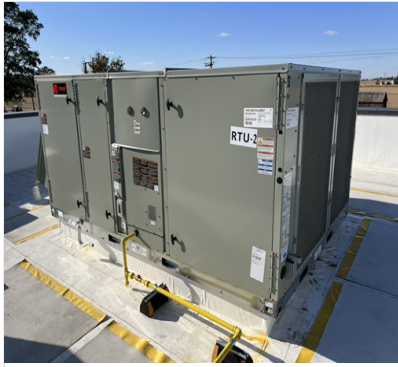
RTU-2

Asset: RTU2

Test Data		
	Design	Actual
SF CFM	5000	4659
SF RPM	-	574
RA CFM	4400	4000
OA CFM	600	659
RL Voltage	-	211/211/211
RL Amperage	-	6.4/6.4/6.4
SF Rotation	-	CW, CORRECT
Min OA Damper Position	-	0.5"
Min OA Damper Type	-	ECONOMIZER

Performance Data		
	Design	Actual
MA Plenum SP	-	-0.24"
Fan Suction SP	-	-0.45"
Fan Discharge SP	-	0.38"
Total ESP	0.84"	0.62"
Fan Total SP	-	0.83"

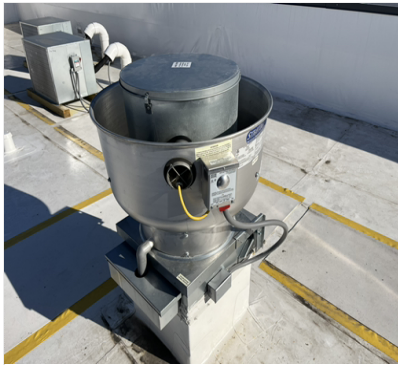
EF-1

Asset: EF1

Design	Actual
CFM	1050	1096
Fan RPM	1344	DD
Fan Rotation	-	CCW, CORRECT
Motor RPM	-	DD
System SetPt	-	LOW
RL Voltage	-	86
RL Amperage	-	4.6
Total ESP	0.9"	0.44"
Fan Inlet SP	-	-0.44"
Fan Discharge SP	-	ATM

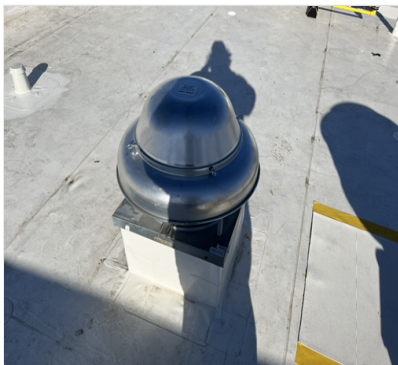
EF-2

Asset: EF2

Test Data		
	Design	Actual
CFM	570	531
Fan RPM	1025	DD
Fan Rotation	-	CCW, CORRECT
Motor RPM	-	DD
System SetPt	-	LOW
RL Voltage	-	77
RL Amperage	-	2.3
Total ESP	0.375"	0.29"
Fan Inlet SP	-	-0.29"
Fan Discharge SP	-	ATM
