Report: FINAL TAB REPORT
Function: Test, Adjust, & Balance
Date: 09/22/2022

10-17 TACO BELL - MT. VERNON, IN

1328 E 4TH ST

MOUNT VERNON, IN

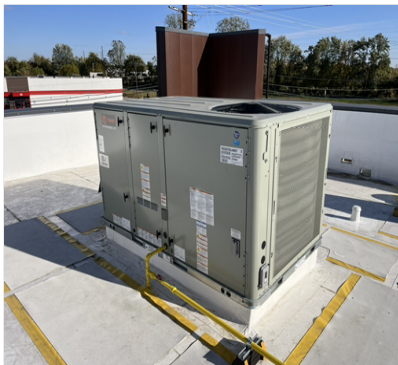
RTU-1

Unit Data			Test Data		
	Design	Actual		Design	Actual
MFG	TRANE	TRANE	SF CFM	2900	2937
Serial Num	-	222612576L	SF RPM	-	979 (4.19 DCV)
Model Num	YHC092	YHC092F3RLA27F0C1A2A0B0A30000	OA CFM	2000	1956
Type	RTU	RTU	OA CFM	900	981
Configuration	VERTICAL	VERTICAL	RL Voltage	-	210/210/210
Num OA Filters 1	-	1	RL Amperage	-	1.4/1.4/1.4
OA Filter Size 1	-	35.5x15	SF Rotation	-	CW, CORRECT
Num Final Filter 1	-	4	Min OA Damper Position	-	1.75"
Final Filter Size 1	-	20X25X2	Min OA Damper Type	-	MOTORIZED DAMPER

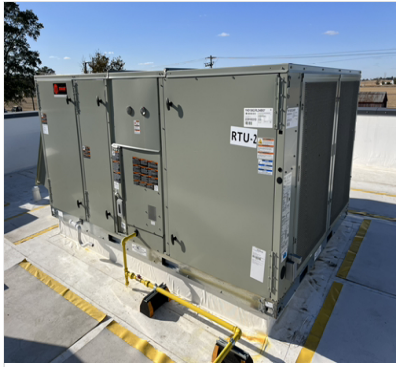
RTU-2

Unit Data			Test Data		
	Design	Actual		Design	Actual
MFG	TRANE	TRANE	SF CFM	5000	4659
Serial Num	-	222910331D	SF RPM	-	574
Model Num	YHD150	YHD150G3RLD19F0C1A2A0B0A300000	OA CFM	4400	4000
Type	RTU	RTU	OA CFM	600	659
Configuration	VERTICAL	VERTICAL	RL Voltage	-	211/211/211
Num OA Filters 1	-	1	RL Amperage	-	6.4/6.4/6.4
OA Filter Size 1	-	59.5x17.5	SF Rotation	-	CW, CORRECT
Num Final Filter 1	-	4	Min OA Damper Position	-	0.5"
Final Filter Size 1	-	20X20X2	Min OA Damper Type	-	ECONOMIZER
Num Final Filter 2	-	4			
Final Filter Size 2	-	20X25X2

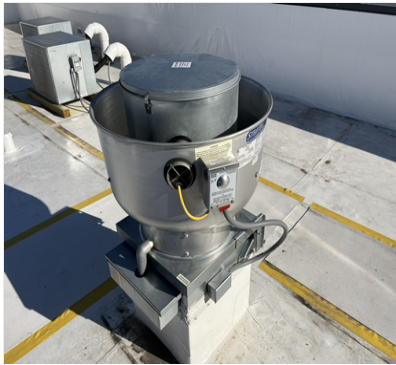
EF-1

Test Data		
	Design	Actual
CFM	1050	1096
Fan RPM	1344	DD
Fan Rotation	-	CCW, CORRECT
Motor RPM	-	DD
System SetPt	-	LOW
RL Voltage	-	86
RL Amperage	-	4.6
Total ESP	0.9"	0.44"
Fan Inlet SP	-	-0.44"
Fan Discharge SP	-	ATM

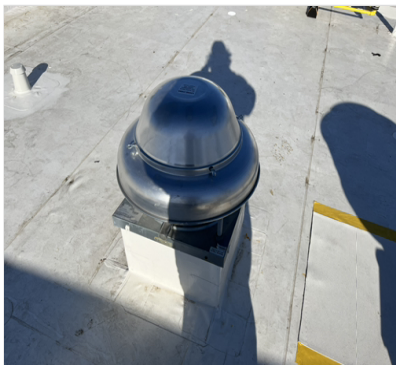
EF-2

Test Data		
	Design	Actual
CFM	570	531
Fan RPM	1025	DD
Fan Rotation	-	CCW, CORRECT
Motor RPM	-	DD
System SetPt	-	LOW
RL Voltage	-	77
RL Amperage	-	2.3
Total ESP	0.375"	0.29"
Fan Inlet SP	-	-0.29"
Fan Discharge SP	-	ATM

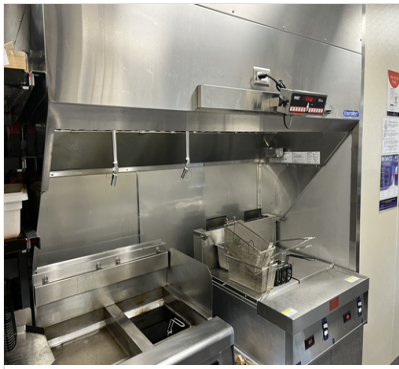
HOOD-1

Performance Data		
	Design	Actual
Smoke Generation Type	-	SMOKE EMITTER
Hood Capture %	-	100%
End Panels Installed (Y/N)	-	YES

Test Data Exhaust		
	Design	Actual
Filter Type	BAFFLE	BAFFLE
Filter Size 1	16X16	16X16
Filter Qty 1	4	4
Filter AK factor size 1	1.66	1.66
Filter Total AK Area	6.64	6.64
Filter1 FPM	-	148
Filter2 FPM	-	177
Filter3 FPM	-	184
Filter4 FPM	-	149
Filter Ave FPM(corr)	-	165
CFM	1050	1096
