**Report: TAB Report**  
**Function: Test, Adjust, & Balance**  
**Date: 03/06/2026**  
**Completed By: National TAB**

**PROJECT**  
**03-16-26 QT #1024 CHARLOTTE, NC**

Project: 03-16-26 QT #1024 CHARLOTTE, NC

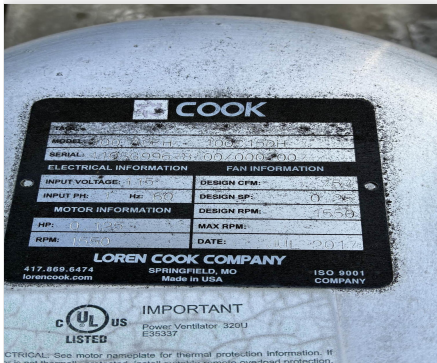
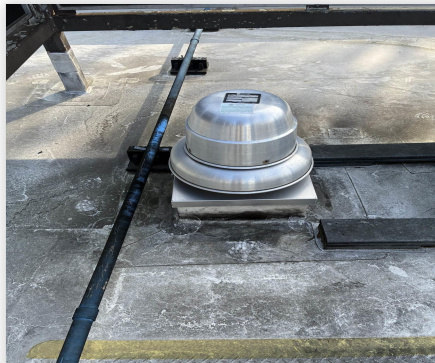
**Issue Name :** EF-1 Excessive Flow  
**Description :** EF-1 is set to the lowest possible limit and there is more air being exhausted than necessary.  
**Created By :** National TAB                      **Assigned To :** National TAB - Dan Hertenstein  
**Status :** Open  
**Priority :** Low                                      **Asset Tag :** EF1  
**Originated Date :** 03/24/2026 - Alex Bauer - National TAB

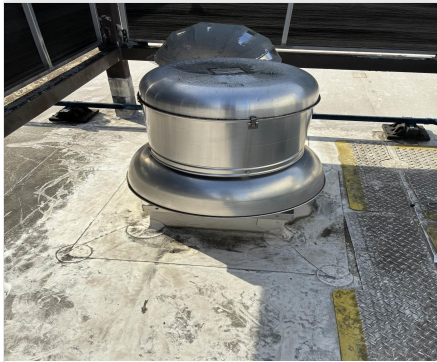
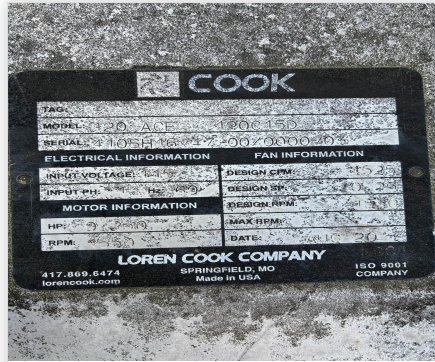
**Issue Name :** EF-2 Low Flow  
**Description :** EF-2 is set to the maximum speed and not enough air is being exhausted. It should also be noted neither diffuser have dampers.  
**Created By :** National TAB      **Assigned To :** National TAB - Dan Hertenstein  
**Status :** Open  
**Priority :** High      **Asset Tag :**  
**Originated Date :** 03/24/2026 - Alex Bauer - National TAB

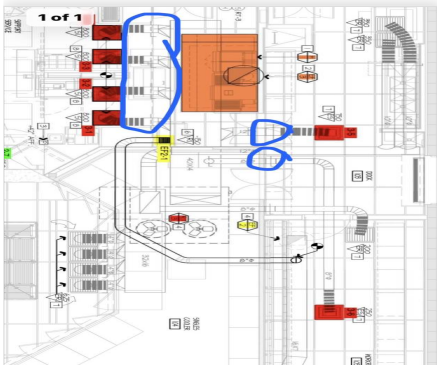
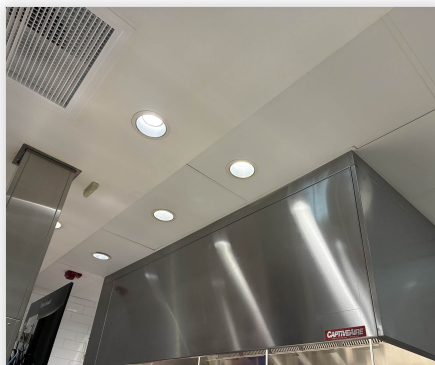
**Issue Name :** RTU-3 Dampers Inaccessible  
**Description :** The dampers for all the RTU-3 diffusers are inaccessible. Dampers 3-1 through 3-4 are above a ceiling tile wall with lights installed. These panels are immovable and the dampers can't be accessed on the other side of the wall. Dampers 3-5 and 3-6 are behind a wall that makes them unreachable.  
**Created By :** National TAB                      **Assigned To :** National TAB - Dan Hertenstein  
**Status :** Open  
**Priority :** Urgent                                      **Asset Tag :** RT-3  
**Originated Date :** 03/24/2026 - Alex Bauer - National TAB

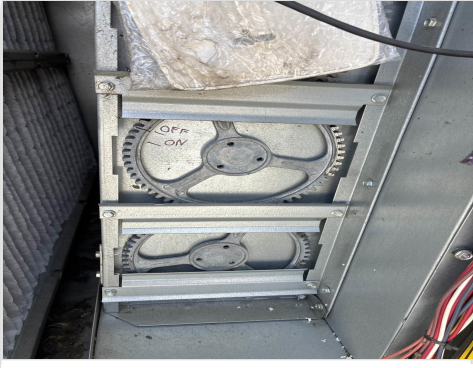
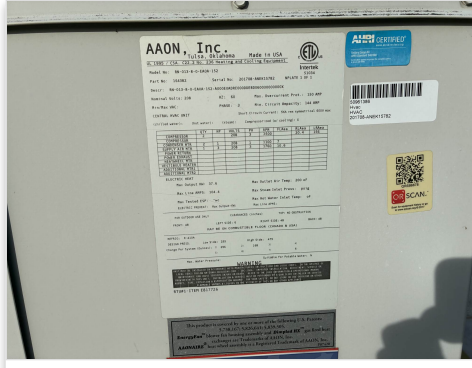
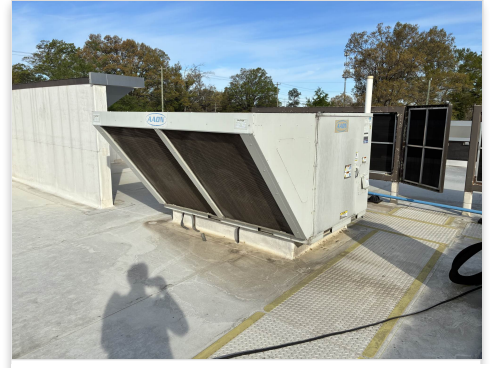
# Unit Data - PHOTO LOG

Unit Data	
	Actual
MFG	AAON
Serial Num	201708-ANEK15782
Model Num	RN-013-8-0-EA0A-152
Num OA Filters 1	1
OA Filter Size 1	22.5X44.5
Num Final Filter 1	2
Final Filter Size 1	19.5X46.5X2

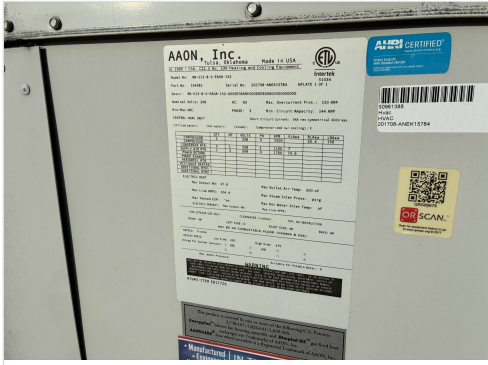
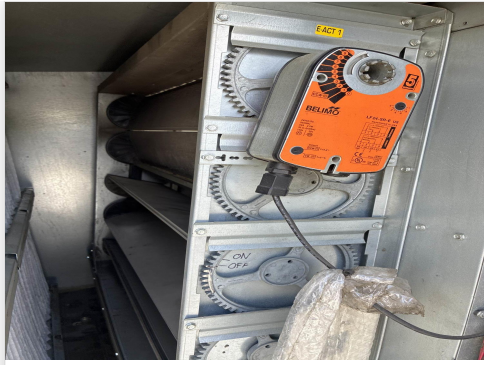
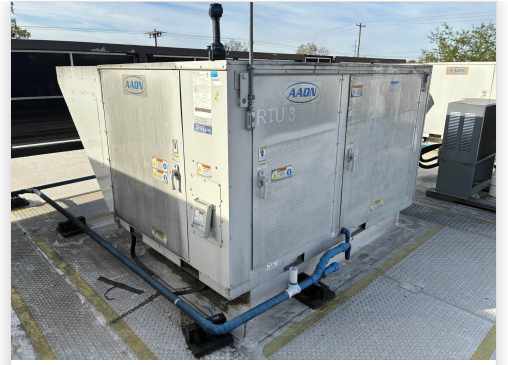
# Unit Data - PHOTO LOG

Unit Data	
	Actual
MFG	AAON
Serial Num	201708-ANEK15784
Model Num	RN-013-8-0-EA0A-152
Num OA Filters 1	1
OA Filter Size 1	22.5X44.5
Num Final Filter 1	2
Final Filter Size 1	19.5X46.5X2

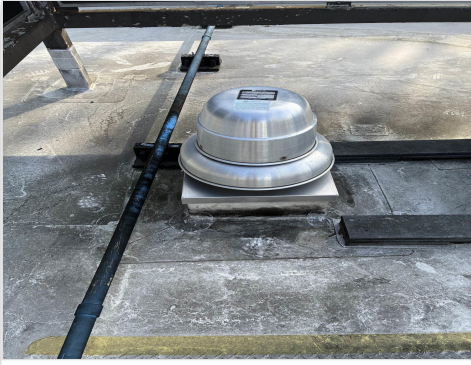
# Unit Data - PHOTO LOG

Design	Actual
MFG	NA	COOK
Model Num	NA	100 ACEH 100C15DH
Serial Num	-	410SG99678- 00/0002007
Type	-	DOWNBLAST
Configuration	-	VERTICAL

Design	Actual
CFM	225	386
Fan RPM	-	NA
Fan Rotation	-	CCW
Motor RPM	-	NA
System SetPt	-	LOW
RL Voltage	-	NA
RL Amperage	-	0.311
Total ESP	-	0.23"
Fan Inlet SP	-	-0.23"
Fan Discharge SP	-	ATM

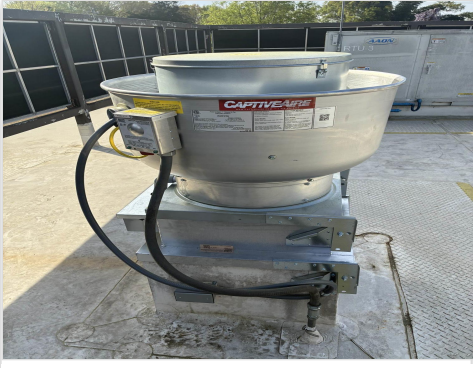
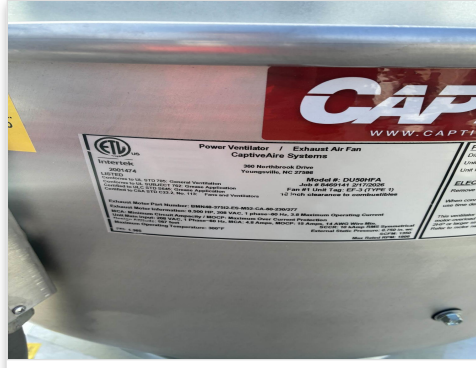
# Unit Data - PHOTO LOG

Design	Actual
MFG	NA	CAPTIVEAIRE
Model Num	NA	DU50HFA
Serial Num	-	8469141
Type	UPBLAST	UPBLAST
Configuration	VERTICAL	VERTICAL
