Report: TAB Report
Function: Test, Adjust, & Balance
Date: 12/31/2025
Completed By: National TAB

12-15-25 CULVERS BUSHNELL, FL (DOAS)

Project: 12-15-25 CULVERS BUSHNELL, FL (DOAS)

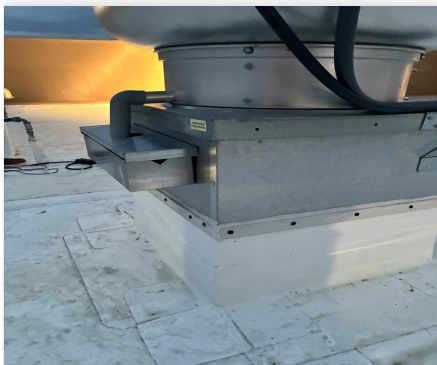
Issue Name : Kitchen exhausts curb screws
Description : Kitchen exhaust fans do not have screws securing them to curb. Free to tilt back. No leaks found.
Created By : National TAB **Assigned To :** National TAB - Dan Hertenstein
Status : Open
Priority : Medium **Asset Tag :**
Originated Date : 12/19/2025 - Jackson Gunnels - National TAB

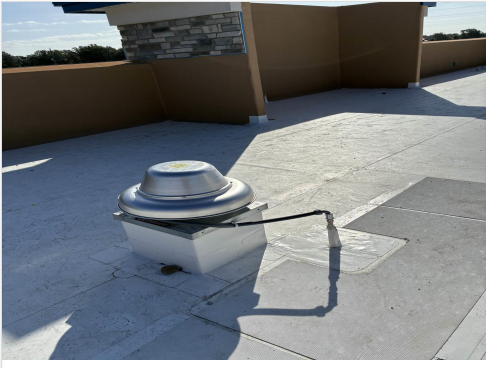
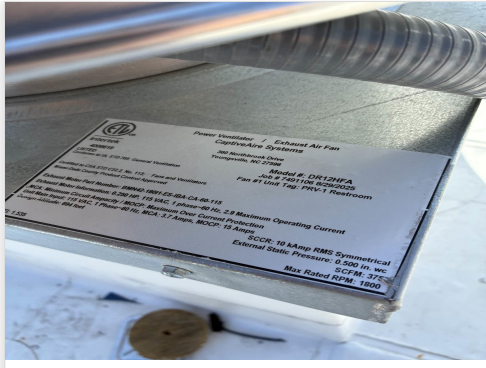
Unit Data - PHOTO LOG

Test Data		
	Design	Actual
CFM	375	377
Fan RPM	1369	973
Fan Rotation	-	CCW
Motor RPM	-	DIRECT DRIVE
System SetPt	-	52%
Total ESP	0.500"	0.09"
Fan Inlet SP	-	-0.09"
Fan Discharge SP	-	ATM

Unable to safely read current

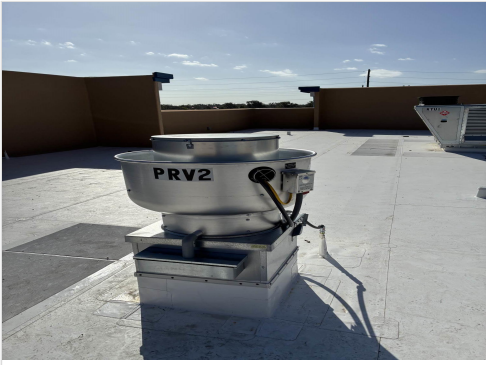
Unit Data - PHOTO LOG

Test Data		
	Design	Actual
CFM	1500	1520
Fan RPM	1406	1157
Fan Rotation	-	CCW
Motor RPM	-	DIRECT DRIVE
System SetPt	-	58%
RL Voltage	-	123
RL Amperage	-	4.7
Total ESP	1.412"	0.64"
Fan Inlet SP	-	-0.64"
Fan Discharge SP	-	ATM

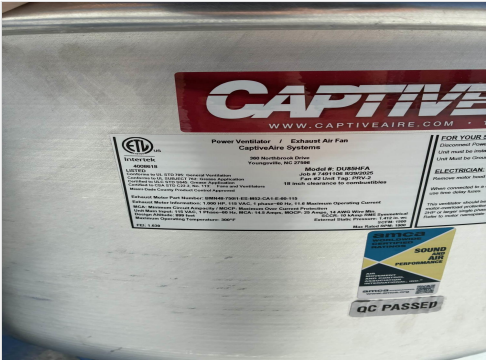
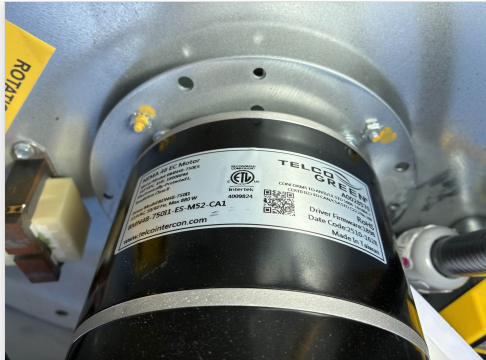
Motor Data - PHOTO LOG

Motor Data		
	Design	Actual
Motor MFG	-	TELCO-GREEN
Horsepower	1.00	1.00
Motor Rpm	-	1800
Phase	1	1
Voltage (rated)	115	115
Amperage (rated)	-	11.6

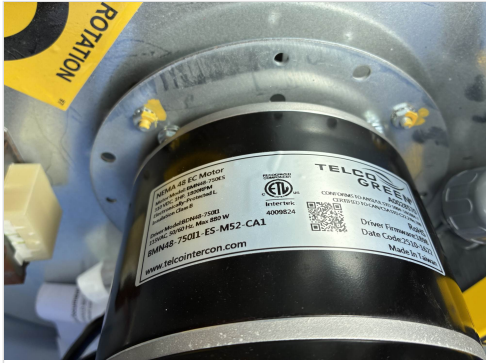
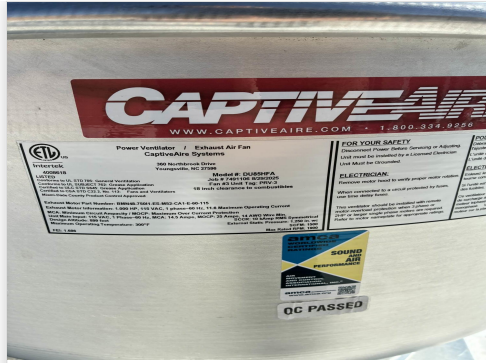
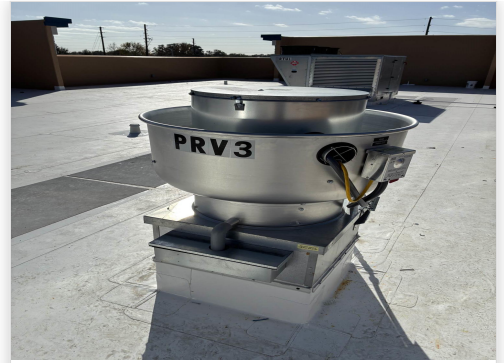
Unit Data - PHOTO LOG

Test Data		
	Design	Actual
CFM	1500	1531
Fan RPM	1348	993
Fan Rotation	-	CCW
Motor RPM	-	DIRECT DRIVE
System SetPt	-	50%
RL Voltage	-	124
RL Amperage	-	4.03
Total ESP	1.250"	0.58"
Fan Inlet SP	-	-0.58"
Fan Discharge SP	-	ATM

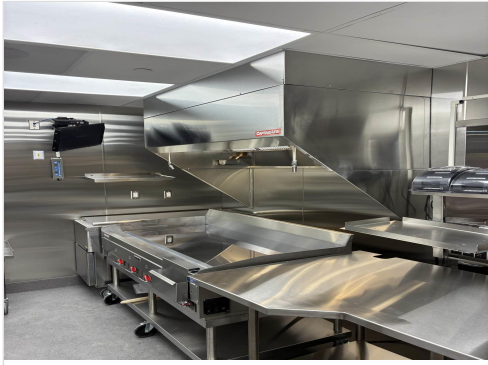
Unit Data - PHOTO LOG

Unit Data		
	Design	Actual
MFG	CAPTIVE-AIRE	CAPTIVE-AIRE
Model Num	3347 BD-2	3347 BD-2
Job / Serial Num	-	7491106
Type	TYPE 1 LOW PROXIMITY	TYPE I LOW
Hood length	66"	66"
Hood Width	33"	33"

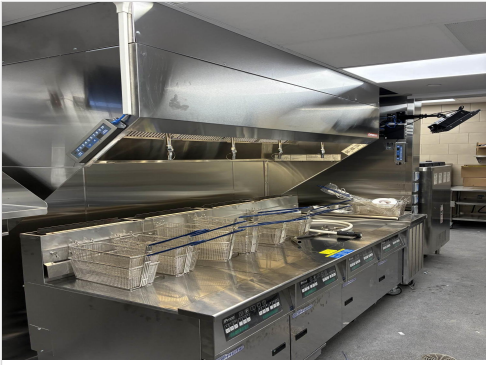
Unit Data - PHOTO LOG

Unit Data		
	Design	Actual
MFG	CAPTIVE-AIRE	CAPTIVE-AIRE
Model Num	3347 BD-2	3347 BD-2
Job / Serial Num	-	7491106
Type	TYPE 1 LOW PROXIMITY	TYPE I LOW
Hood length	84"	84"
Hood Width	33"	33"

Test Data Exhaust		
	Design	Actual
Filter Type	CAPTRATE SOLO FILTER	CAPTRATE SOLO FILTER
Filter Size 1	16X16	16X16
Filter Qty 1	5	5
Filter AK factor size 1	1.62	1.62
Filter Total AK Area	8.1	8.1
Filter1 FPM	-	193
Filter2 FPM	-	185
Filter3 FPM	-	211
Filter4 FPM	-	183
Filter5 FPM	-	171
Filter Ave FPM(corr)	-	189
CFM	1500	1531
