Report: TAB Report
Function: Test, Adjust, & Balance
Date: 07/10/2024

PROJECT
06-24-24 CULVERS - ORLANDO, FL

13320 E COLONIAL DRIVE

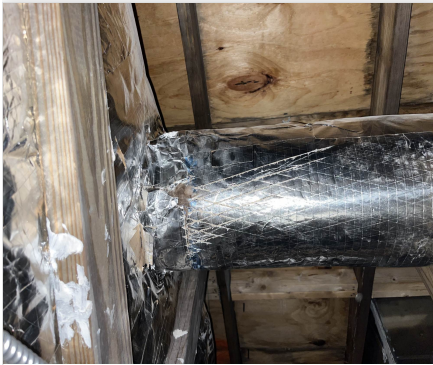
Diffuser2_16
06/27/2024

Issue Name : Diffuser 2-16 Missing Damper
Description : There is no damper installed on RTU 2 Diffuser 16. If comfort issues arise, recommend installing damper and rebalancing diffuser to design airflow. Kitchen was comfortable at time of balancing.
Created By : National TAB **Assigned To :** National TAB - Will Turnbough
Status : Open
Priority : High **Asset Tag :**
Originated Date : 06/27/2024 - Stephen Tassinaro - National TAB

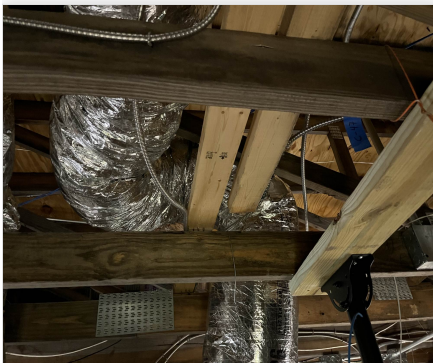
Diffuser2_4_243850440..
07/10/2024

Issue Name : Diffuser 2-4 Restrictive Ductwork
Description : When diffuser 4 was moved to match the location shown in the plans, the duct kinked and is now restricting airflow to the diffuser. Even with the damper opened fully, design airflow could not be achieved. If comfort issues arise, recommend straightening the duct run and rebalancing to design. Kitchen was comfortable at time of balancing.
Created By : National TAB **Assigned To :** National TAB - Will Turnbough
Status : Open
Priority : High **Asset Tag :**
Originated Date : 07/10/2024 - Stephen Tassinaro - National TAB

- **07/10/2024 National TAB - Stephen Tassinaro**
 - Smoke containment 100% successful as-is.

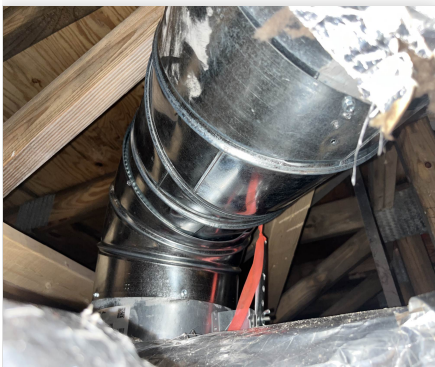
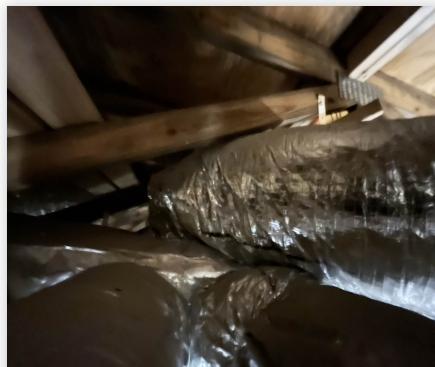
Diffuser2_5_156143215..
07/10/2024

Issue Name : Diffuser 2-5 Restrictive Takeoff
Description : RTU 2 (Kitchen) Diffuser 5 has a restrictive takeoff. Currently this takeoff is installed on the top of the duct. It is not recommended to install the takeoffs on top of the trunkline. If comfort issues arise, recommend moving take-off and rebalancing so that design airflow may be achieved.
Created By : National TAB **Assigned To :** National TAB - Will Turnbough
Status : Open
Priority : High **Asset Tag :**
Originated Date : 06/27/2024 - Stephen Tassinaro - National TAB

- **07/10/2024 National TAB - Stephen Tassinaro**
 - Smoke containment 100% successful as-is.

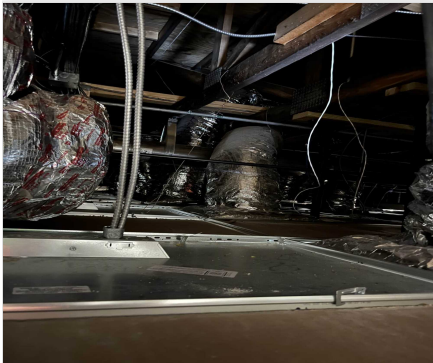
CooklineDucts
06/27/2024

Issue Name : Flex Duct Ran Directly To Cookline Diffuser
Description : Cookline diffusers should have 12"-18" of straight pipe followed by a rigid 90. Currently flex duct is ran directly to cookline diffusers.
Created By : National TAB **Assigned To :** National TAB - Will Turnbough
Status : Open
Priority : High **Asset Tag :**
Originated Date : 06/27/2024 - Stephen Tassinaro - National TAB

No, flex ran directly to cookline diffusers and no rigid 90s

- **07/10/2024 National TAB - Stephen Tassinaro**
 - No changes made. Smoke containment 100% successful as-is.

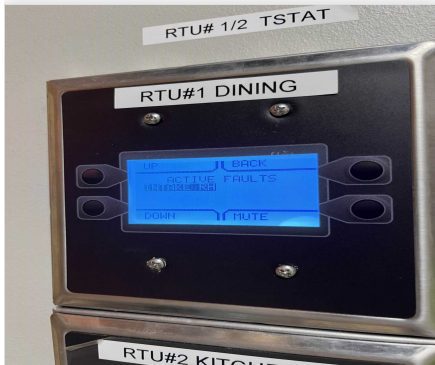
IMG_3344_495849008.jp..
07/10/2024

Issue Name : RTU 1 - Alarm
Description : RTU 1 is alarming "Intake RH". Unit was still operational for TAB purposes but it is still recommended to resolve ASAP.
Created By : National TAB **Assigned To :** National TAB - Will Turnbough
Status : Open
Priority : Medium **Asset Tag :**
Originated Date : 07/10/2024 - Stephen Tassinaro - National TAB

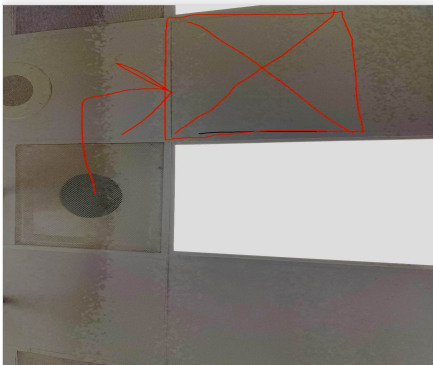
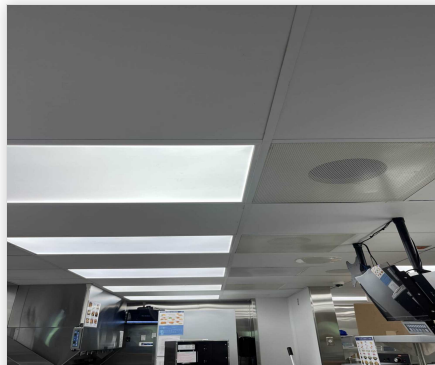
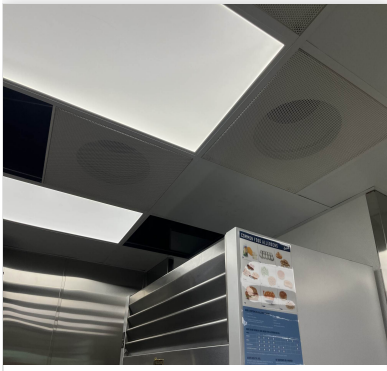
CooklineDiffusers_2_...
06/27/2024

Issue Name : RTU 2 Cookline Diffuser Locations Incorrect
Description : The cookline diffusers (RTU 2, Diffusers 3 thru 8 per NTi GRD Layout) need to be moved closer to the hoods, in between the lights. An example picture is attached. The diffuser locations are imperative for proper hood smoke containment. When looking at the kitchen hoods, each diffuser needs to be moved 24" closer to hoods and 24" to the right.
Created By : National TAB **Assigned To :** National TAB - Will Turnbough
Status : Open
Priority : Medium **Asset Tag :**
Originated Date : 06/27/2024 - Stephen Tassinaro - National TAB

- **07/10/2024 National TAB - Stephen Tassinaro**
 - Diffusers 7 & 8 were not able to be moved into their correct locations due to ceiling grid constraints. All other diffuser locations now correct. Smoke containment 100% successful in current arrangement.
