Report: TAB Report
Function: Test, Adjust, & Balance
Date: 07/10/2024

PROJECT
06-24-24 CULVERS - ORLANDO, FL

13320 E COLONIAL DRIVE

Table Of Contents

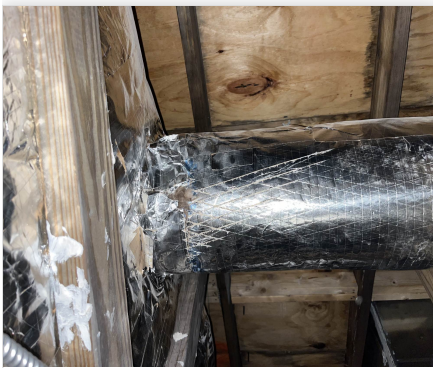
Diffuser2_16
06/27/2024

Issue Name : Diffuser 2-16 Missing Damper
Description : There is no damper installed on RTU 2 Diffuser 16. If comfort issues arise, recommend installing damper and rebalancing diffuser to design airflow. Kitchen was comfortable at time of balancing.
Created By : National TAB **Assigned To :** National TAB - Will Turnbough
Status : Open
Priority : High **Asset Tag :**
Originated Date : 06/27/2024 - Stephen Tassinaro - National TAB

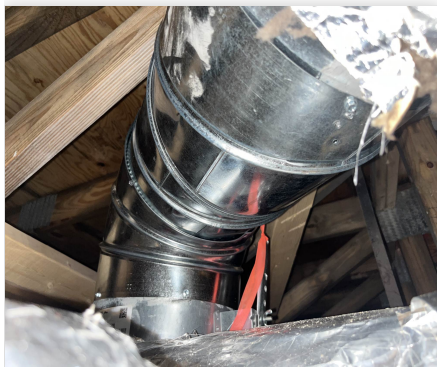
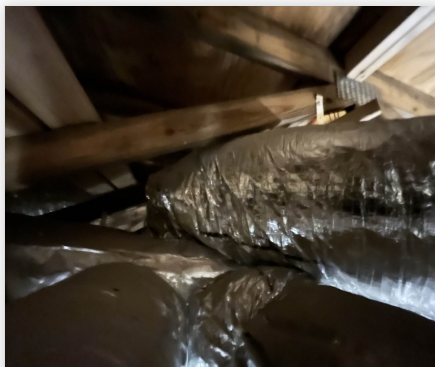
Diffuser2_5_156143215..
07/10/2024

Issue Name : Diffuser 2-5 Restrictive Takeoff
Description : RTU 2 (Kitchen) Diffuser 5 has a restrictive takeoff. Currently this takeoff is installed on the top of the duct. It is not recommended to install the takeoffs on top of the trunkline. If comfort issues arise, recommend moving take-off and rebalancing so that design airflow may be achieved.
Created By : National TAB **Assigned To :** National TAB - Will Turnbough
Status : Open
Priority : High **Asset Tag :**
Originated Date : 06/27/2024 - Stephen Tassinaro - National TAB

- **07/10/2024 National TAB - Stephen Tassinaro**
 - Smoke containment 100% successful as-is.

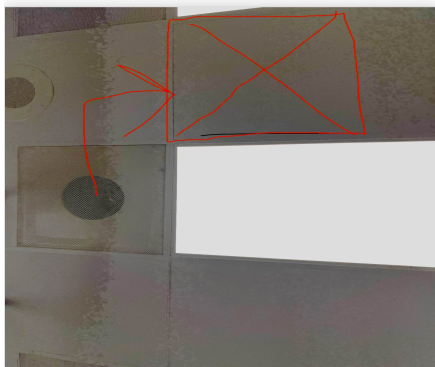
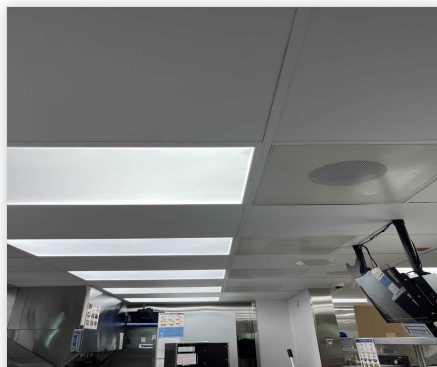
CooklineDiffusers_2_...
06/27/2024

Issue Name : RTU 2 Cookline Diffuser Locations Incorrect
Description : The cookline diffusers (RTU 2, Diffusers 3 thru 8 per NTi GRD Layout) need to be moved closer to the hoods, in between the lights. An example picture is attached. The diffuser locations are imperative for proper hood smoke containment. When looking at the kitchen hoods, each diffuser needs to be moved 24" closer to hoods and 24" to the right.
Created By : National TAB **Assigned To :** National TAB - Will Turnbough
Status : Open
Priority : Medium **Asset Tag :**
Originated Date : 06/27/2024 - Stephen Tassinaro - National TAB

- **07/10/2024 National TAB - Stephen Tassinaro**
 - Diffusers 7 & 8 were not able to be moved into their correct locations due to ceiling grid constraints. All other diffuser locations now correct. Smoke containment 100% successful in current arrangement.
