**Report: TAB Report**  
**Function: Test, Adjust, & Balance**  
**Date: 01/19/2026**  
**Completed By: National TAB**

**PROJECT**  
**01-26-26 QT #1400 TEMPE, AZ**

QUIKTRIP  
4705 SOUTH 129TH EAST AVENUE  
TULSA, OK 74134

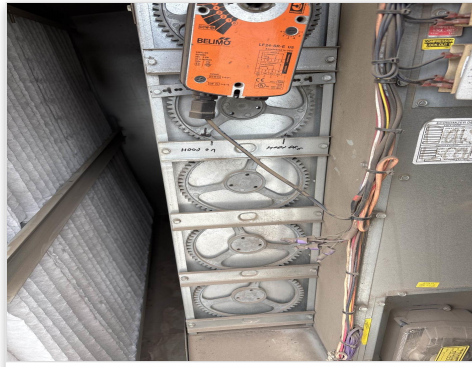
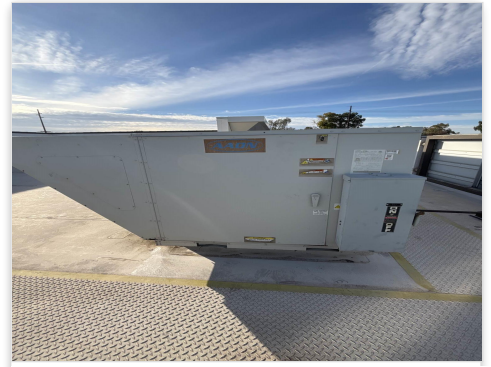
# Unit Data - PHOTO LOG

Unit Data	
	Actual
MFG	AAON
Serial Num	201111-ANEL05899
Model Num	RN-015-8-0-EA0A-152
Num OA Filters 1	1
OA Filter Size 1	45X22.5
Num Final Filter 1	2
Final Filter Size 1	44X20

Test Data		
	Design	Actual
SF CFM	4200	4493
SF RPM	-	1173
OA CFM (Hoods On)	800	794
OA CFM (Hoods Off)	350	337
RL Voltage	-	115@VFD
RL Amperage	-	9.2@VFD
VFD Max SetPt	-	40HZ
VFD Min SetPt	-	24Hz
OA Damper Position (Hoods On)	-	46%
OA Damper Position (Hoods Off)	-	24%

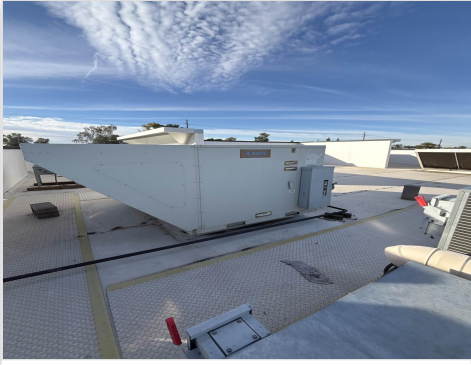
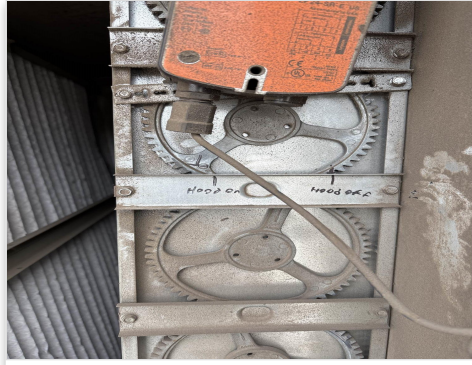
# Unit Data - PHOTO LOG

Unit Data	
	Actual
MFG	AAON
Serial Num	201111-ANEL05900
Model Num	RN-015-8-0-EA0A-152
Num OA Filters 1	1
OA Filter Size 1	45X22.5
Num Final Filter 1	2
Final Filter Size 1	44X20

Test Data		
	Design	Actual
SF CFM	4200	4181
SF RPM	-	1114
OA CFM (Hoods On)	800	878
OA CFM (Hoods Off)	350	358
RL Voltage	-	103@VFD
RL Amperage	-	8.5@VFD
VFD Max SetPt	-	38HZ
VFD Min SetPt	-	24HZ
OA Damper Position (Hoods On)	-	46%
OA Damper Position (Hoods Off)	-	26%

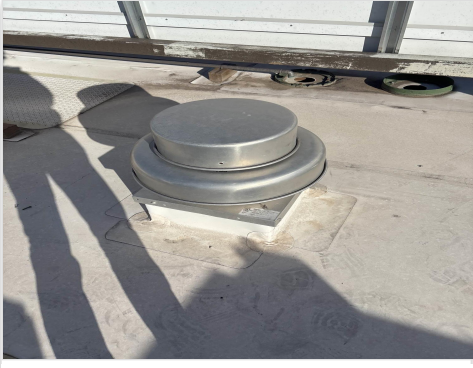
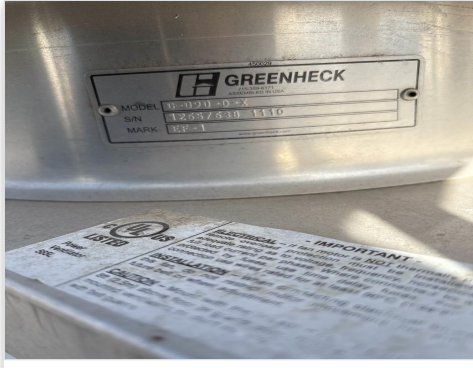
# Unit Data - PHOTO LOG

Unit Data		
	Design	Actual
MFG	NA	GREENHECK
Model Num	NA	G-090-D-X
Serial Num	-	12657638 1110
Type	-	DOWNBLAST
Configuration	-	VERTICAL

Test Data		
	Design	Actual
CFM	225	219
Fan RPM	-	NA
Fan Rotation	-	CCW
Motor RPM	-	NA
System SetPt	-	LOW
RL Voltage	-	NA
RL Amperage	-	1.12
Total ESP	-	0.26"
Fan Inlet SP	-	-0.26"
Fan Discharge SP	-	ATMS

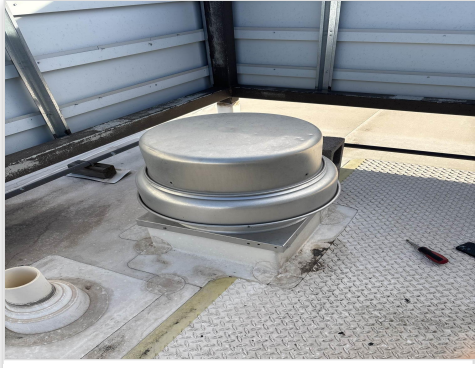
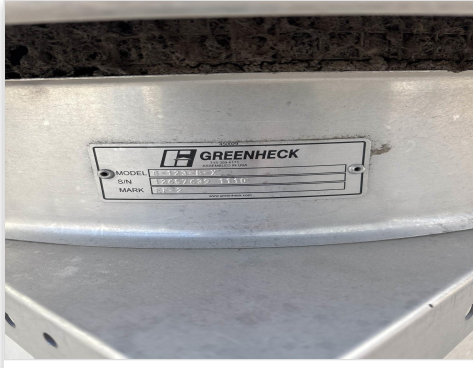
**Unit Data - PHOTO LOG**

Unit Data		
	Design	Actual
MFG	NA	GREENHECK
Model Num	NA	G-123-B-X
Serial Num	-	1265763D 1110
Type	-	DOWNBLAST
Configuration	-	VERTICAL

Test Data		
	Design	Actual
CFM	525	537
Fan RPM	-	NA
Fan Rotation	-	CCW
Motor RPM	-	NA
System SetPt	-	LOW
RL Voltage	-	NA
RL Amperage	-	NA
Total ESP	-	0.19"
Fan Inlet SP	-	-0.19"
Fan Discharge SP	-	ATMS

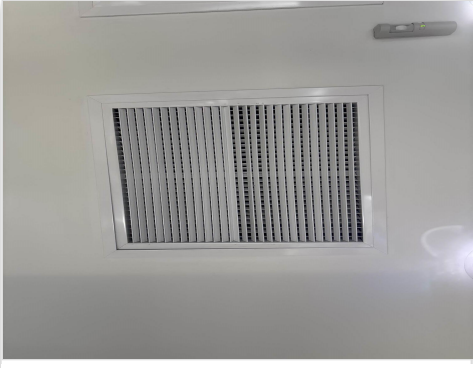
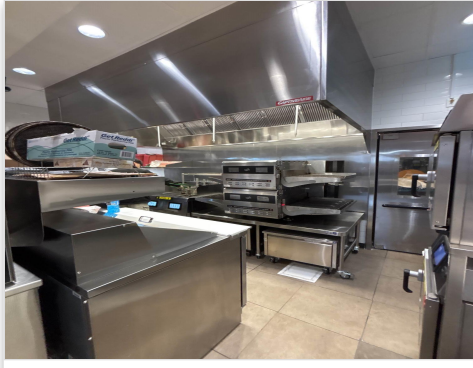
**Unit Data - PHOTO LOG**

Design	Actual
MFG	CAPTIVEAIRE	CAPTIVEAIRE
Model Num	6030ND-2-F	6030ND-2-F
Job / Serial Num	-	8257608
Type	TYPE I CANOPY	TYPE I CANOPY
Hood length	108"	108"
Hood Width	60"	60"

Design	Actual
Filter Type	-	BAFFLE
Filter Size 1	-	16X20
Filter Qty 1	-	6
Filter AK factor size 1	-	2.08
Filter Total AK Area	-	12.48
Filter1 FPM	-	95
Filter2 FPM	-	119
Filter3 FPM	-	111
Filter4 FPM	-	107
Filter5 FPM	-	110
Filter6 FPM	-	103
Filter Ave FPM(corr)	-	107
CFM	1350	1335

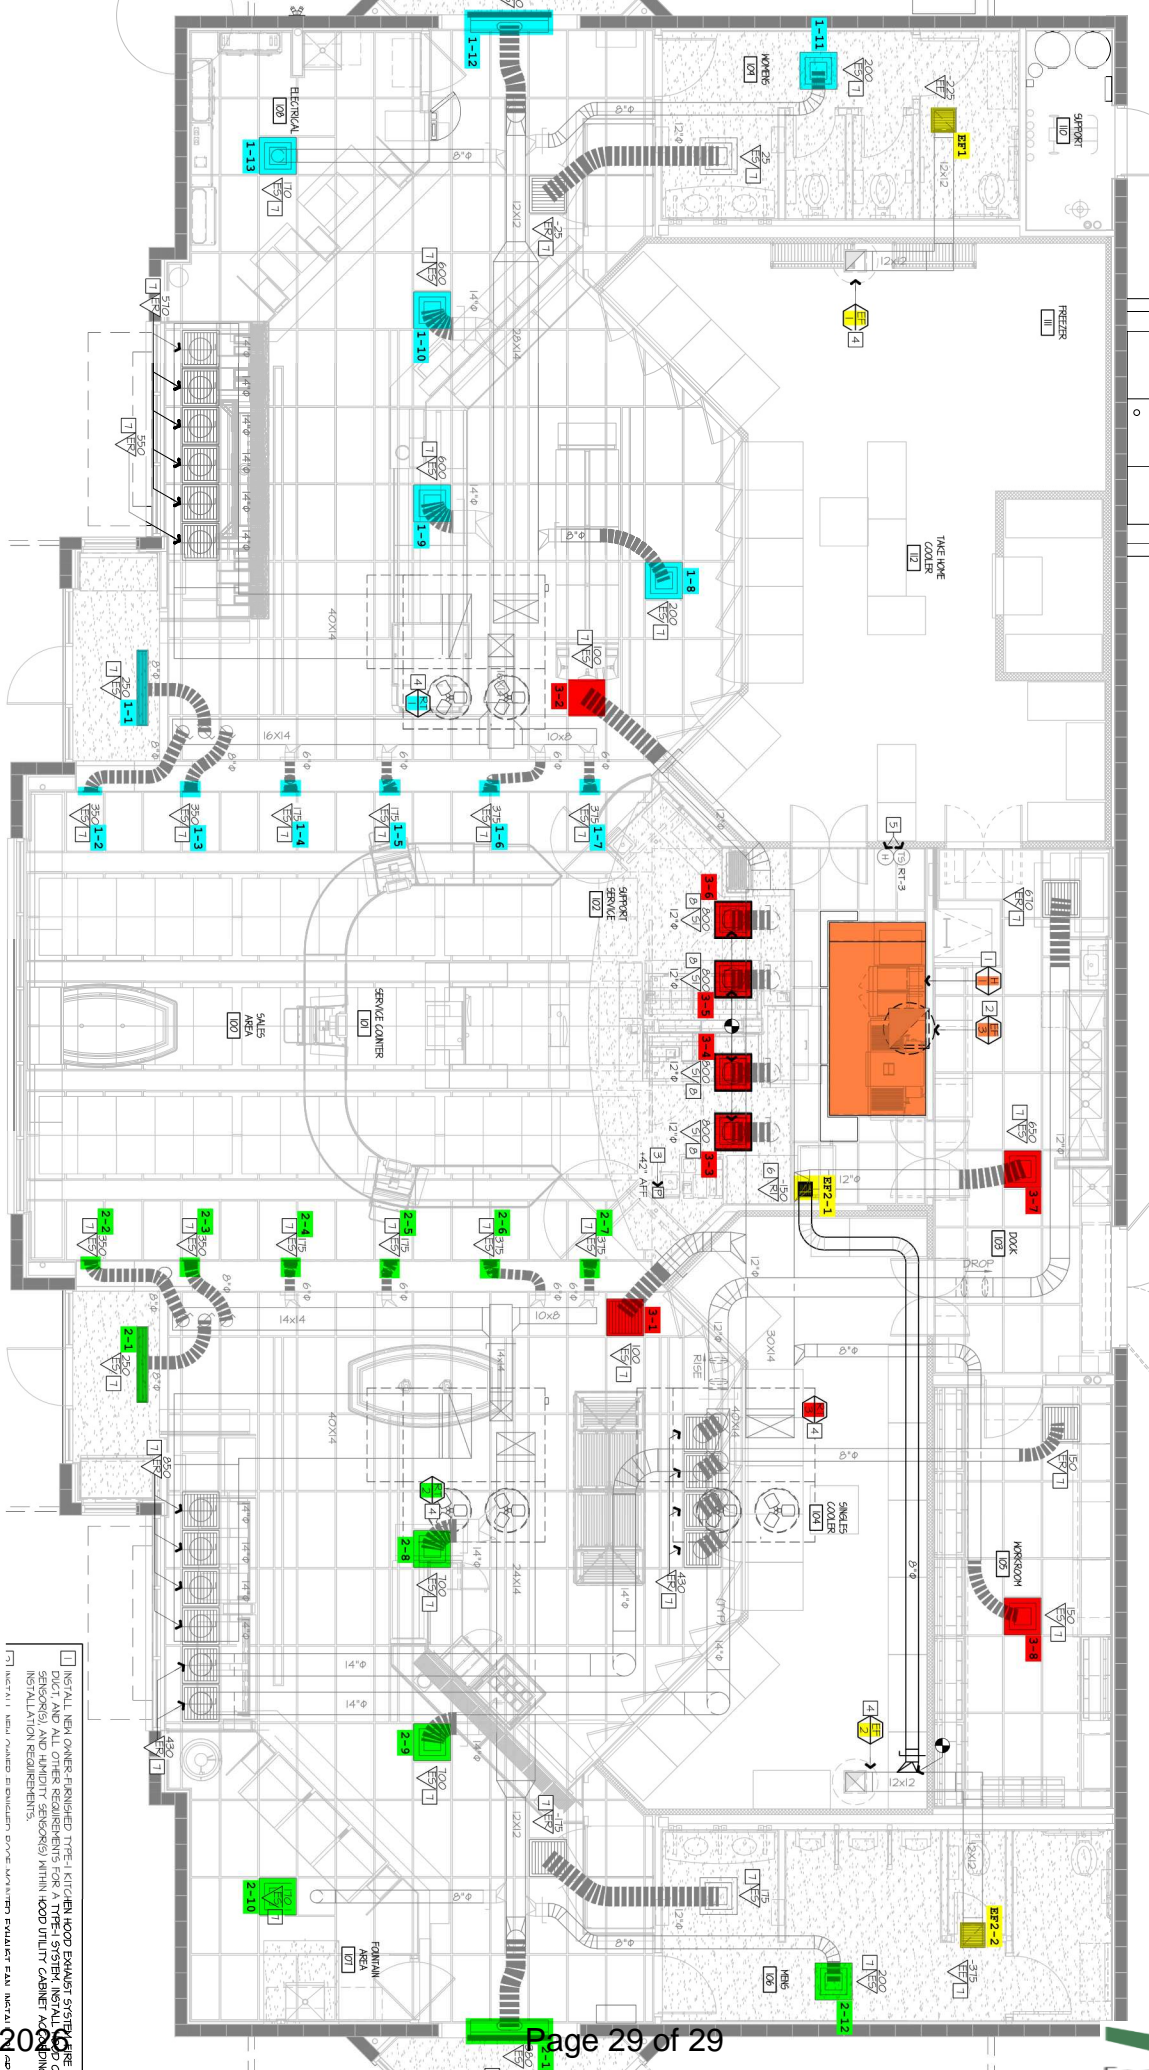
□ INSTALL NEW OWNER-FURNISHED TYPE-I KITCHEN HOOD EXHAUST SYSTEMS WITH 90° ELBOWS, DUCT, AND ALL OTHER REQUIREMENTS FOR A TYPE-I SYSTEM. INSTALL TYPE-I HOOD EXHAUST SYSTEMS (SENSORS) AND HUMIDITY SENSORS) WITHIN HOOD UTILITY CABINET ACCORDING TO MANUFACTURER'S INSTALLATION REQUIREMENTS.  
 □ INSTALL 1 NEW OWNER-FURNISHED TYPE-I KITCHEN HOOD EXHAUST SYSTEM WITH 90° ELBOWS, DUCT, AND ALL OTHER REQUIREMENTS FOR A TYPE-I SYSTEM. INSTALL TYPE-I HOOD EXHAUST SYSTEMS (SENSORS) AND HUMIDITY SENSORS) WITHIN HOOD UTILITY CABINET ACCORDING TO MANUFACTURER'S INSTALLATION REQUIREMENTS.
