Report: TAB Report
Function: Test, Adjust, & Balance
Date: 01/19/2026
Completed By: National TAB

PROJECT
01-26-26 QT #1400 TEMPE, AZ

Project: 01-26-26 QT #1400 TEMPE, AZ

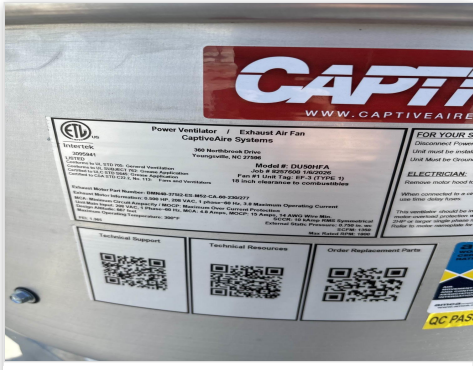
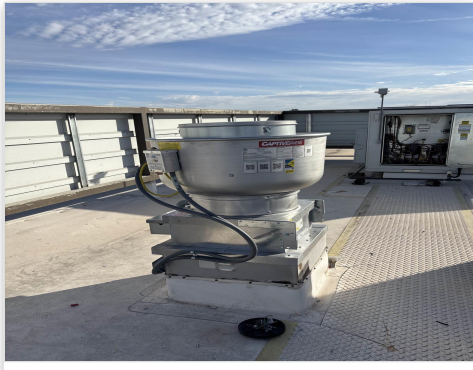
Unit Data - PHOTO LOG

Unit Data		
	Design	Actual
MFG	NA	CAPTIVEAIRE
Model Num	NA	DU50HFA
Serial Num	-	8257608
Type	UPBLAST	UPBLAST
Configuration	VERTICAL	VERTICAL

Test Data		
	Design	Actual
CFM	1350	1335
Fan RPM	-	1367
Fan Rotation	-	CCW
Motor RPM	-	1367
System SetPt	-	56.8HZ
RL Voltage	-	216
RL Amperage	-	2.7
Total ESP	-	0.33"
Fan Inlet SP	-	-0.33"
Fan Discharge SP	-	ATMS
