Report: REPORT
Function: Test, Adjust, & Balance
Date: 12/03/2025
Completed By: National TAB

PROJECT
12-01-25 CHIPOTLE #4809 BELMONT, NC

Project: 12-01-25 CHIPOTLE #4809 BELMONT, NC

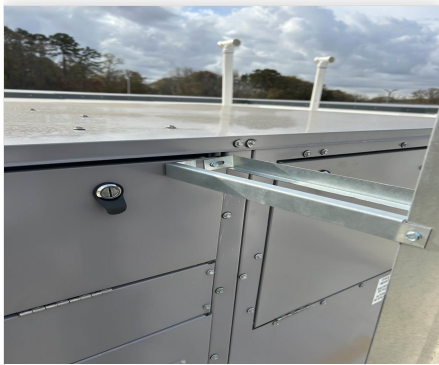
Issue Name : RTU 1 heat exhaust attached to unit
Description : RTU 1 heater exhaust attached to control panel. Unable to open 100% without possibility damage ductwork.
Created By : National TAB **Assigned To :** National TAB - Dan Hertenstein
Status : Open
Priority : InfoOnly **Asset Tag :** RTU1
Originated Date : 12/02/2025 - Jearod Ferrette - National TAB

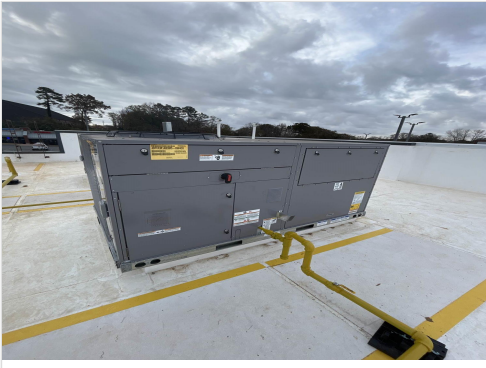
Unit Data - PHOTO LOG

Asset: RTU2

Test Data		
	Design	Actual
SF CFM	4400	4305
SF RPM	-	1755
RA CFM	3400	3267
OA CFM	1000	1038
RL Voltage	-	213/214/213
RL Amperage	-	6.25/ 6.24/6. 25
SF Rotation	-	CCW
SF System SetPt	-	OPT. B 50%
RA Damper Position	-	5.6
Min OA Damper Position	-	4.4
Min OA Damper Type	-	ECON
OA Enthalpy Setpt	-	S5
