**Report: REPORT**

**Function: Test, Adjust, & Balance**

## **12-01-25 CHIPOTLE #4809 BELMONT, NC**

6404 W WILKINSON BLVD

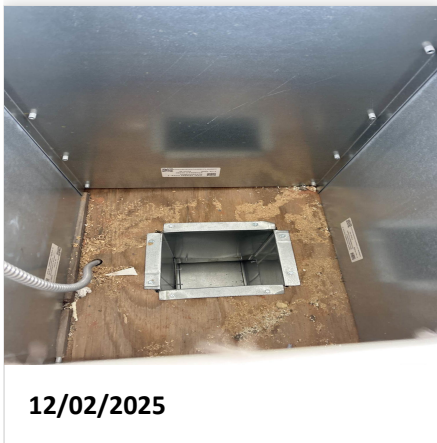
**Issue Name :** Back draft damper missing  
**Description :** EF2 missing back draft damper  
**Created By :** National TAB                      **Assigned To :** National TAB - Dan Hertenstein  
**Status :** Open  
**Priority :** High                                      **Asset Tag :** EF2  
**Originated Date :** 12/02/2025 - Jearod Ferrette - National TAB

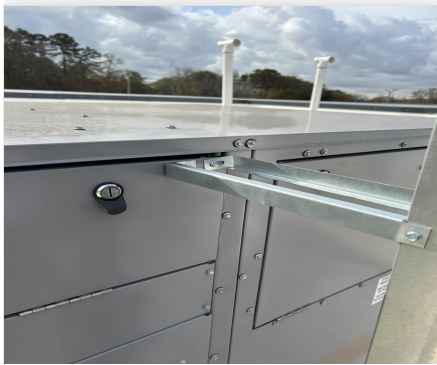
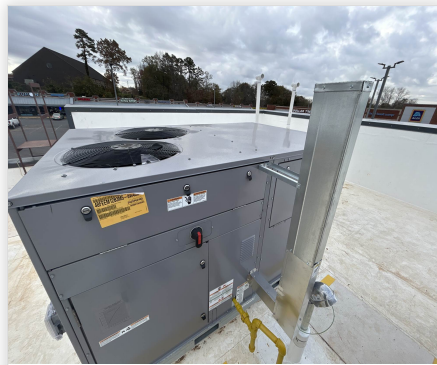
**Issue Name :** RTU 1 heat exhaust attached to unit  
**Description :** RTU 1 heater exhaust attached to control panel. Unable to open 100% without possibility damage ductwork.  
**Created By :** National TAB                      **Assigned To :** National TAB - Dan Hertenstein  
**Status :** Open  
**Priority :** InfoOnly                                      **Asset Tag :** RTU1  
**Originated Date :** 12/02/2025 - Jearod Ferrette - National TAB

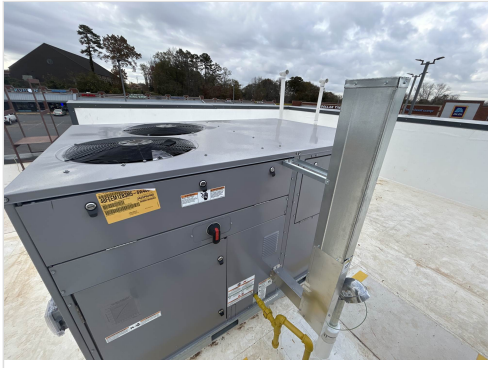
## Unit Data - PHOTO LOG

Asset: RTU1

Unit Data		
	Design	Actual
MFG	CARRIER	CARRIER
Serial Num	-	3425P62460
Model Num	48FE_M12	48FE_M12
Type	RTU	RTU
Configuration	VERTICAL	VERTICAL
Num OA Filters 1	-	1
OA Filter Size 1	-	35X19.5
Num Final Filter 1	-	4
Final Filter Size 1	-	20X20X2

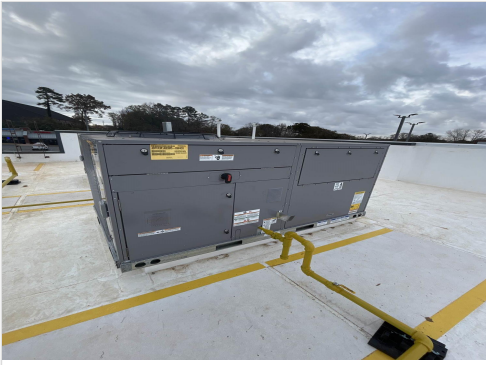
## Unit Data - PHOTO LOG

Asset: RTU2

Unit Data		
	Design	Actual
MFG	CARRIER	CARRIER
Serial Num	-	3325P62309
Model Num	48FE_M14	48FE_M14
Type	RTU	RTU
Configuration	VERTICAL	VERTICAL
Num OA Filters 1	-	1
OA Filter Size 1	-	35X19.5
Num Final Filter 1	-	4
Final Filter Size 1	-	20X20X2

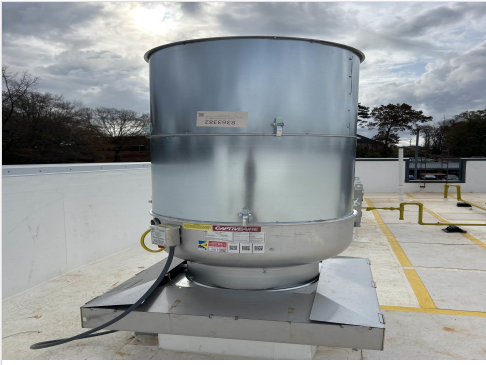
## Unit Data - PHOTO LOG

Asset: EF1

Unit Data		
	Design	Actual
MFG	CAPTIVE-AIRE	CAPTIVE-AIRE
Model Num	DU180HFA	DU180HFA
Serial Num	-	7626669
Type	UPBLAST	UPBLAST
Configuration	VERTICAL	VERTICAL

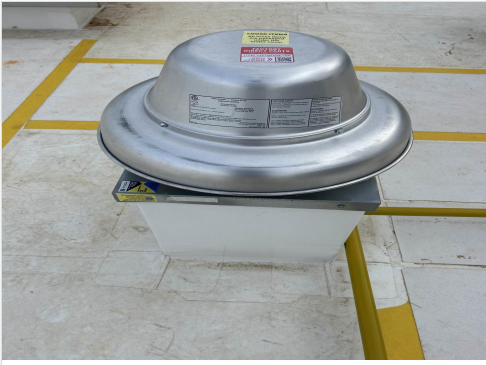
## Unit Data - PHOTO LOG

Asset: EF2

Unit Data		
	Design	Actual
MFG	CAPTIVE-AIRE	CAPTIVE-AIRE
Model Num	DR12HFA	DR12HFA
Serial Num	-	7626669
Type	DOWNBLAST	DOWNBLAST
Configuration	VERTICAL	VERTICAL

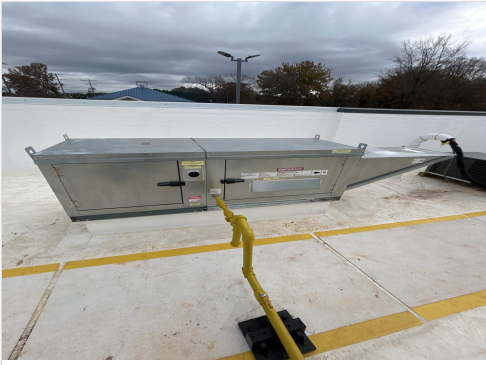
## Unit Data - PHOTO LOG

Asset: MAU1

Unit Data		
	Design	Actual
MFG	CAPTIVE-AIRE	CAPTIVE-AIRE
Model Num	A1-D.250-15D	A1-D.250-15D
Serial Num	-	7626669
Type	MAU	MAU
Configuration	VERTICAL	VERTICAL

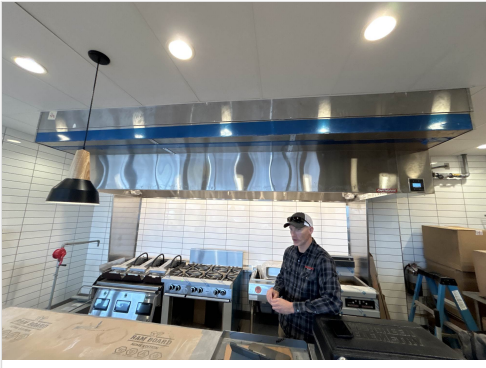
## Unit Data - PHOTO LOG

Asset: HD1

Unit Data		
	Design	Actual
MFG	CAPTIVE-AIRE	CAPTIVE-AIRE
Model Num	5424 ND-2-ACPSP-F	5424 ND-2-ACPSP-F
Job / Serial Num	-	7626669
Type	TYPE 1 CANOPY	TYPE 1 CANOPY
Hood length	153"	153"
Hood Width	54"	54"
Supply Plenum Type	-	ACPSP
Supply Plenum Width	9"	9"
Supply Plenum Length	165"	165"
