**Report: TAB Report**  
**Function: Test, Adjust, & Balance**  
**Date: 03/18/2026**  
**Completed By: National TAB**

**03-16-26 WHATABURGER #1499**  
**CARROLLTON, GA**

Project: 03-16-26 WHATABURGER #1499 CARROLLTON, GA

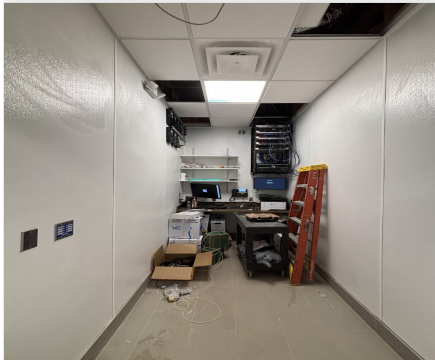
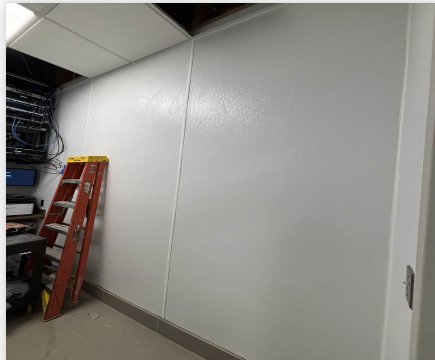
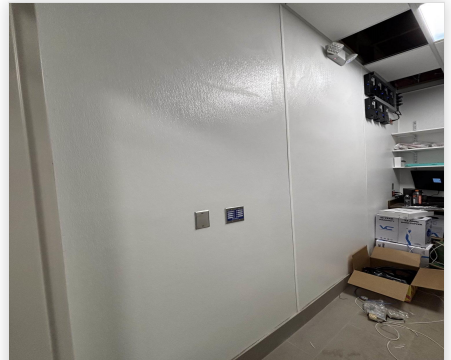
Project Issue File Details

**Issue Name :** No Thermostats Installed  
**Description :** There are no thermostats installed in the office. The mechanical contract said a third party installer would need to put them in.  
**Created By :** National TAB                      **Assigned To :** National TAB - Brianna Biggs  
**Status :** Open  
**Priority :** High                                      **Asset Tag :**  
**Originated Date :** 03/18/2026 - Sagar Patel - National TAB

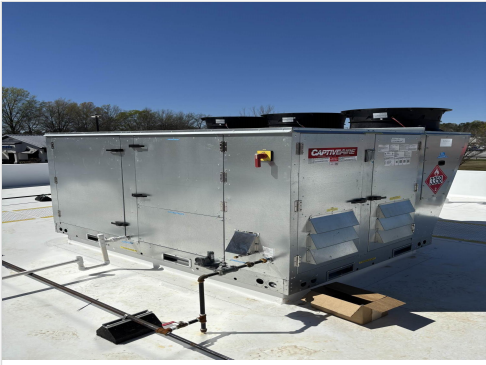
## Unit Data - PHOTO LOG

Asset: RTU-1

General	
	Actual
Unit free of Damage	YES
Fan Rotation Correct	YES
Unit Filters Clean	YES
Condensate Drain Installed	YES

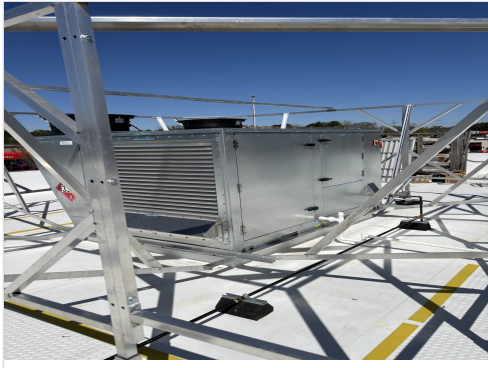
## Unit Data - PHOTO LOG

Asset: RTU-2

General	
	Actual
Unit free of Damage	YES
Fan Rotation Correct	YES
Unit Filters Clean	YES
Condensate Drain Installed	YES

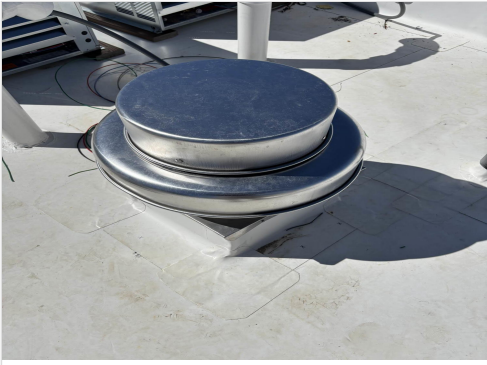
**Unit Data - PHOTO LOG**

Asset: EF-1

[1] UNABLE TO READ VOLTS AND AMPS SAFELY

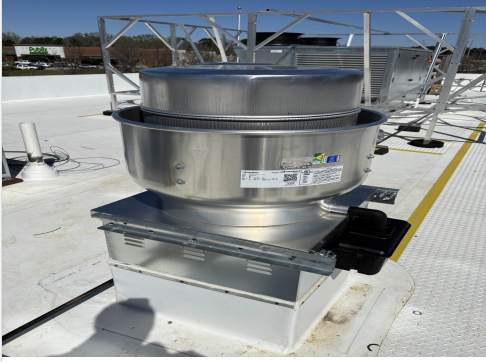
## Unit Data - PHOTO LOG

Asset: KEF-1

Test Data		
	Design	Actual
CFM	1994	2076
Fan Rotation	-	CCW
System SetPt	-	6.5
RL Voltage	-	213
RL Amperage	-	1.3
Total ESP	1.00"	0.37"
Fan Inlet SP	-	-0.37"
Fan Discharge SP	-	ATM

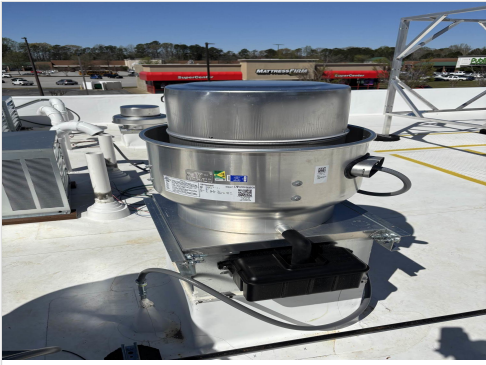
## Unit Data - PHOTO LOG

Asset: KEF-2

Test Data		
	Design	Actual
CFM	1216	169
Fan Rotation	-	CCW
System SetPt	-	6.25
RL Voltage	-	213
RL Amperage	-	1.2
Total ESP	0.75"	0.43"
Fan Inlet SP	-	-0.43"
Fan Discharge SP	-	ATM

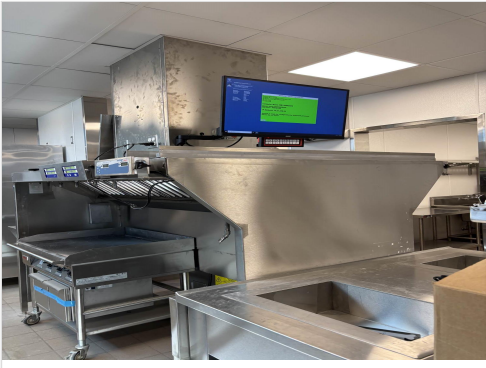
## Unit Data - PHOTO LOG

Asset: HD-1

Test Data Exhaust		
	Design	Actual
Filter Type	FLAMGAURD	FLAMGAURD
Filter Size 1	12X20	12X20
Filter Qty 1	8	8
Filter AK factor size 1	1.5	1.50
Filter Total AK Area	12	12
Filter1 FPM	-	165
Filter2 FPM	-	198
Filter3 FPM	-	180
Filter4 FPM	-	134
Filter5 FPM	-	159
Filter6 FPM	-	193
Filter7 FPM	-	195
Filter8 FPM	-	166
Filter Ave FPM(corr)	-	173
CFM	1994	2076

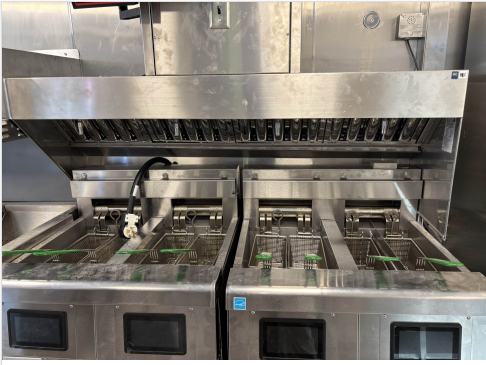
**Unit Data - PHOTO LOG**

Asset: HD-2

Test Data Exhaust		
	Design	Actual
Filter Type	FLAMGAURD	FLAMGAURD
Filter Size 1	12X20	N/A
Filter Size 2	12X16	12X16
Filter Qty 1	2	N/A
Filter Qty 2	2	4
Filter AK factor size 1	1.5	N/A
Filters AK factor size 2	1.16	1.16
Filter Total AK Area	5.32	4.64
Filter1 FPM	-	261
Filter2 FPM	-	293
Filter3 FPM	-	304
Filter4 FPM	-	274
Filter Ave FPM(corr)	-	283
CFM	1216	1313
