**Report: TAB REPORT**  
**Function: Test, Adjust, & Balance**  
**Date: 7/6/2022**

## 06-27 SHAKE SHACK #1380 - BEVERLY HILLS, CA

9601 SOUTH SANTA MONICA BLVD

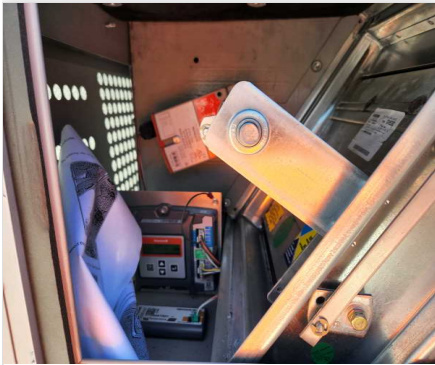
20220628\_112458.jpeg

**Issue Name :** RTU-1 AND RTU-2 OA DAMPER

**Description :** BOTH RTU'S DO NOT HAVE FUNCTIONAL OA DAMPERS. BOTH ARE MANUALLY SET.

- **07/06/2022 National TAB - Will Turnbough**
  - BUILDING PRESSURE WAS MEASURED AS SLIGHTLY NEGATIVE/NEUTRAL LIKELY DUE TO FAN SPEEDS MODULATING AND OUTSIDE AIR DAMPERS NOT ADJUSTING TO COMPENSATE. ONCE FULLY FUNCTIONAL BUILDING PRESSURE ANTICIPATED TO BE SLIGHTLY POSITIVE.

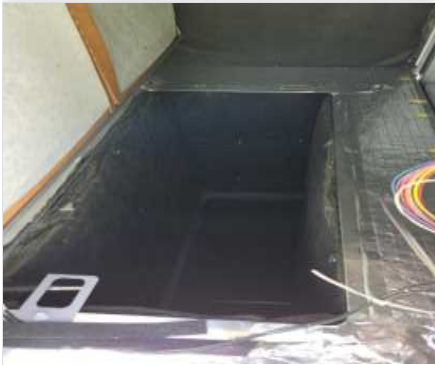
Screenshot\_2022\_07\_06\_110159.png

**Issue Name :** RTU-1 OUTSIDE AIR

**Description :** RTU-1 OUTSIDE AIR IS BELOW DESIGN WITH THE DAMPER FULLY OPEN. THERE IS NO MECHANICALLY LINKED RETURN DAMPER INTERNAL OF THE UNIT. UNABLE TO INCREASE OUTSIDE AIR FURTHER. NET BUILDING PRESSURIZATION IS POSITIVE SO MAY NOT BE AN ISSUE.
