National TAB
1329 E. KEMPER ROAD
SUITE 4210
CINCINNATI, OH 45246

Report: TAB REPORT
Function: Test, Adjust, & Balance
Date: 7/6/2022

06-27 SHAKE SHACK #1380 - BEVERLY HILLS, CA

Table Of Contents

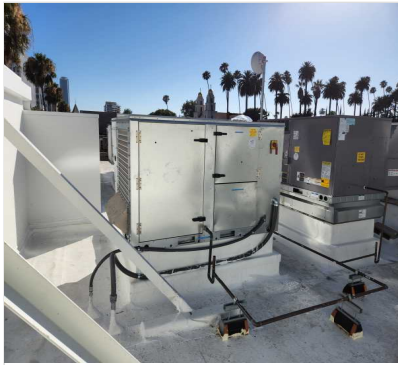
RTU-1

Test Data		
	Design	Actual
SF CFM	2100	2168
SF RPM	2310	2320
RA CFM	1500	1829
OA CFM	600	339
RL Voltage	-	244
RL Amperage	-	7.9
SF Rotation	-	CW
RA Damper Position	-	NONE
Min OA Damper Position	-	100%
Min OA Damper Type	-	MOTORIZED
OA Enthalpy Setpt	-	[1]
Brake Horse Power	-

Notes:DIFFUSER DESIGN TOTAL = 2080CFM. UNIT SCHEDULED AT 2100CFM. [1] ETHALPY CANNOT BE SET DUE TO HONEYWELL DAMPER CONTROL NOT BEING POWERED

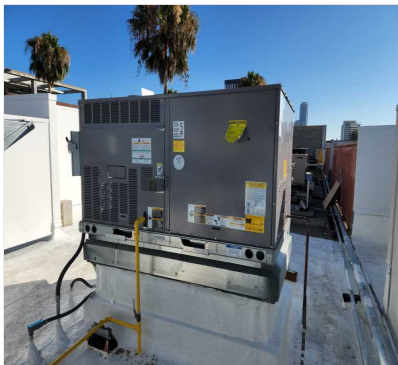
RTU-2

Test Data		
	Design	Actual
SF CFM	2100	2334
SF RPM	2310	2004
RA CFM	1820	2046
OA CFM	280	288
RL Voltage	-	243
RL Amperage	-	7.6
SF Rotation	-	CW
RA Damper Position	-	NONE
Min OA Damper Position	-	60% open
Min OA Damper Type	-	MOTORIZED
OA Enthalpy Setpt	-	[1]
Brake Horse Power	-

Notes:DIFFUSER DESIGN TOTALS =2250CFM. UNIT SCHEDULED AT 2100CFM. Diffuser 7 cannot be dampered down any further [1] ETHALPY CANNOT BE SET DUE TO HONEYWELL DAMPER CONTROL NOT BEING POWERED

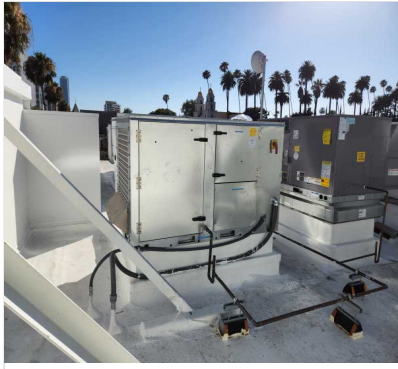
RTU-3

Test Data		
	Design	Actual
SF CFM	2500	2419
SF RPM	2304	2304
RA CFM	2050	1940
OA CFM	450	479
RL Voltage	-	243
RL Amperage	-	5.54
SF Rotation	-	CCW
RA Damper Position	-	4.4
Min OA Damper Position	-	6.6
Min OA Damper Type	-	MOTORIZED
OA Enthalpy Setpt	-	LOW
Brake Horse Power	-	1.12

Notes:OA SETPOINT 4.5 CURRENTLY 6.6

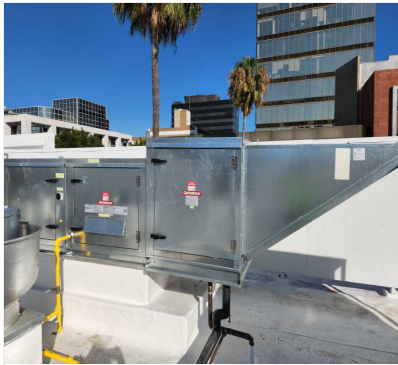
MAU-1

Gas Heat		
	Design	Actual
Heater Operates (y/n)	-	NO
Flame Status (pass/fail)	-	NO
Inlet Air Temp SetPt	-	55
Discharge Air Temp SetPt	-	65
Air Flow Switch SP Actual	-	0.21"

Test Data		
	Design	Actual
CFM	2764	2882
SF RPM	1335	713
Motor RPM	-	713
RL Voltage	-	244
RL Amperage	-	4.6
Total ESP	-	NA
Fan Discharge SP	-	NA

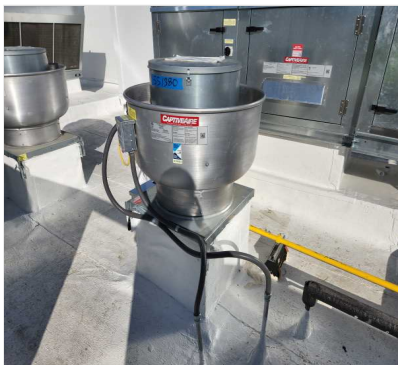
KEF-1

Test Data		
	Design	Actual
CFM	1633	1712
Fan RPM	1323	1347
Fan Rotation	-	CW
Motor RPM	-	1347
System SetPt	-	63%
RL Voltage	-	243
RL Amperage	-	3.3
Total ESP	1.0"	0.7"
Fan Inlet SP	-	-0.7"
Fan Discharge SP	-	ATM

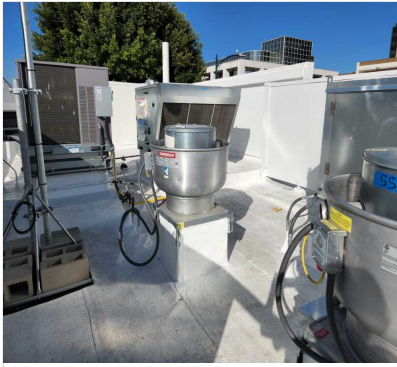
EF-1

Test Data		
	Design	Actual
CFM	270	330
Fan RPM	1542	1542
Fan Rotation	-	CW
Motor RPM	-	1542
System SetPt	-	100%
RL Voltage	-	NA
RL Amperage	-	NA
Total ESP	0.25"	0.1"
Fan Inlet SP	-	-0.1"
Fan Discharge SP	-	ATM

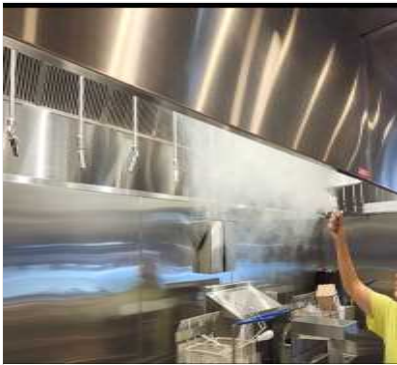
HOOD-1

Performance Data		
	Design	Actual
Exh-Supply Net CFM	163	187
Smoke Generation Type	-	S102
Cooking Equip Heat On	-	NONE
Hood Capture %	-	100%
End Panels Installed (Y/N)	-	YES
Space Offset Temp Riser 1	-	15
Space Offset Temp Riser 2	-	
Riser Temp F (idle) Riser 1	-	72
Riser Temp F (idle) Riser 2	-	71
Ambient Room Temp	-	70.2

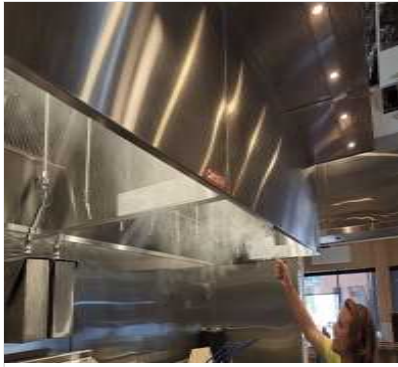
HOOD-2

Performance Data		
	Design	Actual
Exh-Supply Net CFM	323	328
Smoke Generation Type	-	S102
Cooking Equip Heat On	-	NONE
Hood Capture %	-	100%
End Panels Installed (Y/N)	-	YES
Space Offset Temp Riser 1	-	15
Space Offset Temp Riser 2	-	
Riser Temp F (idle) Riser 1	-	71
Riser Temp F (idle) Riser 2	-	72
Ambient Room Temp	-	70.2
