National TAB
1329 E. KEMPER ROAD
SUITE 4210
CINCINNATI, OH 45246

Report: TAB REPORT
Function: Test, Adjust, & Balance
Date: 7/6/2022

06-27 SHAKE SHACK #1380 - BEVERLY HILLS, CA

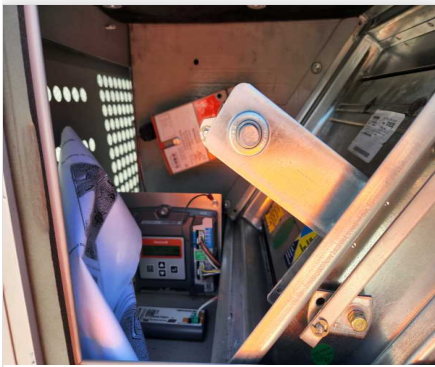
20220628_112458.jpeg

Issue Name : RTU-1 AND RTU-2 OA DAMPER

Description : BOTH RTU'S DO NOT HAVE FUNCTIONAL OA DAMPERS. BOTH ARE MANUALLY SET
