**Report: Test, Adjust, & Balance**

**Date: 5/25/2022**

## 05-16 CULVERS - SHELBYVILLE, IN

1930 NORTH MORRISTOWN RD

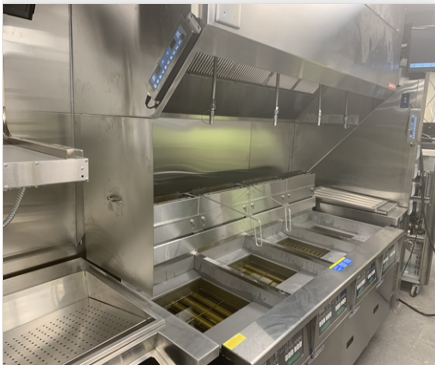
FuseIT3e6425ca431c4f6cbb971c  
fb4cf2e262.jpeg

**Issue Name :** HD-2 smoke capture

**Description :** Smoke capture is not 100%. I tested all diffusers for drafts and increased fan cfm to 110%. Only solution was to use end panel on the left side for 100% smoke capture

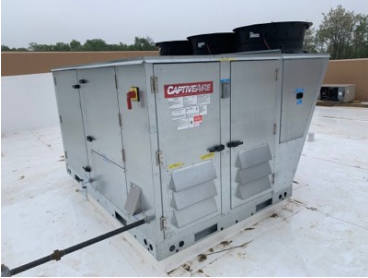
**DOAS-2**

DOAS-2 Economizer not functional, CAS has a new control board ordered. NTAB to Manually adjust and mark damper position.

**Description :** Per Tom with CAS the board is bad and sends a constant 10V signal to the motor preventing adjustment of the damper.

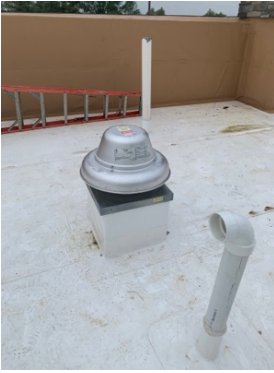
**PRV-1**  
Serves restroom

Design	Actual
<b>CFM</b>	375	378
<b>Fan RPM</b>	1479	864
<b>Fan Rotation</b>	-	CCW
<b>Motor RPM</b>	-	864
<b>System SetPt</b>	-	48%
<b>RL Voltage</b>	-	120.2
<b>RL Amperage</b>	-	0.63
<b>Total ESP</b>	0.5"	0.10"
<b>Fan Inlet SP</b>	-	-0.10"
<b>Fan Discharge SP</b>	-	ATM

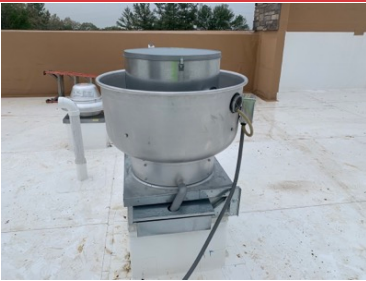
**PRV-2**  
Serves Griddle hood

Test Data		
	Design	Actual
CFM	1500	1497
Fan RPM	2411	1093
Fan Rotation	-	CCW
Motor RPM	-	1093
RL Voltage	-	102.2/102.7/102.4
RL Amperage	-	1.9 AVG
Suction ESP	-	-0.70"
Discharge ESP	-	ATM
Total ESP	2.337"	0.70"

Notes:FAN SPEED SETPOINT: 38HZ

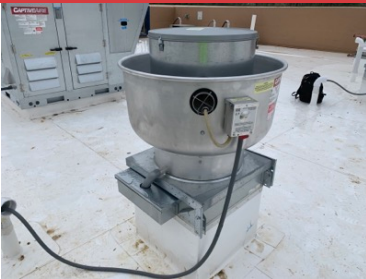
**PRV-3**  
Serves Fryer hood

Test Data		
	Design	Actual
CFM	-	1628
Fan RPM	-	1147
Fan Rotation	-	CCW
Motor RPM	-	1147
RL Voltage	-	104.2/104.5/104.3
RL Amperage	-	2.1 AVG
Suction ESP	-	-0.72"
Discharge ESP	-	ATM
Total ESP	-	0.72"

Notes:FAN SPEED SETPOINT: 39.9HZ

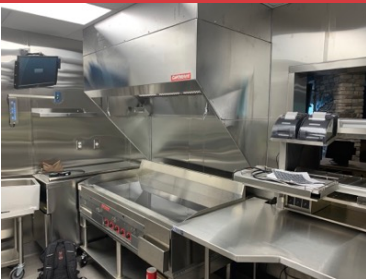
**HD-1**

Performance Data		
	Design	Actual
Smoke Generation Type	-	45 SEC SMOKE
Hood Capture %	-	100%
End Panels Installed (Y/N)	-	45 DEG PANELS

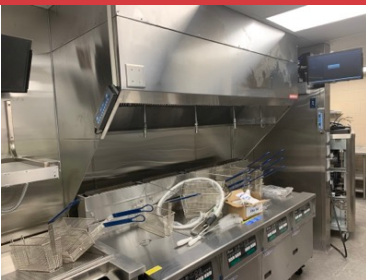
**HD-2**

Performance Data		
	Design	Actual
Smoke Generation Type	-	45 SEC SMOKE
Hood Capture %	-	90%
End Panels Installed (Y/N)	-	CORNER PANELS

Notes: THERE IS SMOKE ESCAPING TO THE LEFT SIDE, NTAB VERIFIED ALL DIFFUSERS WERE CORRECT FLOW, ALL EQUIPMENT IS IN PLACE AND ON. INCREASED FAN TO 110% OF DESIGN. PUTTING A MOCK END PANEL INCREASED HOOD CAPTURE TO 100%.
