Report: TAB Report
Function: Test, Adjust, & Balance
Date: 01/02/2026
Completed By: National TAB

PROJECT
01-12-26 QT #0823 LITHONIA, GA

QUIKTRIP
4705 SOUTH 129TH EAST AVENUE
TULSA, OK 74134

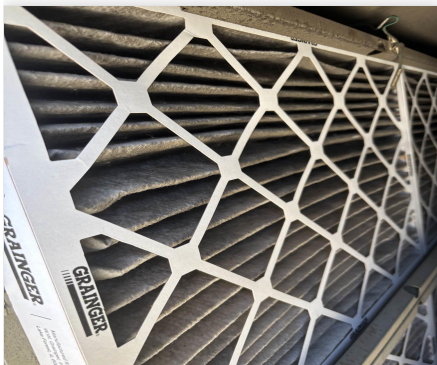
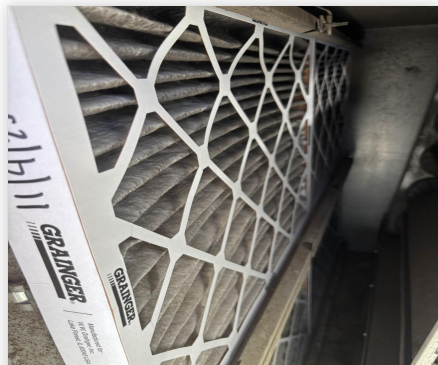
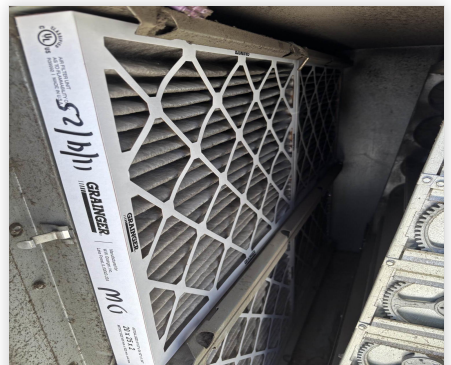
Issue Name : Dirty final filters
Description : All RTU's have dirty final filters. These should be replaced soon.
Created By : National TAB **Assigned To :** National TAB - Dan Hertenstein
Status : Open
Priority : High **Asset Tag :**
Originated Date : 01/13/2026 - Christian Moller - National TAB

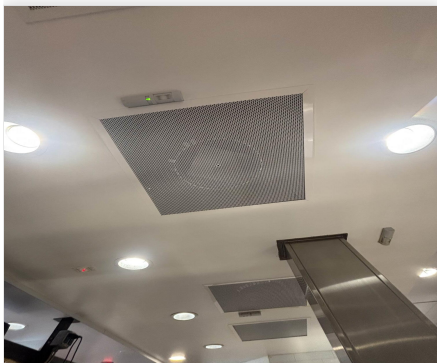
Issue Name : Final diffusers not installed
Description : The final diffusers for the combi oven as well as the cook line diffusers have not been installed. The GC does not know when they will be installed.
Created By : National TAB **Assigned To :** National TAB - Dan Hertenstein
Status : Open
Priority : Medium **Asset Tag :**
Originated Date : 01/13/2026 - Christian Moller - National TAB

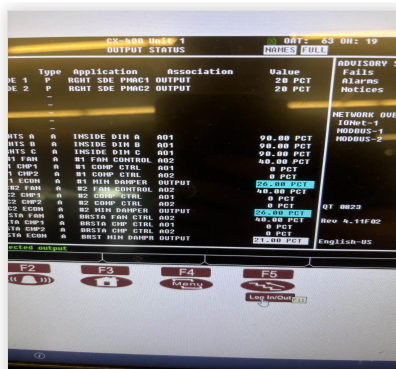
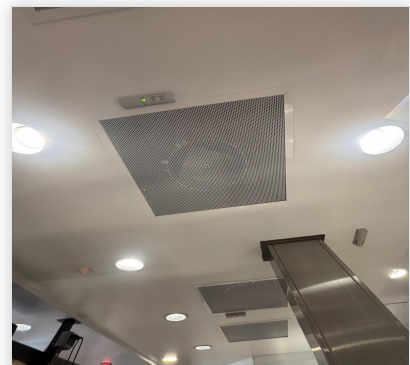
RTU's/AHU's

Evaporator coils are clean?

Pass

Condenser coils are clean?

Gas piping is installed and valves are turned on?

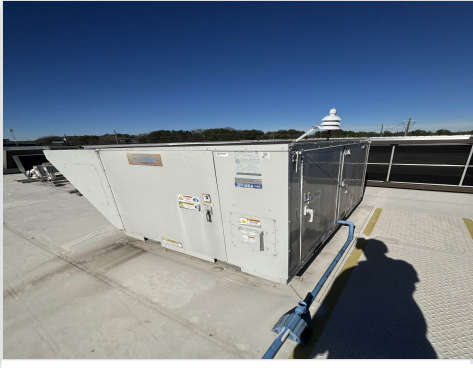
Unit Data - PHOTO LOG

Unit Data	
	Actual
MFG	AAON
Serial Num	201904-ANEK18798
Model Num	RN-013-8-0-EA0A-152
Num OA Filters 1	1
OA Filter Size 1	45X24
Num Final Filter 1	4
Final Filter Size 1	20X25X2

General	
	Actual
Fan Rotation Correct	YES
Unit Filters Clean	NO
Condensate Drain Installed	YES

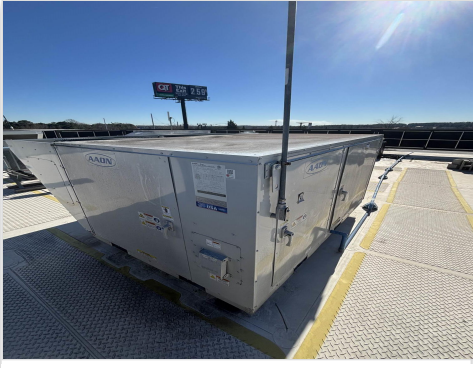
Unit Data - PHOTO LOG

Unit Data	
	Actual
MFG	AAON
Serial Num	201904-ANEK18796
Model Num	RN-013-8-0-EA0A-152
Num OA Filters 1	1
OA Filter Size 1	45X24
Num Final Filter 1	4
Final Filter Size 1	20X25X2

General	
	Actual
Fan Rotation Correct	YES
Unit Filters Clean	NO
Condensate Drain Installed	YES

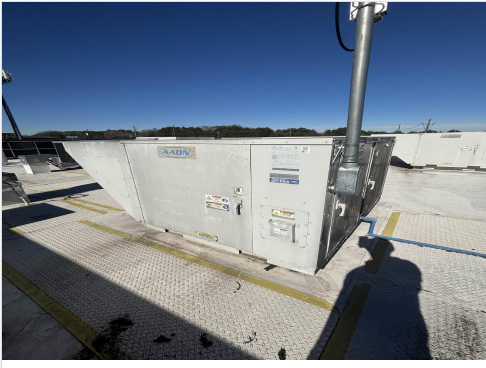
Unit Data - PHOTO LOG

Unit Data	
	Actual
MFG	AAON
Serial Num	201904-ANEK18797
Model Num	RN-013-8-0-EA0A-152
Num OA Filters 1	1
OA Filter Size 1	45X24
Num Final Filter 1	4
Final Filter Size 1	20X25X2

General	
	Actual
Fan Rotation Correct	YES
Unit Filters Clean	NO
Condensate Drain Installed	YES

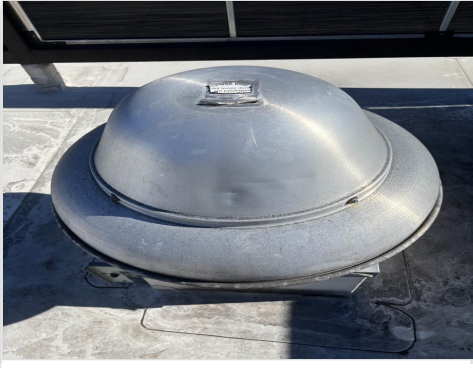
Unit Data - PHOTO LOG

Unit Data	
	Actual
MFG	CAPTIVEAIRE
Model Num	DR50HFA
Serial Num	3849185
Type	UPBLAST
Configuration	VERTICAL

Test Data		
	Design	Actual
CFM	750	689
Fan RPM	-	DD
Fan Rotation	-	CCW
Motor RPM	-	DD
System SetPt	-	MEDIUM SPEED
RL Voltage	-	112
RL Amperage	-	3.7
Total ESP	-	0.24"
Fan Inlet SP	-	-0.24"
Fan Discharge SP	-	ATM

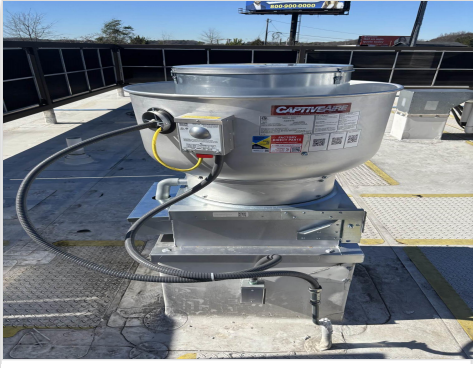
Unit Data - PHOTO LOG

Unit Data		
	Design	Actual
MFG	NA	CAPTIVEAIRE
Model Num	NA	DU50HFA
Serial Num	-	7632006
Type	UPBLAST	UPBLAST
Configuration	VERTICAL	VERTICAL

Test Data		
	Design	Actual
CFM	1350	1346
Fan RPM	-	DD
Fan Rotation	-	CCW
Motor RPM	-	DD
System SetPt	-	HMI/56.8Hz
RL Voltage	-	212
RL Amperage	-	2.1
Total ESP	-	0.31"
Fan Inlet SP	-	-0.31"
Fan Discharge SP	-	ATM

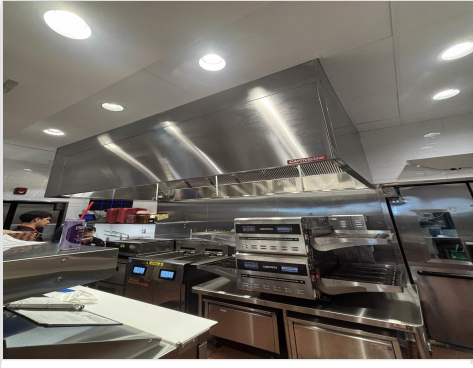
Unit Data - PHOTO LOG

Design	Actual
MFG	CAPTIVEAIRE	CAPTIVEAIRE
Model Num	6030ND-2-F	6030ND-2
Job / Serial Num	-	7632006
Type	-	TYPE I CANOPY
Hood length	-	122"
Hood Width	-	60"

Design	Actual
Filter Type	-	BAFFLE FILTERS
Filter Size 1	-	16X20
Filter Size 2	-	
Filter Qty 1	-	6
Filter Qty 2	-	
Filter AK factor size 1	-	2.08
Filters AK factor size 2	-	
Filter Total AK Area	-	12.48
Filter1 FPM	-	107
Filter2 FPM	-	115
Filter3 FPM	-	111
Filter4 FPM	-	112
Filter5 FPM	-	104
Filter6 FPM	-	98
Filter7 FPM	-	
Filter8 FPM	-	
Filter9 FPM	-	
Filter10 FPM	-	
Filter11 FPM	-	
Filter12 FPM	-	
Filter Ave FPM(corr)	-	108
CFM	1350	1346
