**Report: Prelim\_Report  
Function: Test, Adjust, & Balance  
Date: 10/16/2024  
Completed By: National TAB**

**PROJECT  
10-14-24 CULVERS PALMETTO, FL**

Project: 10-14-24 CULVERS PALMETTO, FL

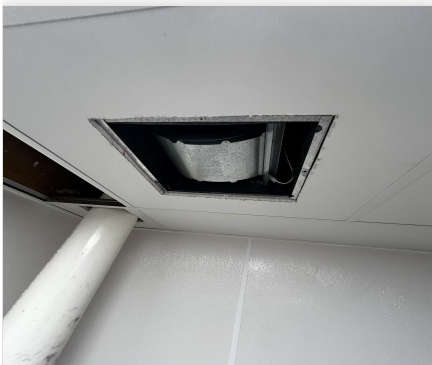
**Issue Name :** EF-1A RR  
**Description :** There is no power to this fan. Recommend having the electrician check wiring.  
**Created By :** National TAB **Assigned To :** National TAB - Will Turnbough  
**Status :** Closed  
**Priority :** Urgent **Asset Tag :**  
**Originated Date :** 10/14/2024 - Kristopher Passley - National TAB

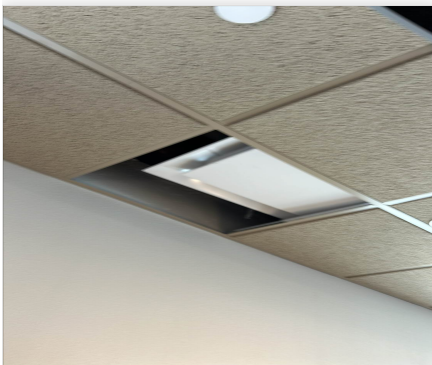
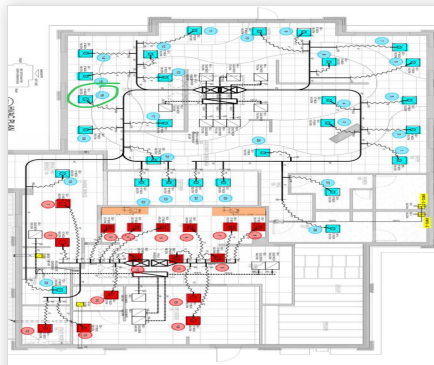
**Issue Name :** RTU 1 Diffuser 16  
**Description :** Diffusers not installed in ceiling grid - Unable to balance until resolved  
**Created By :** National TAB  
**Assigned To :** National TAB - Will Turnbough  
**Status :** Closed  
**Priority :** Urgent  
**Asset Tag :**  
**Originated Date :** 10/14/2024 - Kristopher Passley - National TAB
