Report: Prelim_Report
Function: Test, Adjust, & Balance
Date: 10/16/2024
Completed By: National TAB

PROJECT
10-14-24 CULVERS PALMETTO, FL

Project: 10-14-24 CULVERS PALMETTO, FL

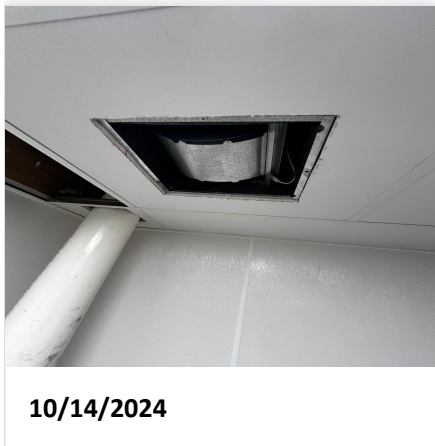
Issue Name : EF-1A RR
Description : There is no power to this fan. Recommend having the electrician check wiring.
Created By : National TAB **Assigned To :** National TAB - Will Turnbough
Status : Closed
Priority : Urgent **Asset Tag :**
Originated Date : 10/14/2024 - Kristopher Passley - National TAB

- **10/15/2024 National TAB - Kristopher Passley**
 - Fan now has power.

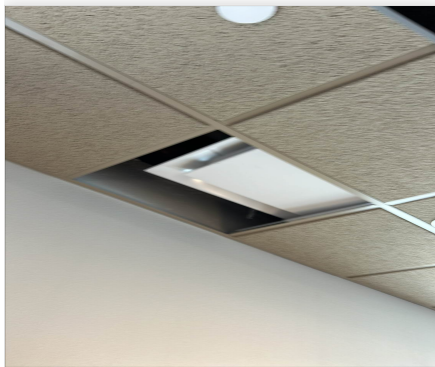
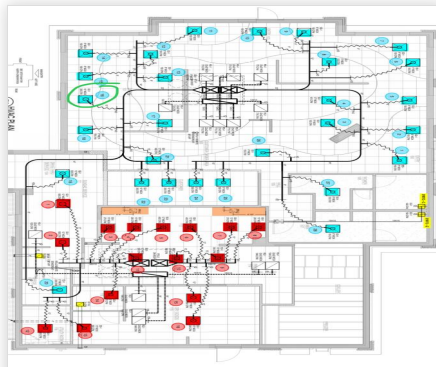
Issue Name : RTU 1 Diffuser 16
Description : Diffusers not installed in ceiling grid - Unable to balance until resolved
Created By : National TAB **Assigned To :** National TAB - Will Turnbough
Status : Closed
Priority : Urgent **Asset Tag :**
Originated Date : 10/14/2024 - Kristopher Passley - National TAB

- **10/16/2024 National TAB - Kristopher Passley**
 - Diffuser was installed in the ceiling grid.
