Report: TAB Report
Function: Test, Adjust, & Balance
Date: 03/02/2026
Completed By: National TAB

**02-23-26 WHATABURGER #1644 GARNER,
NC**

79 INSPIRATION DRIVE

Project: 02-23-26 WHATABURGER #1644 GARNER, NC

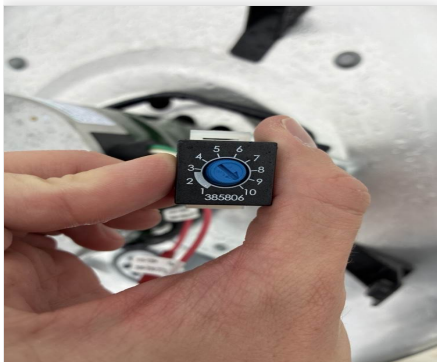
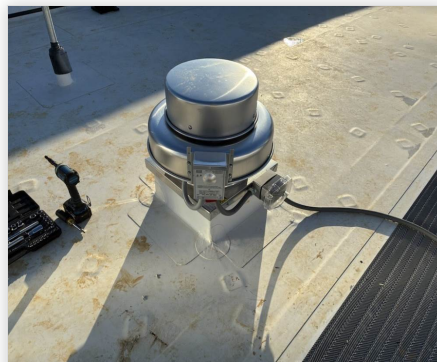
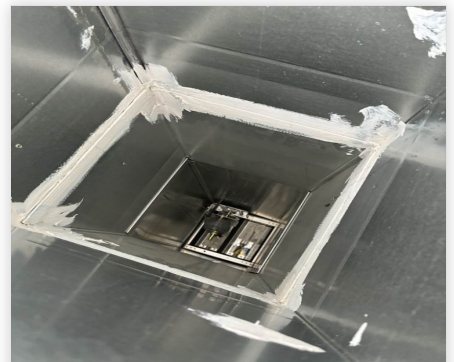
Issue Name : EF-1 Damper Not Opening
Description : The damper in the drop is not opening resulting in low flow for the two bathroom exhaust diffusers. The fan is set to the maximum speed, there are no odd shapes/angles in the duct work, and the branch dampers are 100% open. The damper in the drop needs to open in order for there to be appropriate flow.

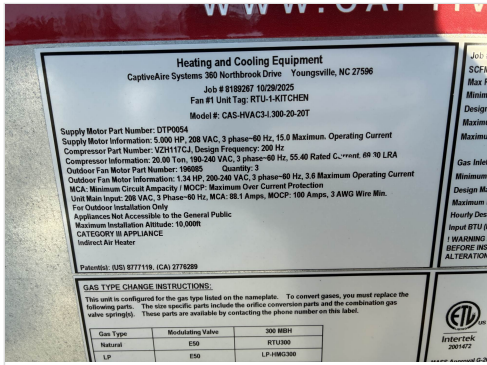
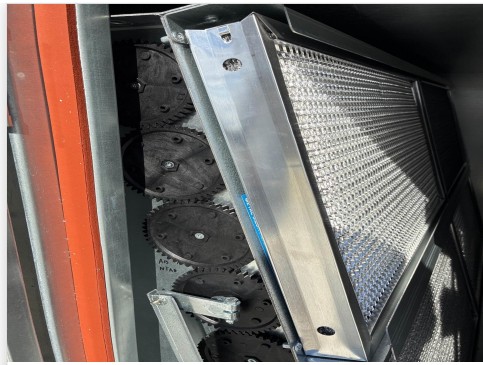
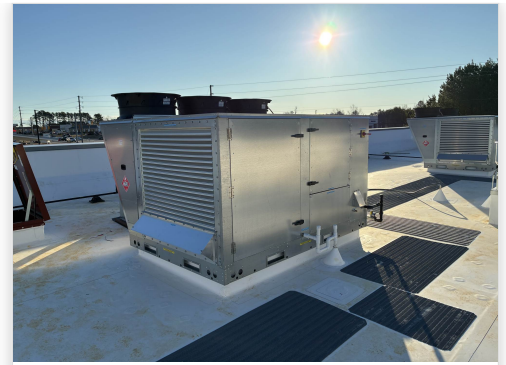
Asset: RTU1

Unit Data	
	Actual
MFG	CAPTIVE-AIRE
Serial Num	8189267
Model Num	CAS-HVAC3-I.300-20-20T
Num OA Filters 1	4
OA Filter Size 1	16X20X2
Num Final Filter 1	8
Final Filter Size 1	20X25X2

Test Data		
	Design	Actual
SF CFM	3650	3507
SF RPM	-	1195
MOTOR RPM	-	1195
RA CFM	1533	1395
OA CFM	2117	2112
RL Voltage	-	128 VFD
RL Amperage	-	9.70 VFD
SF System SetPt	-	41 Hz
Min OA Damper Position	-	60%
Min OA Damper Type	-	ECON

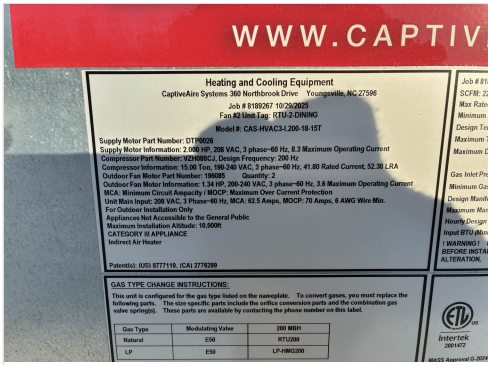
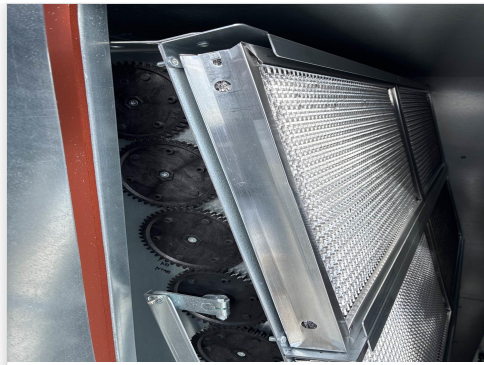
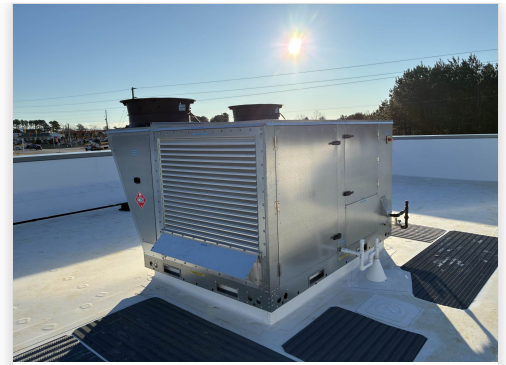
Asset: RTU2

Unit Data	
	Actual
MFG	CAPTIVE-AIRE
Serial Num	8189267
Model Num	CAS-HVAC3-I.200-15-15T
Num OA Filters 1	4
OA Filter Size 1	16X20X2
Num Final Filter 1	8
Final Filter Size 1	20X25X2

Test Data		
	Design	Actual
SF CFM	2240	2189
SF RPM	-	1575
MOTOR RPM	-	1575
RA CFM	493	444
OA CFM	1747	1745
RL Voltage	-	128 VFD
RL Amperage	-	5.1 VFD
SF System SetPt	-	54 Hz
Min OA Damper Position	-	40%
Min OA Damper Type	-	ECON

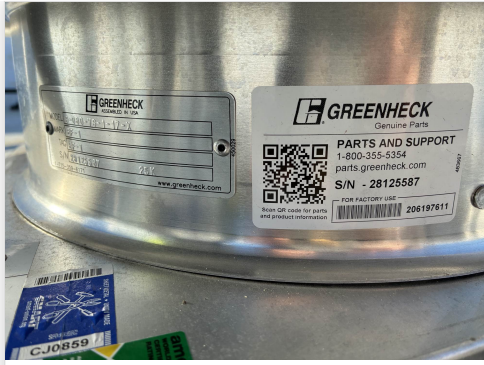
Asset: EF1

Unit Data		
	Design	Actual
MFG	GREENHECK	GREENHECK
Model Num	G-080-VG	G-080-VG-1-17-X
Serial Num	-	28125587
Type	DOWNBLAST	DOWNBLAST
Configuration	VERTICAL	VERTICAL

Test Data		
	Design	Actual
CFM	300	147
Fan RPM	1679	1750
Fan Rotation	-	CCW
Motor RPM	-	
System SetPt	-	10
RL Voltage	-	NA
RL Amperage	-	NA
Total ESP	0.50"	1.15"
Fan Inlet SP	-	-1.15"
Fan Discharge SP	-	ATM

Unable to read volts and amps because of rain.

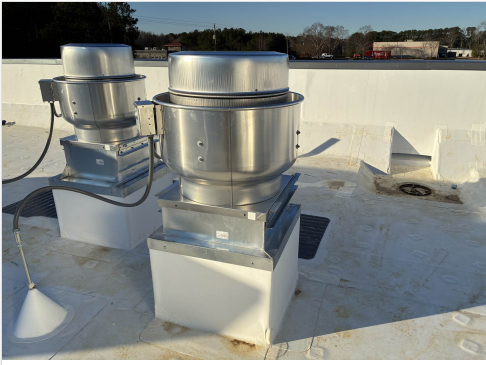
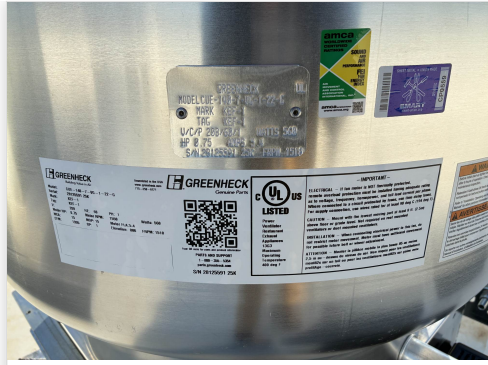
Asset: KEF1

Unit Data		
	Design	Actual
MFG	GREENHECK	GREENHECK
Model Num	CUE-140-VG	CUE-140-7-VG-1-22-G
Serial Num	-	28125591 25K
Type	UPBLAST	UPBLAST
Configuration	VERTICAL	VERTICAL

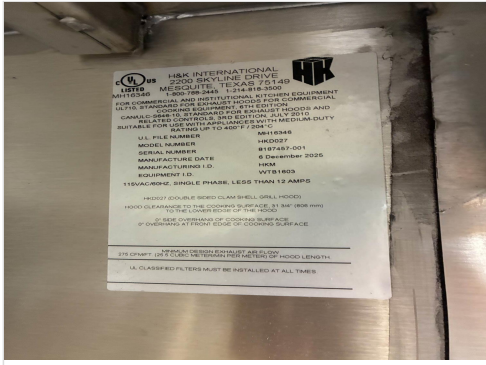
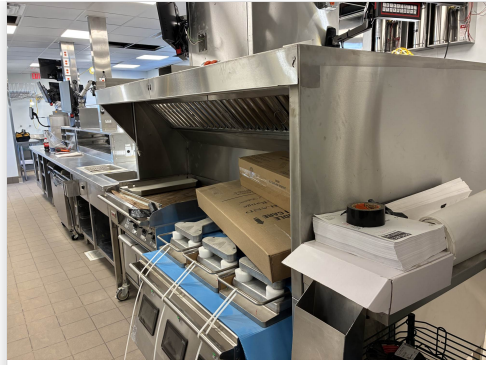
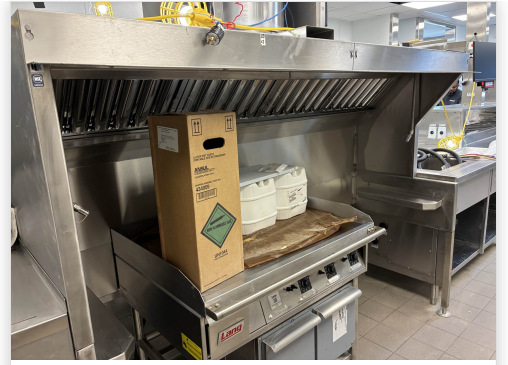
Asset: HD1

Unit Data		
	Design	Actual
MFG	H&K DALLAS	H&K DALLAS
Model Num	HKD0	HKD027
Job / Serial Num	-	8187457-001
Type	TYPE 1 CANOPY	TYPE I CANOPY
Hood length	87"	86.75"
Hood Width	56.19"	56.25"

Test Data Exhaust		
	Design	Actual
Filter Type	-	BAFFLE FILTERS
Filter Size 1	-	9.75X17.75
Filter Qty 1	-	8
Filter AK factor size 1	-	1.20
Filter Total AK Area	-	9.60
Filter1 FPM	-	
Filter2 FPM	-	
Filter3 FPM	-	
Filter4 FPM	-	
Filter5 FPM	-	
Filter6 FPM	-	
Filter7 FPM	-	
Filter8 FPM	-	
Filter Ave FPM(corr)	-	
CFM	1994

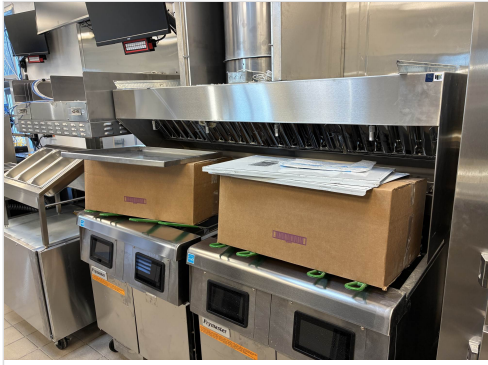
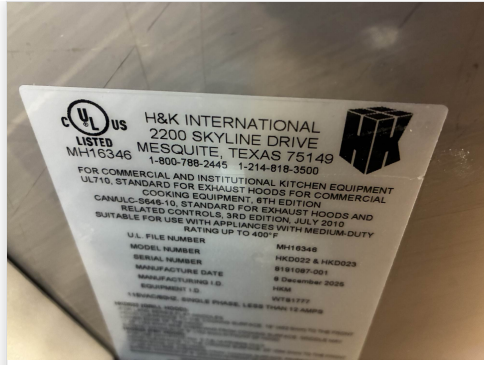
Asset: HD2

Unit Data		
	Design	Actual
MFG	H&K DALLAS	H&K DALLAS
Model Num	HKD0	HKD023
Job / Serial Num	-	8191087-001
Type	TYPE 1 CANOPY	TYPE I CANOPY
Hood length	73"	65.50"
Hood Width	22.19	22.25"

Test Data Exhaust		
	Design	Actual
Filter Type	SS BAFFLE	SS BAFFLE FILTERS
Filter Size 1	12X16	9.50X14
Filter Qty 1	3	4
Filter AK factor size 1	1.16	0.92
Filter Total AK Area	4.98	3.68
Filter1 FPM	-	
Filter2 FPM	-	
Filter3 FPM	-	
Filter4 FPM	-	
Filter Ave FPM(corr)	-	
CFM	1216
