Report: TAB Report
Function: Test, Adjust, & Balance
Date: 03/02/2026
Completed By: National TAB

**02-23-26 WHATABURGER #1644 GARNER,
NC**

79 INSPIRATION DRIVE

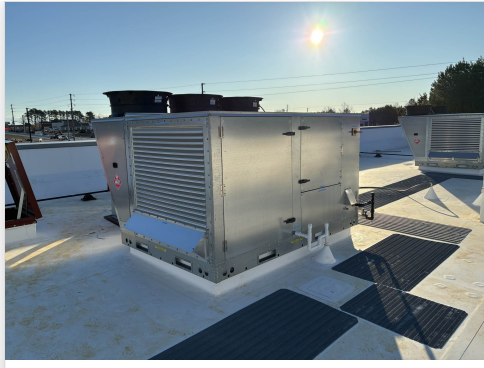
Asset: RTU1

Heating and Cooling Equipment
 CaptiveAire Systems 360 Northbrook Drive Youngsville, NC 27596
 Job # 819267 10/28/2025
 Fan #1 Unit Tag: RTU-1-KITCHEN
 Model #: CAS-HVAC3-300-20-20T
