Report: TAB Report
Function: Test, Adjust, & Balance
Date: 03/02/2026
Completed By: National TAB

**02-23-26 WHATABURGER #1644 GARNER,
NC**

Project: 02-23-26 WHATABURGER #1644 GARNER, NC

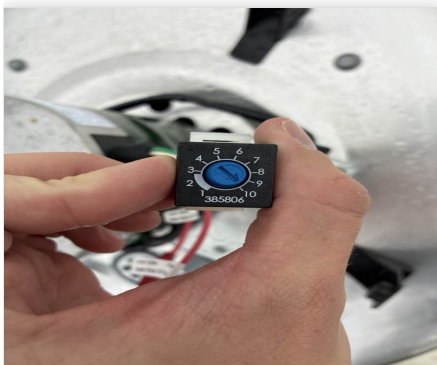
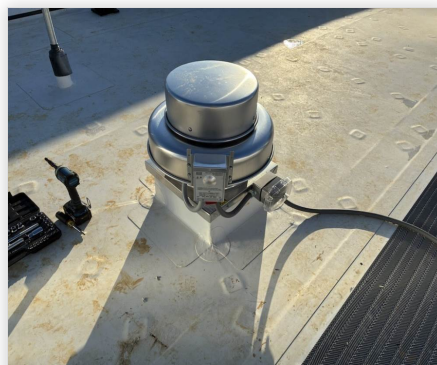
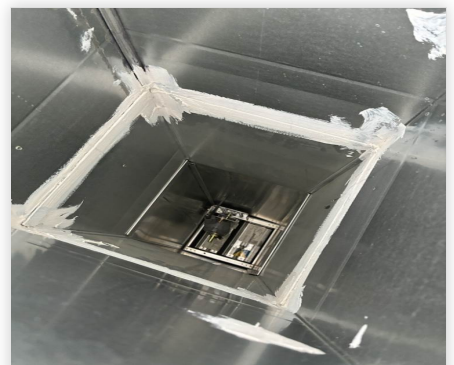
Issue Name : EF-1 Damper Not Opening
Description : The damper in the drop is not opening resulting in low flow for the two bathroom exhaust diffusers. The damper is too far down the drop to be manually opened. The damper actuator wire is not wired to anything. The wire needs to be used in order for the damper to open.
Created By : National TAB **Assigned To :** National TAB - Brianna Biggs
Status : Open
Priority : High **Asset Tag :** EF1
Originated Date : 02/26/2026 - Alex Bauer - National TAB

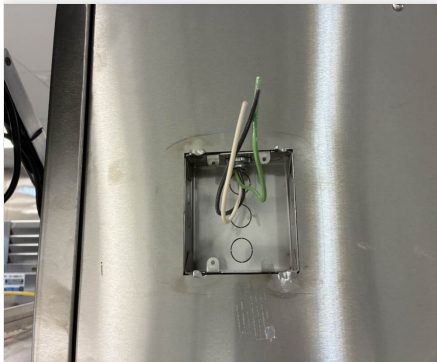
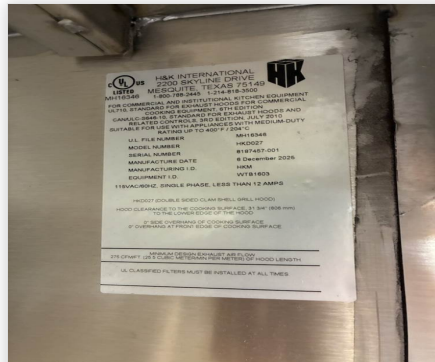
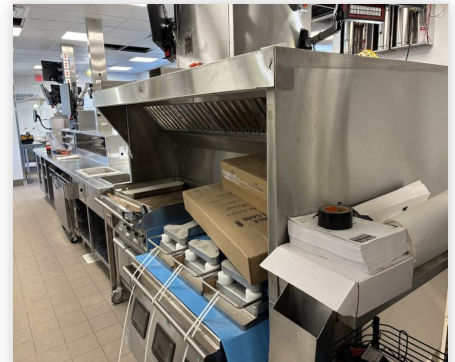
Issue Name : HD-1 Not Wired/Connected
Description : The on/off switch for HD-1 is not wired. The technician from Chisholm Service says the hoods are also not connected to the RTUs. The switch needs to be wired and the hood systems connected to the RTUs.

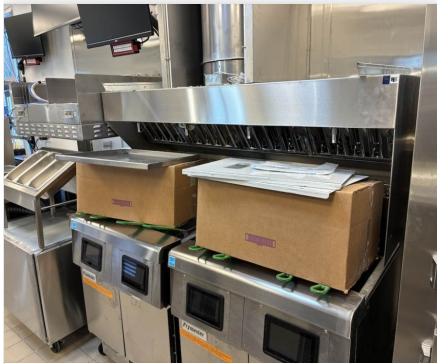
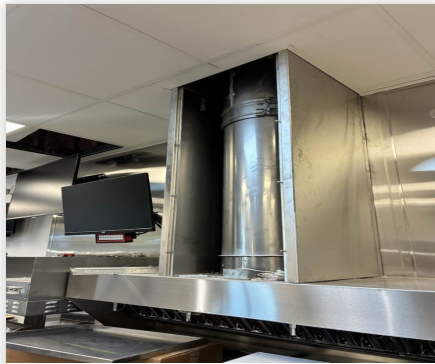
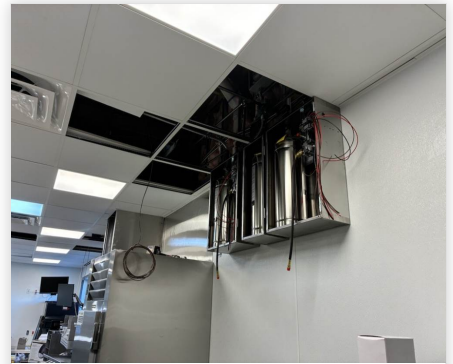
Issue Name : HD-2 Not Wired/Connected
Description : The on/off switch for HD-2 is not wired. The technician from Chisholm Service says the hoods are also not connected to the RTUs. The switch needs to be wired and the hood systems connected to the RTUs.
Created By : National TAB **Assigned To :** National TAB - Brianna Biggs
Status : Closed
Priority : Urgent **Asset Tag :** HD2
Originated Date : 02/23/2026 - Alex Bauer - National TAB

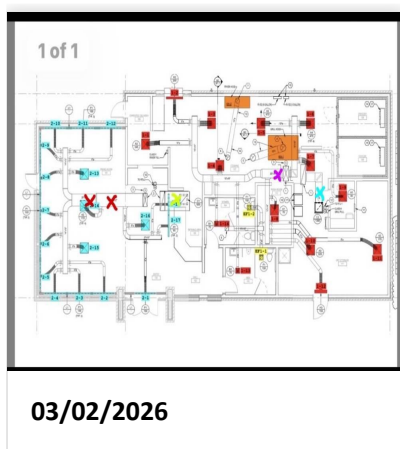
Screenshot of the GRD marked up with supply and return traverse locations for RTU-1 (Add picture here)

The returns were not traversed as they were not reachable.

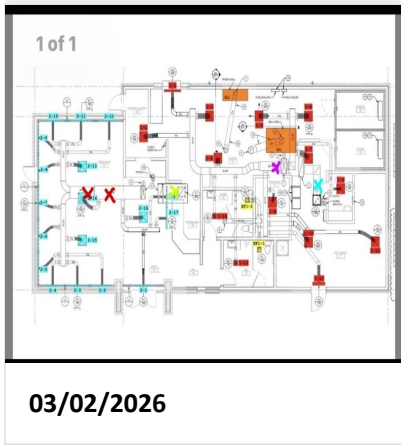
Screenshot of the GRD marked up with supply and return traverse locations for RTU-2 (Add picture here)

The returns were not traversed as they were not reachable.

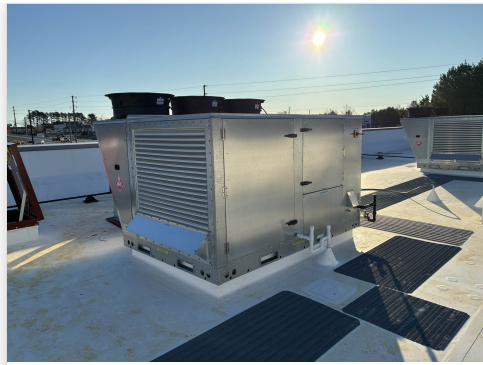
Asset: RTU1

Heating and Cooling Equipment
 CaptiveAire Systems 360 Northbrook Drive Youngsville, NC 27596
 Job # 819267 10/28/2025
 Fan #1 Unit Tag: RTU-1-KITCHEN
 Model #: CAS-HVAC3-300-20-T

Supply Motor Part Number: DTP0054
 Supply Motor Information: 5.000 HP, 208 VAC, 3 phase-60 Hz, 15.0 Maximum Operating Current
 Compressor Part Number: VQ111TC4 Design Frequency: 200 Hz
 Compressor Information: 20.00 Ton, 190-240 VAC, 3 phase-60 Hz, 55.40 Rated Current, 69.70 LRA
 Outdoor Fan Motor Part Number: 196895 Quantity: 3
 Outdoor Fan Motor Information: 1.34 HP, 200-240 VAC, 3 phase-60 Hz, 3.8 Maximum Operating Current
 MCA: Minimum Circuit Ampacity / MOCP: Maximum Over Current Protection
 Unit Main Input: 208 VAC, 3 Phase-60 Hz, MCA: 98.1 Amps, MOCP: 100 Amps, 3 AWG Wire Min.
 For Outdoor Installation Only
 Appliance Not Accessible to the General Public
 Maximum Installation Altitude: 10,000ft
 CATEGORY III APPLIANCE
 Indirect Air Heater

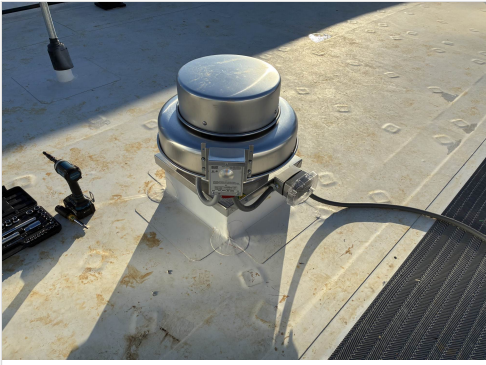
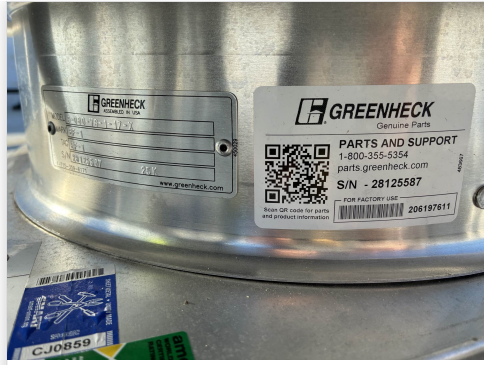
Asset: EF1

Test Data		
	Design	Actual
CFM	300	138
Fan RPM	1679	1750
Fan Rotation	-	CCW
Motor RPM	-	1750
System SetPt	-	10
RL Voltage	-	125
RL Amperage	-	1.71
Total ESP	0.50"	1.15"
Fan Inlet SP	-	-1.15"
Fan Discharge SP	-	ATM

Notes:
See issues list.
