Report: TAB REPORT
Function: Test, Adjust, & Balance
Date: 10/18/2023

PROJECT
10-16-23 FREDDYS - PROVO, UT

1025 S University Ave

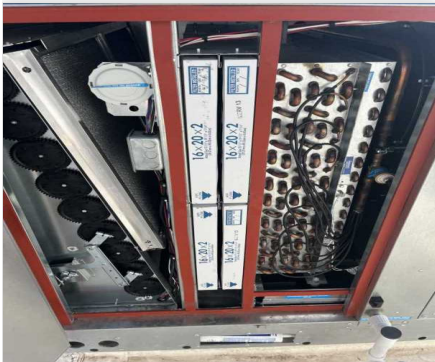
IMG_5360
10/16/2023

Issue Name : DOAS Clogged Filter active fault
Description : The DOAS unit HMI is showing a clogged filter active fault. Unit was checked and the filters are new. GC is aware and CAS is scheduled to come out and address issues with DOAS with Morris Controls. Fan is running for TAB purposes.

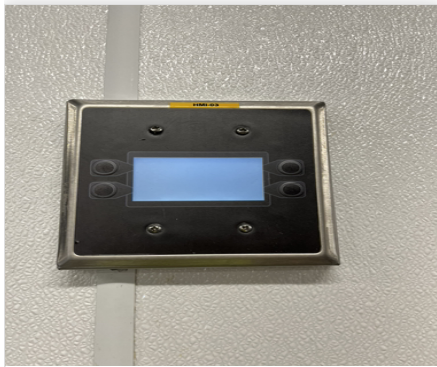
HMIblank
10/17/2023

Issue Name : DOAS kitchen HMI blank screen
Description : Kitchen HMI for DOAS unit is blank and cannot be controlled. GC is aware and CAS is scheduled to come look at the DOAS unit to address the fault messages with Morris controls company..
Created By : National TAB **Assigned To :** National TAB - Jacob Davidson
Status : Open
Originated Date : 10/17/2023 - Jacob Davidson - National TAB

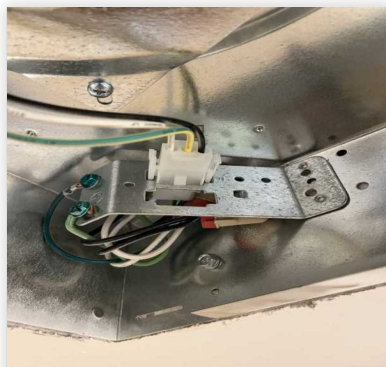
Issue Name : EF1/EF2 no speed controller
Description : EF1 and EF2 for the restrooms are high on flow and have no speed controller to reduce the speed of the fans. Recommend having the responsible party add them to the fans to reduce the airflow.
Created By : National TAB **Assigned To :** National TAB - Jacob Davidson
Status : Open
Originated Date : 10/17/2023 - Jacob Davidson - National TAB

Test Data		
	Design	Actual
CFM	75	117
Fan RPM	-	950
Fan Rotation	-	CCW
Motor RPM	-	950
System SetPt	-	NO SPEED CONTROLLER
RL Voltage	-	121V
RL Amperage	-	0.23A

Notes:
UNIT DOES NOT HAVE A SPEED CONTROLLER.

Test Data		
	Design	Actual
CFM	150	184
Fan RPM	-	1050
Fan Rotation	-	CCW
Motor RPM	-	1050
System SetPt	-	NO SPEED CONTROLLER
RL Voltage	-	121V
RL Amperage	-	1.8A

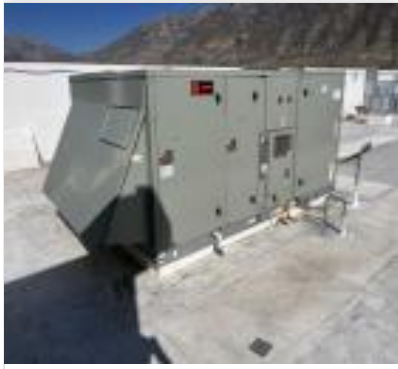
RTU-1

Test Data		
	Design	Actual
SF CFM	4850	4766
SF RPM	-	773
RA CFM	3850	3768
OA CFM	1000	998
RL Voltage	-	206/207/208
RL Amperage	-	9.4/9.2/9.3
SF Rotation	-	CW
RA Damper Position	-	30%
Min OA Damper Position	-	30%
Min OA Damper Type	-	ECONOMIZER
OA Enthalpy Setpt	-	E

Performance Data		
	Design	Actual
MA Plenum SP	-	-0.49"
Fan Suction SP	-	-0.72"
Fan Discharge SP	-	0.55"
Total ESP	1.0"	1.04"
Fan Total SP	-	1.27"

Drive Data		
	Design	Actual
Motor Sheave Size	-	5.25"
Motor Bore Size	-	7/8"
Motor Sheave SetPt	-	4 TURNS OUT
Fan Sheave Size	-	10"
Fan Sheave Bore	-	1-1/8"
Belt CL Distance	-	22.25" TENSIONER IN PLACE
Num of Belts	-	1
Belt Size	-	BX68
Belt Alignment	-	VERIFIED GOOD

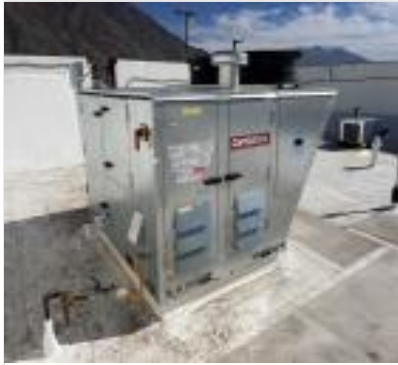
DOAS-1

Test Data		
	Design	Actual
SF CFM	2900	2938
SF RPM	-	1604
RA CFM	0	0
OA CFM	2900	2938
RL Voltage	-	153V VFD
RL Amperage	-	10.9A VFD
SF Rotation	-	CCW
RA Damper Position	-	0%
Min OA Damper Position	-	100%
Min OA Damper Type	-	ECONOMIZER

Performance Data		
	Design	Actual
MA Plenum SP	-	-0.01"
Fan Discharge SP	-	0.09"
Total ESP	0.500	0.10"

Notes:
SPEED SETPOINT: 53.0HZ

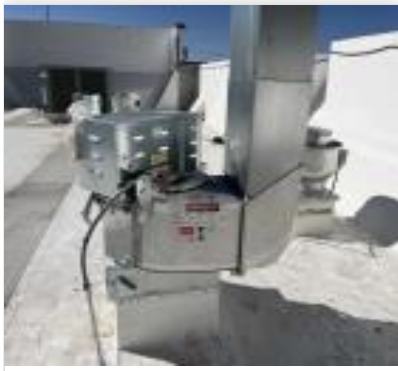
KEF-1

Test Data		
	Design	Actual
CFM	1700	1652
Fan RPM	-	1117
Fan Rotation	-	CCW
Motor RPM	-	1117
System SetPt	-	60.3HZ
RL Voltage	-	164V VFD
RL Amperage	-	2.9A VFD

Notes:
CANNOT GET FAN PRESSURES ON UTILITY FAN.

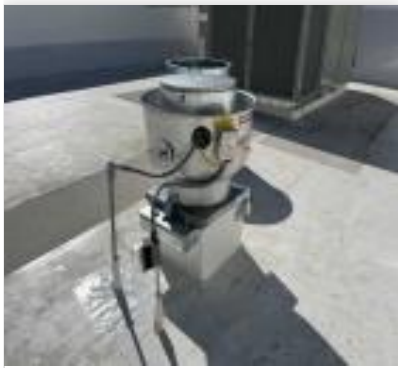
KEF-2

Test Data		
	Design	Actual
CFM	775	782
Fan RPM	-	DD ECM
Fan Rotation	-	CCW
Motor RPM	-	DD ECM
System SetPt	-	60%
RL Voltage	-	122V
RL Amperage	-	2.34A
Total ESP	1.250	0.51"
Fan Inlet SP	-	-0.51"
Fan Discharge SP	-	ATM

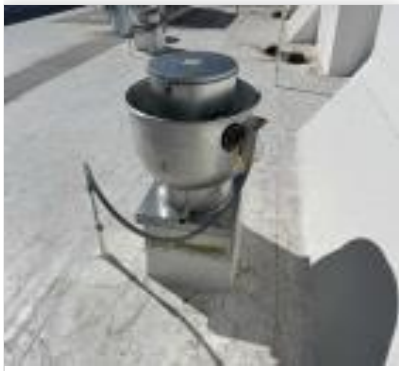
KEF-3

Test Data		
	Design	Actual
CFM	525	558
Fan RPM	-	754
Fan Rotation	-	CCW
Motor RPM	-	754
System SetPt	-	40P
RL Voltage	-	122V
RL Amperage	-	0.55A
Total ESP	0.800"	0.13
Fan Inlet SP	-	-0.13
Fan Discharge SP	-	ATM

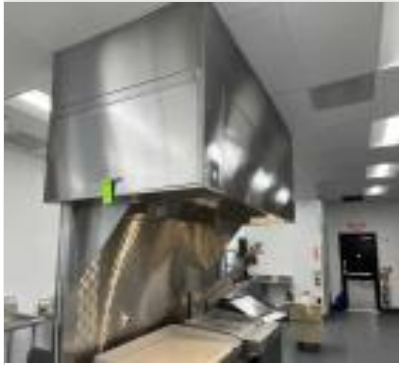
HOOD-1

Test Data Exhaust		
	Design	Actual
Filter Type	CAPTRATE SOLO FILTER	CAPTRATE SOLO FILTER
Filter Size 1	16X16	16X16
Filter Qty 1	6	6
Filter AK factor size 1	1.62	1.62
Filter Total AK Area	9.72	9.72
Filter1 FPM	-	166
Filter2 FPM	-	162
Filter3 FPM	-	180
Filter4 FPM	-	183
Filter5 FPM	-	187
Filter6 FPM	-	142
Filter Ave FPM(corr)	-	170
CFM	1700	1652

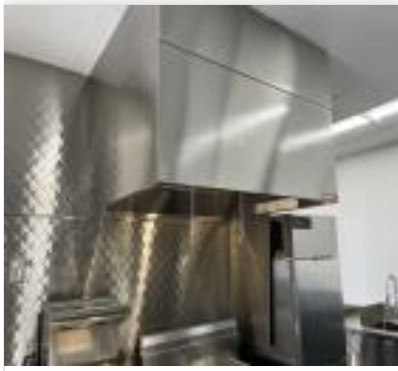
HOOD-2

Test Data Exhaust		
	Design	Actual
Filter Type	CAPTRATE SOLO FILTER	CAPTRATE SOLO FILTER
Filter Size 1	16X16	16X16
Filter Qty 1	3	3
Filter AK factor size 1	1.62	1.62
Filter Total AK Area	4.86	4.86
Filter1 FPM	-	165
Filter2 FPM	-	169
Filter3 FPM	-	149
Filter Ave FPM(corr)	-	161
CFM	775	782

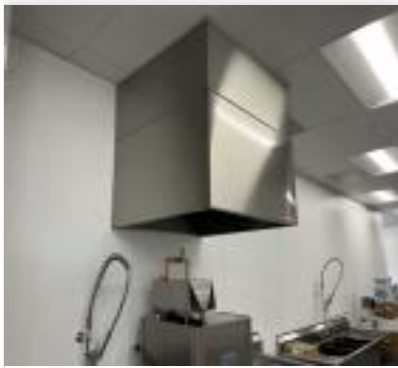
HOOD-3

Test Data		
	Design	Actual
Exhaust CFM	525	558
