TAB Punchlist

Prepared by Tyler Youells

L04810_Expressway Plaza FSU

2280 North Ocean Avenue, Farmingville, New York

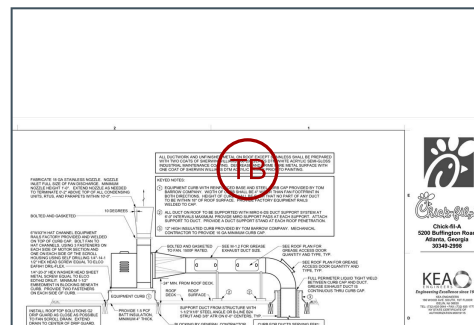
Sheet
M-501

Description
After changes to grease duct repaint/paint ductwork. Exposed grease exhaust duct is to be painted per specification on kitchen hood exhaust fan detail.

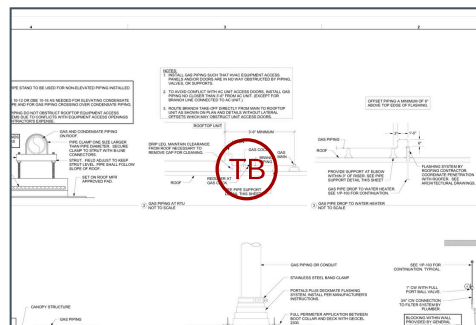
Sheet
P-502

Equipment missing gas grommet, gas startups incomplete, or gas piping is not constructed/supported per normal CFA specifications (incorrect drip leg/missing inverted trap/flex piping connections). Confirm with CFA CM that current installation is acceptable. Typically a reducer occurs pre gas cock. Typical install shown in pics.

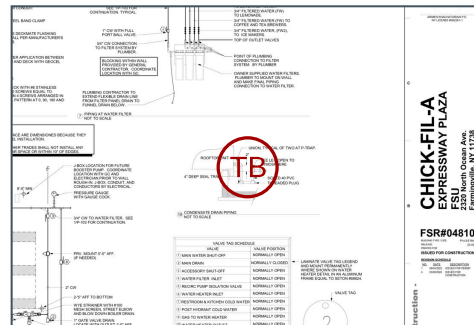
Sheet
P-502

Description
 Equipment condensate piping or p-trap is not constructed per normal CFA specifications. Trap does not have a 2" deep seal and open T vent is not cut below outlet of the unit. Correct all ac unit traps.

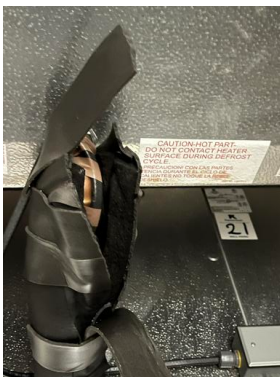
IMG_8620

WIF drain is missing insulation or heat strip. Repair foam tape.

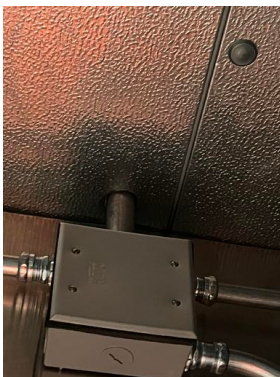
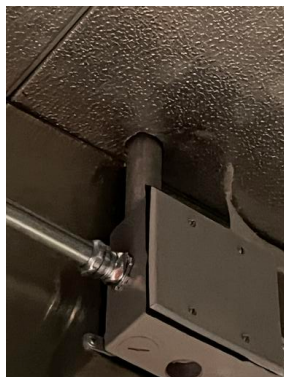
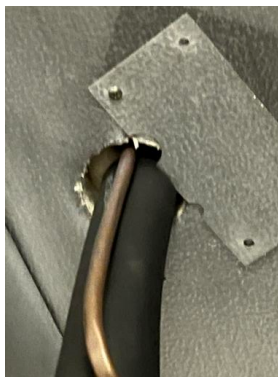
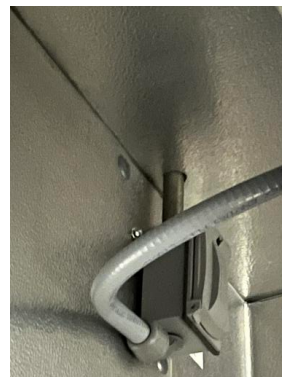
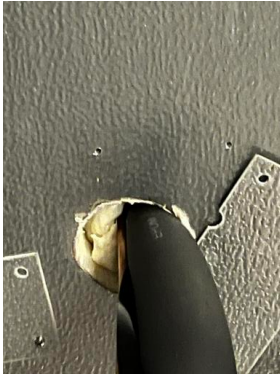
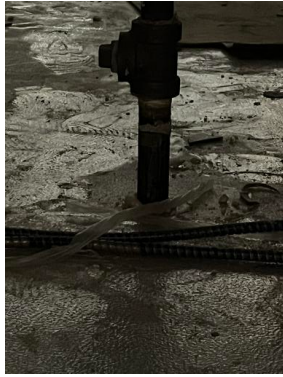
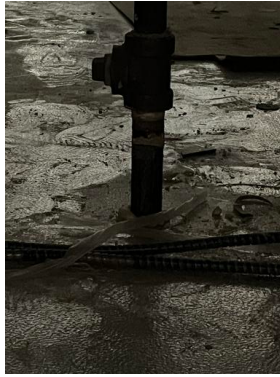
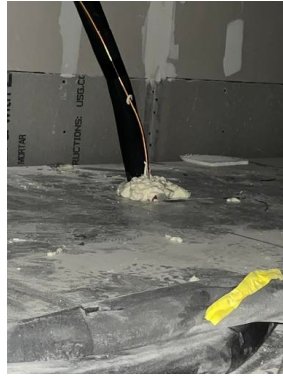
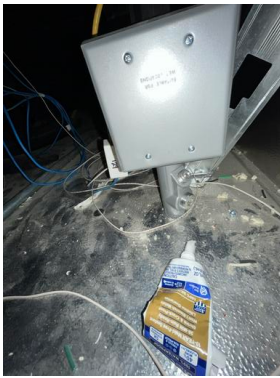
IMG_8616
Tyler Youells
Sep 23, 2024 5:54 PM

WIF/WIC penetrations are not sealed inside with silicone and above ceiling panel with 2 layers of ¼” foam tape 12” above panel at time of inspection.

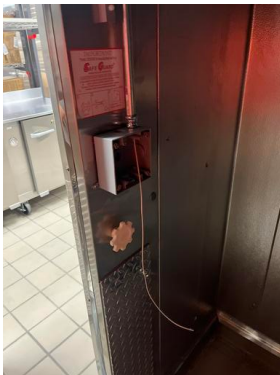
20240923_175501_photo

WIC/WIF heated pressure relief vents not wired.

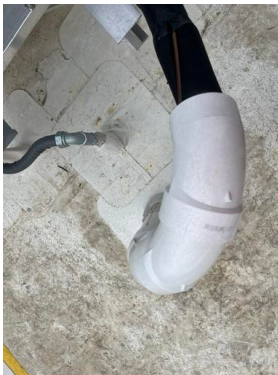
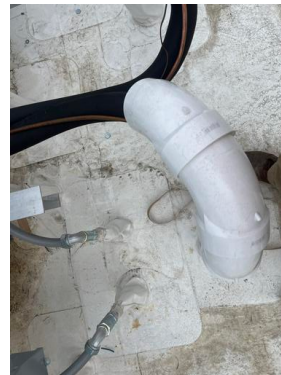
IMG_8604
Tyler Youells
Sep 23, 2024 5:55 PM

PVC pipe chase risers are not constructed to drawing or is not sealed with spray foam to prevent weather/pest infiltration. Gooseneck pieces not glued.
