PlanGrid Task Report - Oct 2, 2024

L04810_Expressway Plaza FSU

2280 North Ocean Avenue, Farmingville, New York

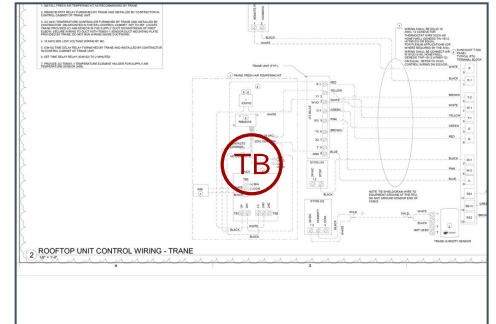
M-701T

#90 [UNIT 504] [NEW] Equipment Fresh Air Tempering.

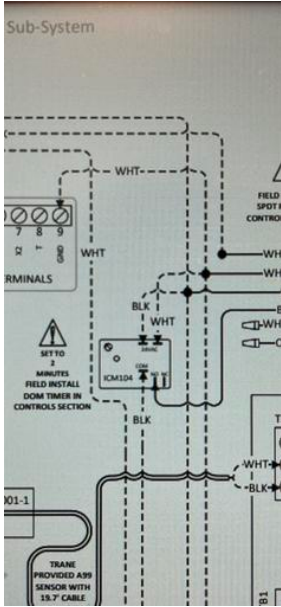
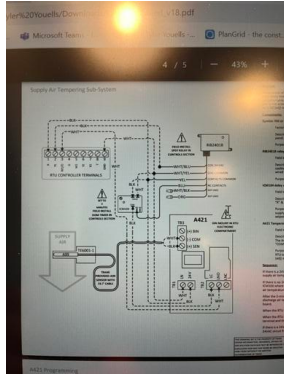
FAT Tempering kits are not functioning properly. The wiring was installed per the Trane drawings provided which also does not match the MSET. When rewired to the MSET drawings the FAT kit still does not work. Per TRANE/SEC MC needs to adapt the kit per the new unreleased spec attached. the new spec requires a different style timer and a few wiring changes.

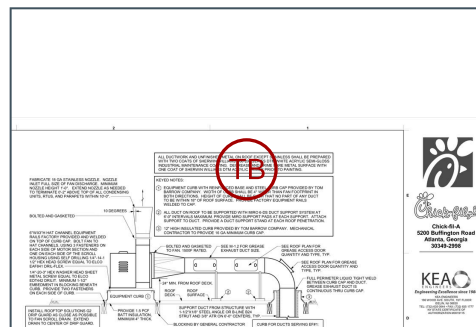
Sheet
M-501

#89 [EXHA 509] [NEW] Grease exhaust duct is not painted.

Description
After changes to grease duct repaint/paint ductwork. Exposed grease exhaust duct is to be painted per specification on kitchen hood exhaust fan detail.

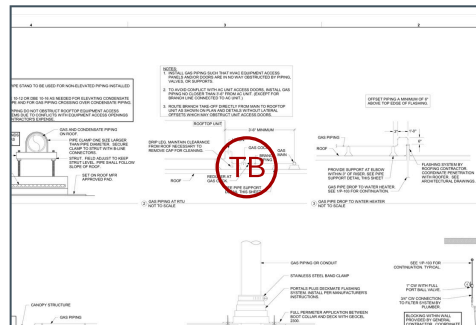
Sheet
P-502

#12 [UNIT 514] [NEW] Equipment gas piping.

Equipment missing gas grommet, gas startups incomplete, or gas piping is not constructed/supported per normal CFA specifications (incorrect drip leg/missing inverted trap/flex piping connections). Confirm with CFA CM that current installation is acceptable. Typically a reducer occurs pre gas cock. Typical install shown in pics.

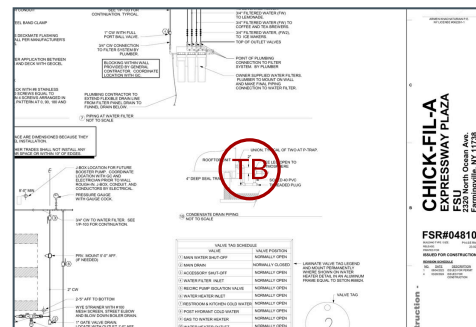
Sheet
P-502

#11 [UNIT 517] [NEW] Condensate piping construction.

Equipment condensate piping or p-trap is not constructed per normal CFA specifications. Trap does not have a 2" deep seal and open T vent is not cut below outlet of the unit. Correct all ac unit traps.

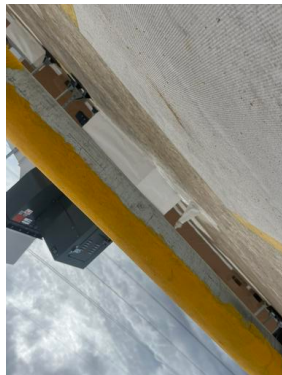
IMG_8587
Tyler Youells
Sep 23, 2024 5:51 PM

Gas piping on roof is not fully painted. Underside of the piping is not painted.

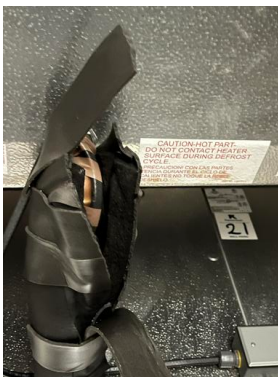
IMG_8620

WIF drain is missing insulation or heat strip. Repair foam tape.

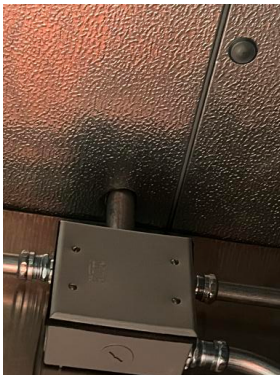
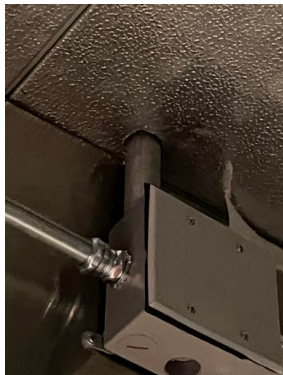
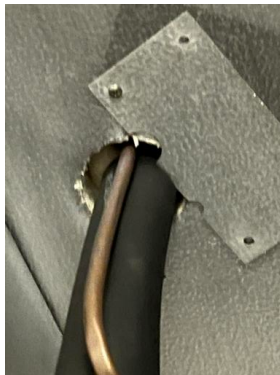
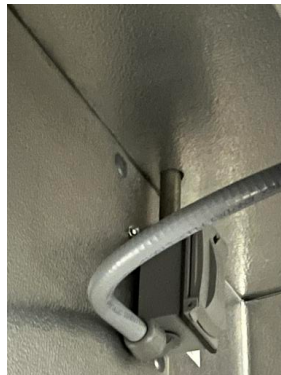
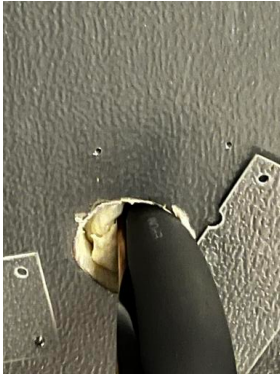
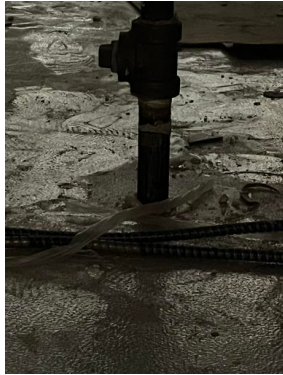
WIF/WIC penetrations are not sealed inside with silicone and above ceiling panel with 2 layers of ¼" foam tape 12" above panel at time of inspection.

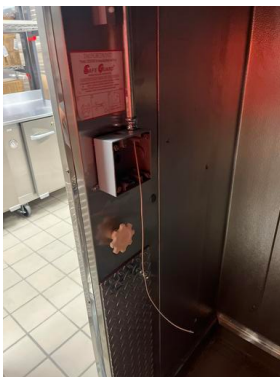
20240923_175501_photo

WIC/WIF heated pressure relief vents not wired.

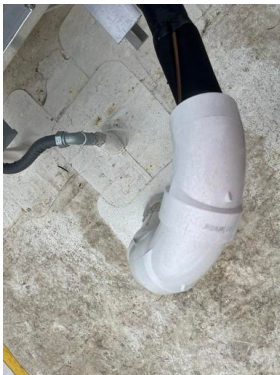
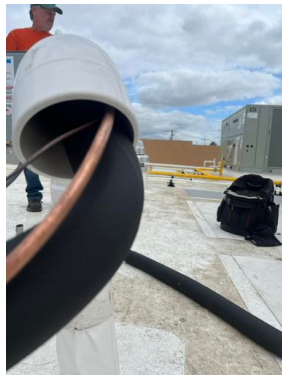
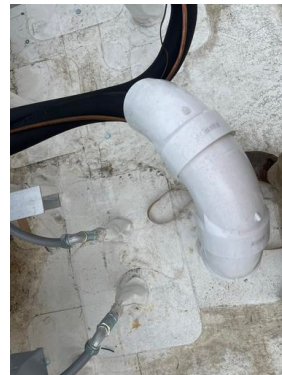
PVC pipe chase risers are not constructed to drawing or is not sealed with spray foam to prevent weather/pest infiltration. Gooseneck pieces not glued.

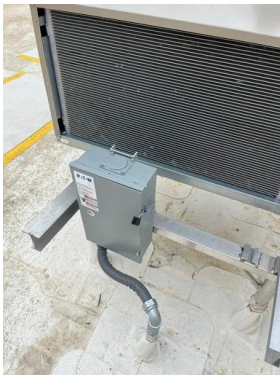
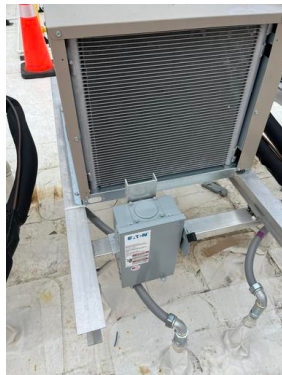
Electrical disconnects are not properly labeled.

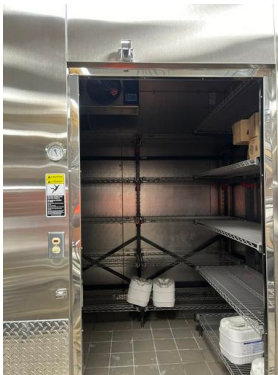
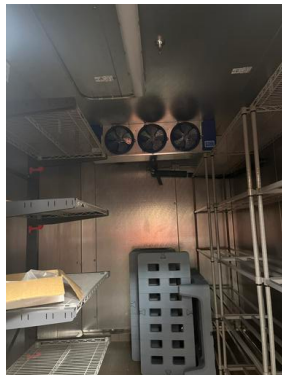
WIC/WIF boxes were not powered at time of inspection and operational functionality could not be verified. Door counters, heaters, heated lines, and temperatures could not be checked.
