Report: TAB Report
Function: Test, Adjust, & Balance
Date: 10/24/2025
Completed By: National TAB

PROJECT
11-03-25 QT #0830 BUFORD, GA

Project: 11-03-25 QT #0830 BUFORD, GA

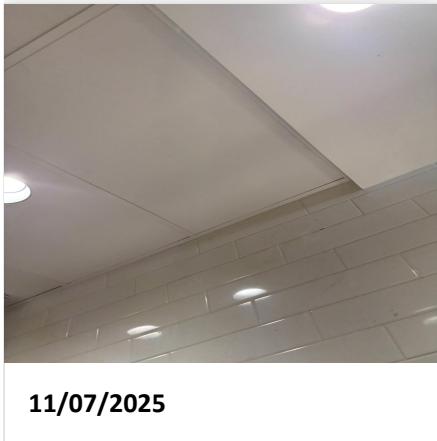
Issue Name : EF-1 COMBI-OVEN EXHAUST GRILL NO INSTALLED
Description : The combi-oven exhaust fan grille is not installed.
Created By : National TAB **Assigned To :** National TAB - Dan Hertenstein
Status : Open
Priority : Urgent **Asset Tag :**
Originated Date : 11/07/2025 - Sagar Patel - National TAB

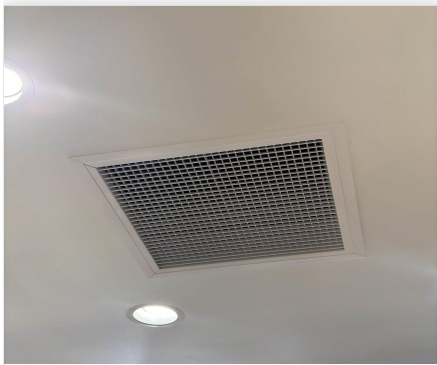
Issue Name : RTU-3: DIFFUSER 3-1 LOW ON AIR FLOW
Description : Diffuser 3-1 is low on airflow and remains unchanged when adjusting the damper. Suspect the damper is stuck. The diffuser is reading 186 cfm.
Created By : National TAB **Assigned To :** National TAB - Dan Hertenstein
Status : Open
Priority : Urgent **Asset Tag :**
Originated Date : 11/07/2025 - Sagar Patel - National TAB

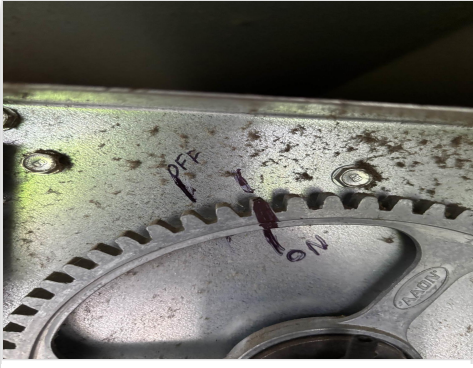
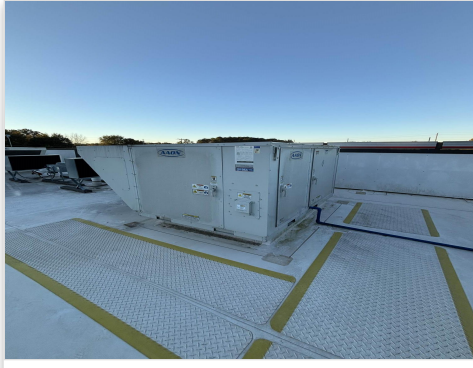
Unit Data - PHOTO LOG

Unit Data	
	Actual
MFG	AAON
Serial Num	202105-ANEK22258
Model Num	RN-013-8-0-EA0A-152
Num OA Filters 1	1
OA Filter Size 1	45X22
Num Final Filter 1	4
Final Filter Size 1	20X25X2

Test Data		
	Design	Actual
SF CFM	4200	4149
SF RPM	-	1496
OA CFM (Hoods On)	800	832
OA CFM (Hoods Off)	350	378
RL Voltage	-	189 VFD
RL Amperage	-	8.62 VFD
VFD Max SetPt	-	51 HZ
VFD Min SetPt	-	24 HZ
OA Damper Position (Hoods On)	-	46%
OA Damper Position (Hoods Off)	-	26%

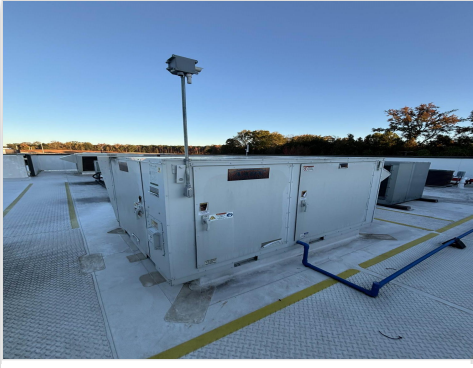
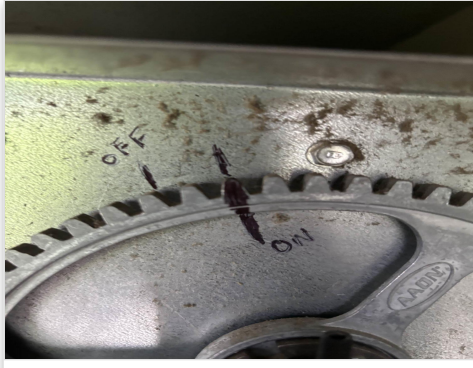
Unit Data - PHOTO LOG

Unit Data	
	Actual
MFG	AAON
Serial Num	202105-ANEK22259
Model Num	RN-013-8-0-EA0A-152
Num OA Filters 1	1
OA Filter Size 1	45X22
Num Final Filter 1	4
Final Filter Size 1	20X25X2

Test Data		
	Design	Actual
SF CFM	4200	4332
SF RPM	-	1408
OA CFM (Hoods On)	800	853
OA CFM (Hoods Off)	350	344
RL Voltage	-	170 VFD
RL Amperage	-	8.31 VFD
VFD Max SetPt	-	48 HZ
VFD Min SetPt	-	24 HZ
OA Damper Position (Hoods On)	-	46%
OA Damper Position (Hoods Off)	-	26%

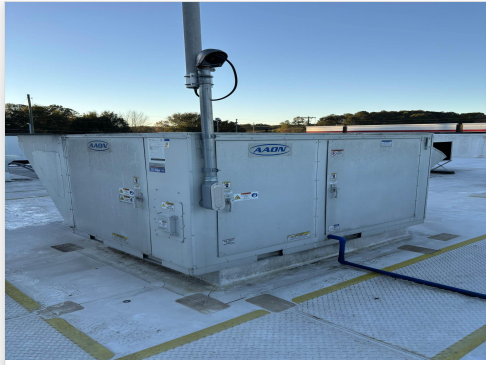
Unit Data - PHOTO LOG

Unit Data	
	Actual
MFG	AAON
Serial Num	202105-ANEK22260
Model Num	RN-013-8-0-EA0A-152
Num OA Filters 1	1
OA Filter Size 1	45X22
Num Final Filter 1	4
Final Filter Size 1	20X25X2

Test Data		
	Design	Actual
SF CFM	4200	3997
SF RPM	-	1496
OA CFM (Hoods On)	800	798
OA CFM (Hoods Off)	350	351
RL Voltage	-	190 VFD
RL Amperage	-	9.16 VFD
VFD Max SetPt	-	51 HZ
VFD Min SetPt	-	24 HZ
OA Damper Position (Hoods On)	-	46%
OA Damper Position (Hoods Off)	-	26%

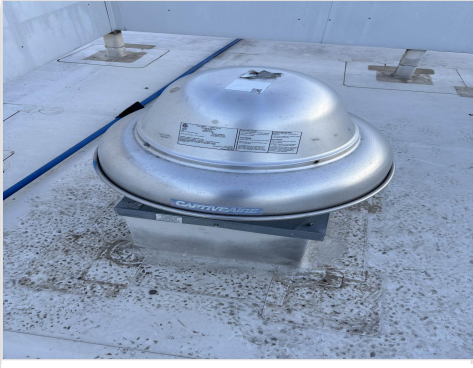
Unit Data - PHOTO LOG

Unit Data		
	Design	Actual
MFG	CAPTIVEAIRE	CAPTIVEAIRE
Model Num	NA	DR50HFA
Serial Num	-	4942353
Type	DOWNBLAST	DOWNBLAST
Configuration	VERTICAL	VERTICAL

[1] UNABLE TO READ VOLTS AND AMPS SAFELY

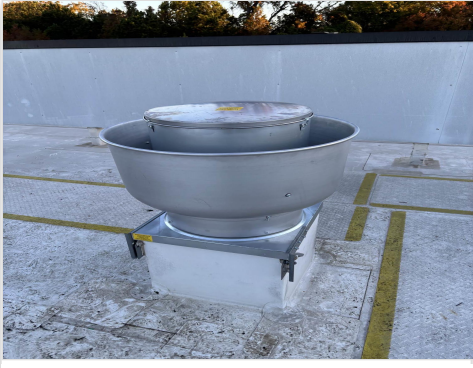
Unit Data - PHOTO LOG

Unit Data		
	Design	Actual
MFG	CAPTIVEAIRE	CAPTIVEAIRE
Model Num	NA	DU50HFA
Serial Num	-	7657526
Type	UPBLAST	UPBLAST
Configuration	VERTICAL	VERTICAL

Test Data		
	Design	Actual
CFM	1350	1323
Fan RPM	-	1174
Fan Rotation	-	CCW
Motor RPM	-	1174
System SetPt	-	51.8 HZ
RL Voltage	-	211
RL Amperage	-	1.6
Total ESP	0.750"	0.33"
Fan Inlet SP	-	-0.33"
Fan Discharge SP	-	1 ATM

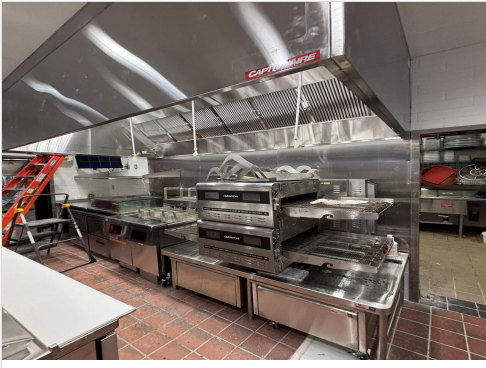
Unit Data - PHOTO LOG

Unit Data		
	Design	Actual
MFG	CAPTIVEAIRE	CAPTIVEAIRE
Model Num	6030ND-2-F	6030ND-2-F
Job / Serial Num	-	7657526
Type	TYPE I CANOPY	TYPE I CANOPY
Hood length	108"	108"
Hood Width	60"	60"

Test Data Exhaust		
	Design	Actual
Filter Type	CAPTRATE SOLO FILTER	CAPTRATE SOLO FILTER
Filter Size 1	20X16	20X16
Filter Qty 1	6	6
Filter AK factor size 1	2.08	2.08
Filter Total AK Area	12.48	12.48
Filter1 FPM	-	107
Filter2 FPM	-	106
Filter3 FPM	-	116
Filter4 FPM	-	107
Filter5 FPM	-	108
Filter6 FPM	-	96
Filter Ave FPM(corr)	-	106
CFM	1350	1323
