**Report: PRELIM TAB**  
**Function: Test, Adjust, & Balance**  
**Date: 10/29/2025**  
**Completed By: National TAB**

**PROJECT**  
**08-25-25 WAWA #7206 COLERAIN, OH**

10329 COLERAIN AVE & STRUBLE RD

Project: 08-25-25 WAWA #7206 COLERAIN, OH

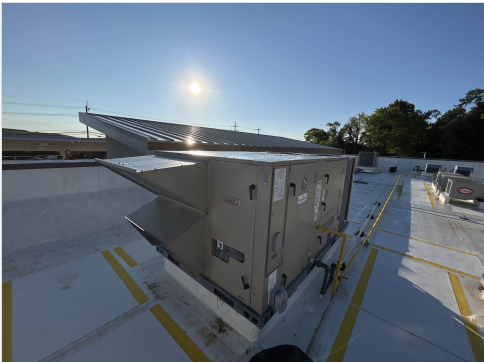
## Unit Data - PHOTO LOG

Asset: RTU2

AREA:RETAIL

Unit Data		
	Design	Actual
MFG	LENNOX	LENNOX
Serial Num	-	5624L01941
Model Num	LGT102H4E	LGT102H4E
Type	RTU	RTU
Configuration	VERTICAL	VERTICAL
Num OA Filters 1	-	2
OA Filter Size 1	-	16"x25"
Num Final Filter 1	-	4
Final Filter Size 1	-	20"x25"x2"

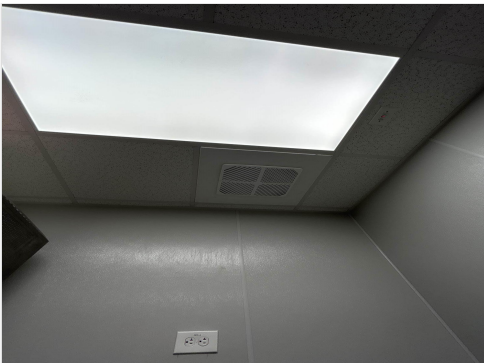
## Unit Data - PHOTO LOG

Asset: EF3

Unit Data		
	Design	Actual
<b>MFG</b>	GREENHECK	GREENHECK
<b>Model Num</b>	SP-B200	SP-B200
<b>Serial Num</b>	-	26473456
<b>Type</b>	CEILING	CEILING
