Report: TAB Report
Function: Test, Adjust, & Balance
Date: 11/11/2025
Completed By: National TAB

08-25-25 WAWA #7206 COLERAIN, OH

Project: 08-25-25 WAWA #7206 COLERAIN, OH

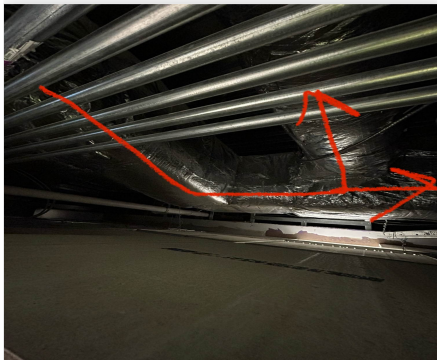
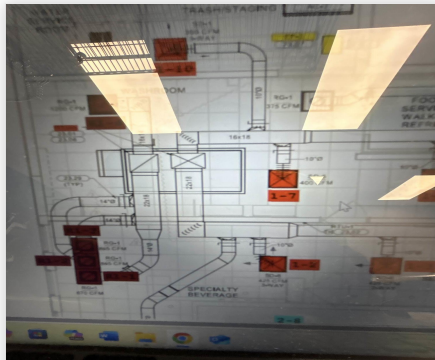
Issue Name : RTU 1 Diffuser 7 Low Flow
Description : Rtu 1 diffuser 7 low on airflow. When other diffusers airflow were reduced the airflow at diffuser 7 remained unchanged. Takeoff for diffuser 7 is close to an 90 degree turn. This may be preventing air from getting to diffuser 7. Other diffusers reopened to keep airflow total at design.
Created By : National TAB **Assigned To :** National TAB - Will Turnbough
Status : Open
Priority : Low **Asset Tag :**
Originated Date : 08/26/2025 - Gabe Merk - National TAB

- **08/28/2025 National TAB - Gabe Merk**
 - This will not be resolved without redesigning the takeoff for this unit.

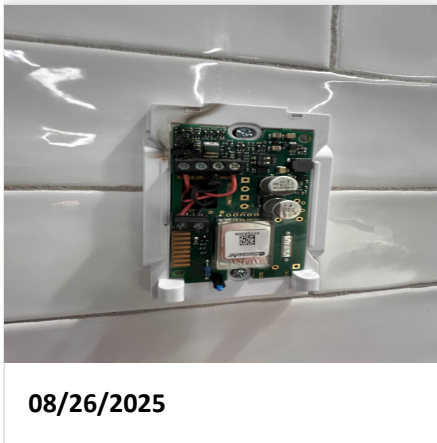
Issue Name : RTU 2 CO2 SENSOR
Description : RTU 2 CO2 sensor shorted. Replacement is needed.
Created By : National TAB **Assigned To :** National TAB - Will Turnbough
Status : Open
Priority : Medium **Asset Tag :**
Originated Date : 08/26/2025 - Gabe Merk - National TAB

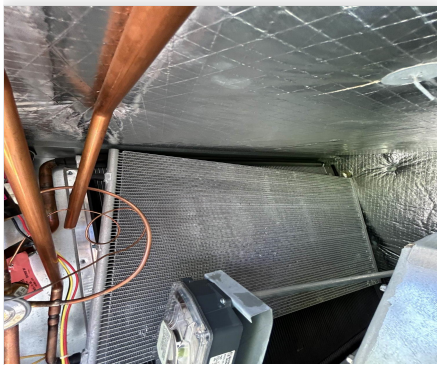
Issue Name : RTU 3 Reheat Coil
Description : Rtu 3 reheat coil improperly installed. This may lead to refrigerant leaks in the future.
Created By : National TAB **Assigned To :** National TAB - Will Turnbough
Status : Open
Priority : Low **Asset Tag :**
Originated Date : 08/26/2025 - Gabe Merk - National TAB

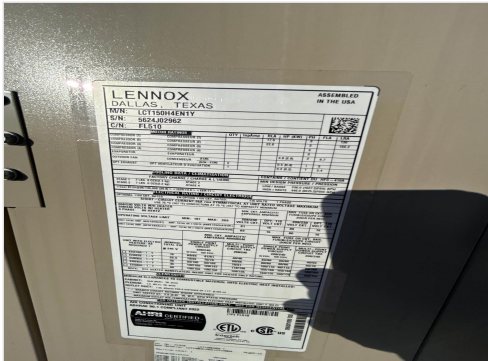
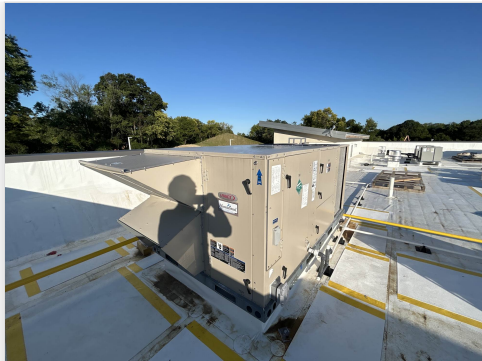
Unit Data - PHOTO LOG

Unit Data		
	Design	Actual
MFG	LENNOX	LENNOX
Serial Num	-	5624J02962
Model Num	LCT150H4E	LCT150H4E
Type	RTU	RTU
Configuration	VERTICAL	VERTICAL
Num OA Filters 1	-	2
OA Filter Size 1	-	16"x25"
Num Final Filter 1	-	4
Final Filter Size 1	-	20"x25"x2"

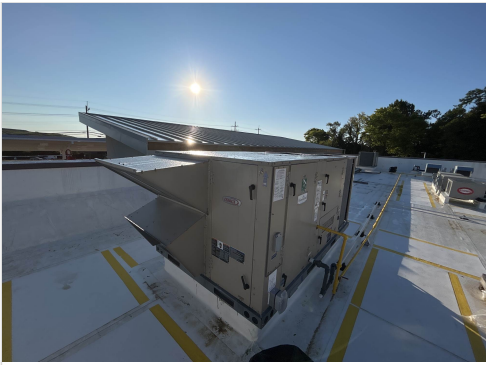
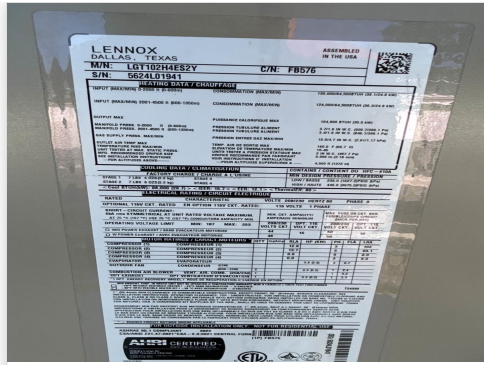
Unit Data - PHOTO LOG

Unit Data		
	Design	Actual
MFG	LENNOX	LENNOX
Serial Num	-	5624L01941
Model Num	LGT102H4E	LGT102H4E
Type	RTU	RTU
Configuration	VERTICAL	VERTICAL
Num OA Filters 1	-	2
OA Filter Size 1	-	16"x25"
Num Final Filter 1	-	4
Final Filter Size 1	-	20"x25"x2"

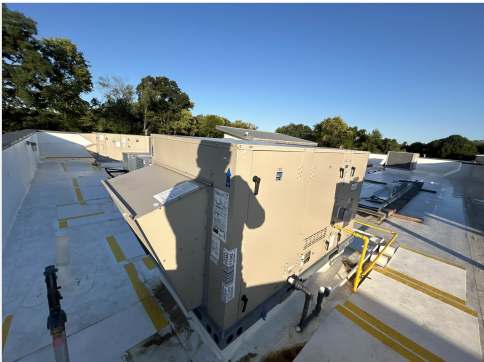
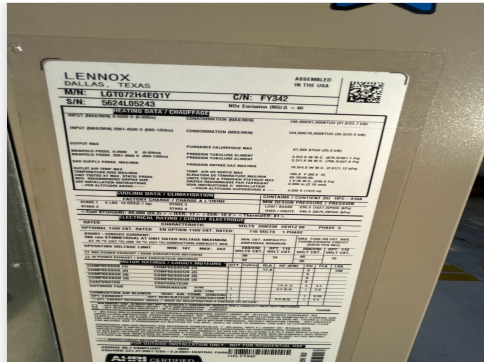
Unit Data - PHOTO LOG

Unit Data		
	Design	Actual
MFG	LENNOX	LENNOX
Serial Num	-	5624L05243
Model Num	LGT072H4E	LGT072H4E
Type	RTU	RTU
Configuration	VERTICAL	VERTICAL
Num OA Filters 1	-	1
OA Filter Size 1	-	16"x31"
Num Final Filter 1	-	4
Final Filter Size 1	-	20"x20"x2"

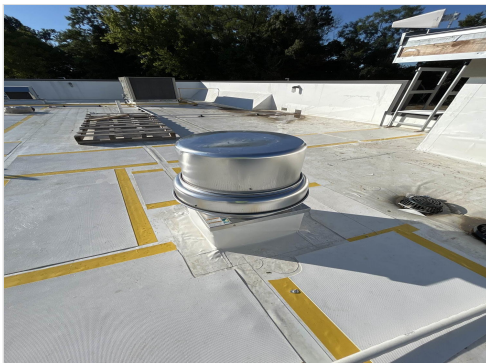
Unit Data - PHOTO LOG

Unit Data		
	Design	Actual
MFG	GREENHECK	GREENHECK
Model Num	GB-098-6	GB-098-6
Serial Num	-	26477762
Type	DOWNBLAST	CRE DOWNBLAST
Configuration	VERTICAL	VERTICAL

- Motor sheave:VP25
- Motor bore: 7/16"
- Fan sheave: 3-7/16"
- Fan bore: 3/4"
- Belt CL: 5-1/4"
- 1-3L180 Belt

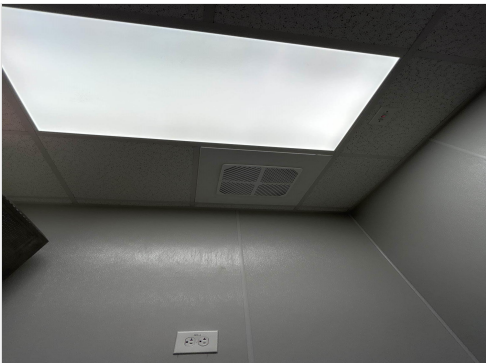
Unit Data - PHOTO LOG

Unit Data		
	Design	Actual
MFG	GREENHECK	GREENHECK
Model Num	SP-B200	SP-B200
Serial Num	-	26473456
Type	CEILING	CEILING
