Report: TAB Report
Function: Test, Adjust, & Balance
Date: 11/11/2025
Completed By: National TAB

08-25-25 WAWA #7206 COLERAIN, OH

10329 COLERAIN AVE & STRUBLE RD

Project: 08-25-25 WAWA #7206 COLERAIN, OH

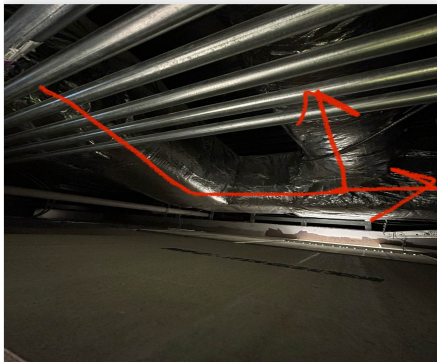
Issue Name : RTU 1 Diffuser 7 Low Flow
Description : Rtu 1 diffuser 7 low on airflow. When other diffusers airflow were reduced the airflow at diffuser 7 remained unchanged. Takeoff for diffuser 7 is close to an 90 degree turn. This may be preventing air from getting to diffuser 7. Other diffusers reopened to keep airflow total at design.
Created By : National TAB **Assigned To :** National TAB - Will Turnbough
Status : Open
Priority : Low **Asset Tag :**
Originated Date : 08/26/2025 - Gabe Merk - National TAB

- **08/28/2025 National TAB - Gabe Merk**
 - This will not be resolved without redesigning the takeoff for this unit.

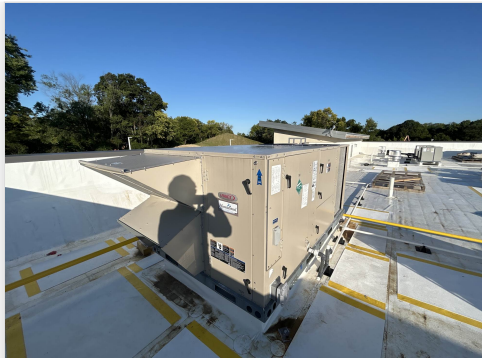
Unit Data - PHOTO LOG

Unit Data		
	Design	Actual
MFG	LENNOX	LENNOX
Serial Num	-	5624J02962
Model Num	LCT150H4E	LCT150H4E
Type	RTU	RTU
Configuration	VERTICAL	VERTICAL
Num OA Filters 1	-	2
OA Filter Size 1	-	16"x25"
Num Final Filter 1	-	4
Final Filter Size 1	-	20"x25"x2"

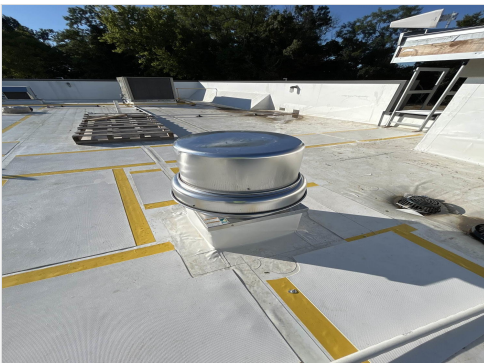
Unit Data - PHOTO LOG

Unit Data		
	Design	Actual
MFG	GREENHECK	GREENHECK
Model Num	GB-098-6	GB-098-6
Serial Num	-	26477762
Type	DOWNBLAST	CRE DOWNBLAST
Configuration	VERTICAL	VERTICAL

Motor sheave:VP25

Motor bore: 7/16"

Fan sheave: 3-7/16"

Fan bore: 3/4"

Belt CL: 5-1/4"

1-3L180 Belt
